# A “Hole” New Look at Corrosion

Michigan Department of  
Environmental Quality

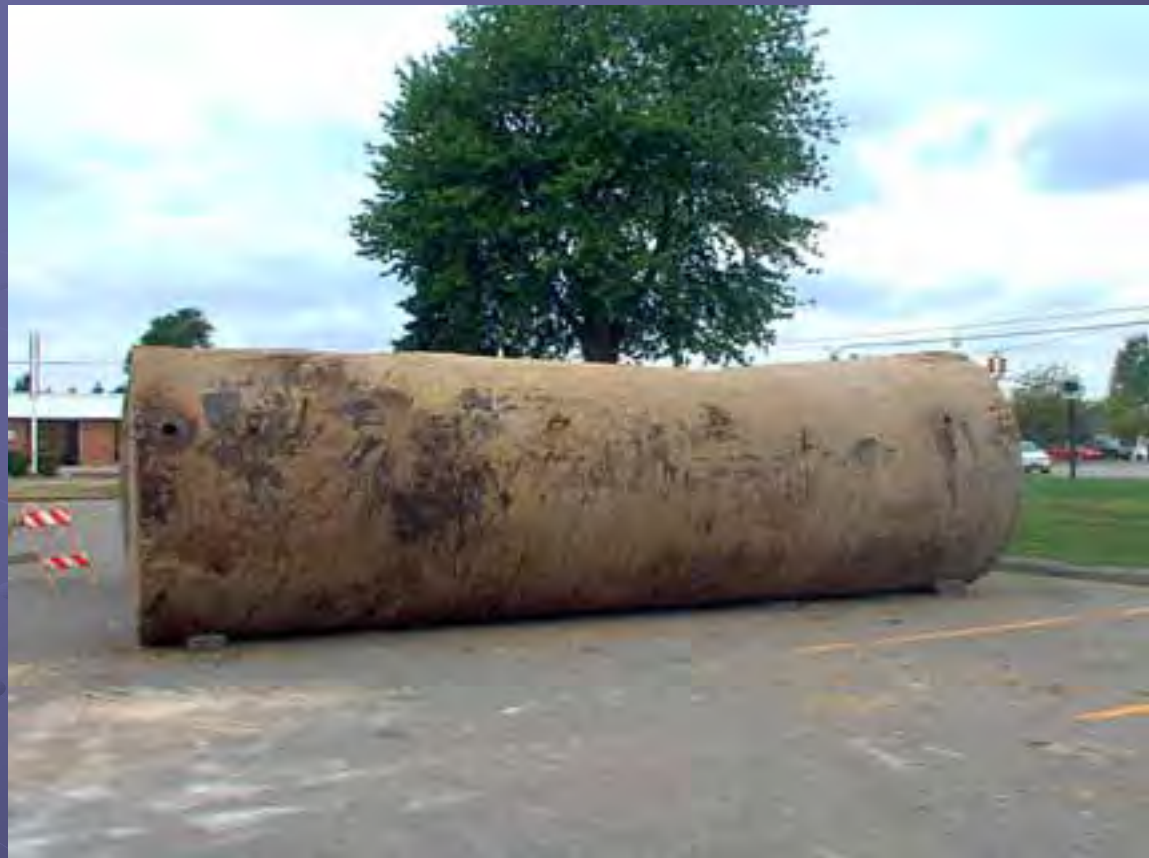
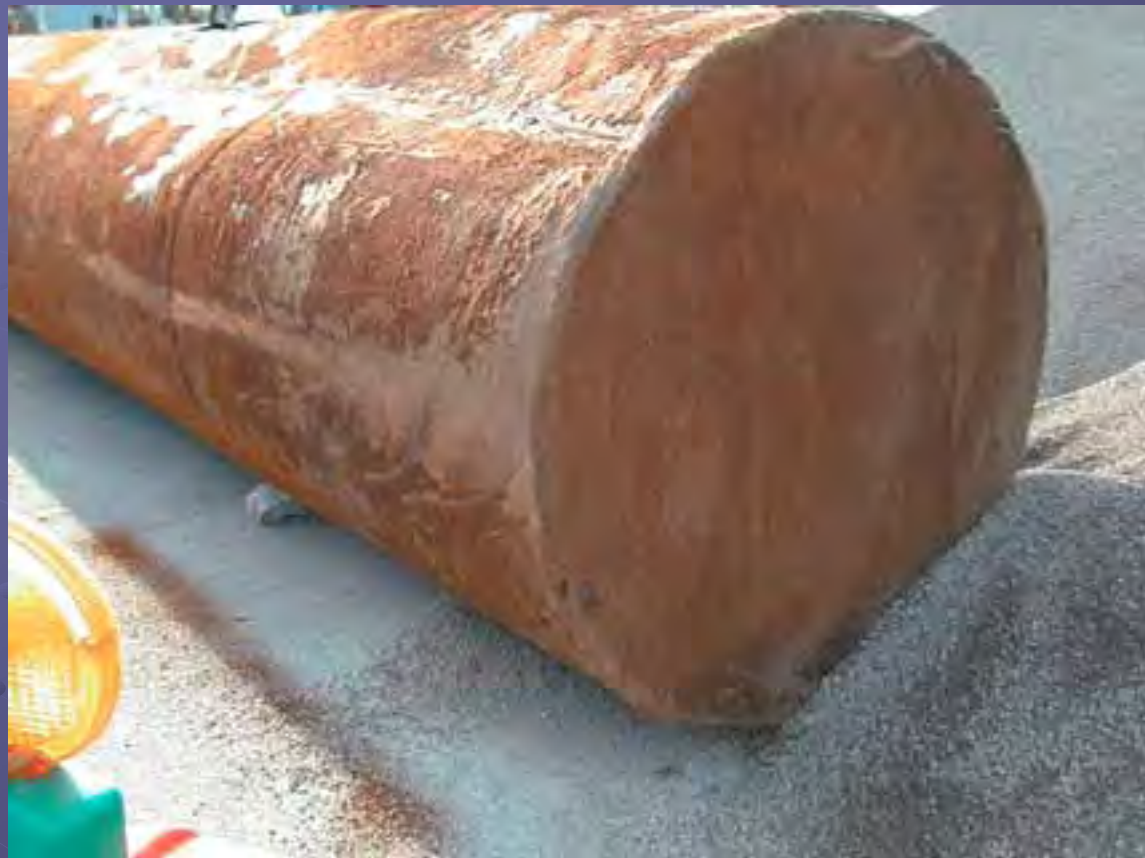
# Tank May Not Continue in Use:

- Tank is greater than 2% out of round.
- Tank has a flat spot which has a cross measurement greater than the radius of the tank endcap.

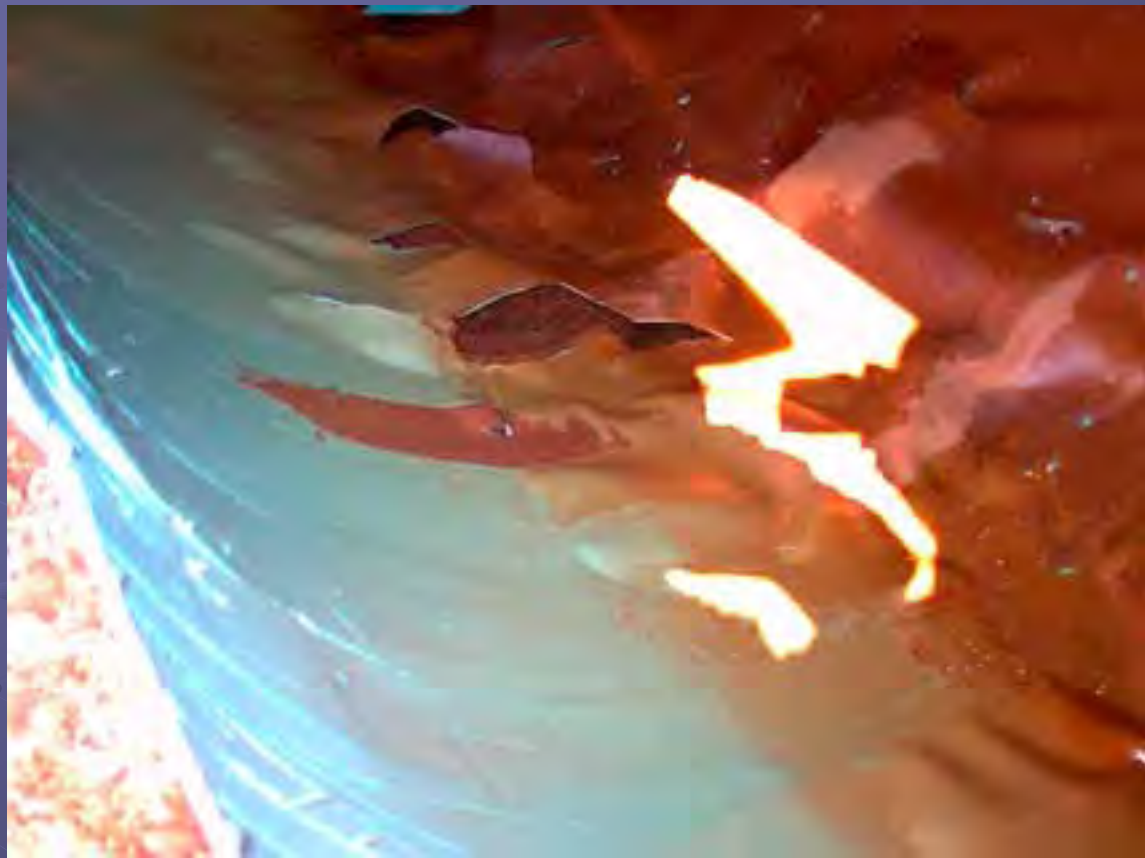
# Lining Problems

- Disbondment
- Flaking
- Bubbled
