SECONDARY CONTAINMENT - DOUBLE TROUBLE ?

KEVIN HENDERSON

**17th ANNUAL UST/LUST NATIONAL CONFERENCE
SEATTLE, WASHINGTON**

MARCH 15, 2005

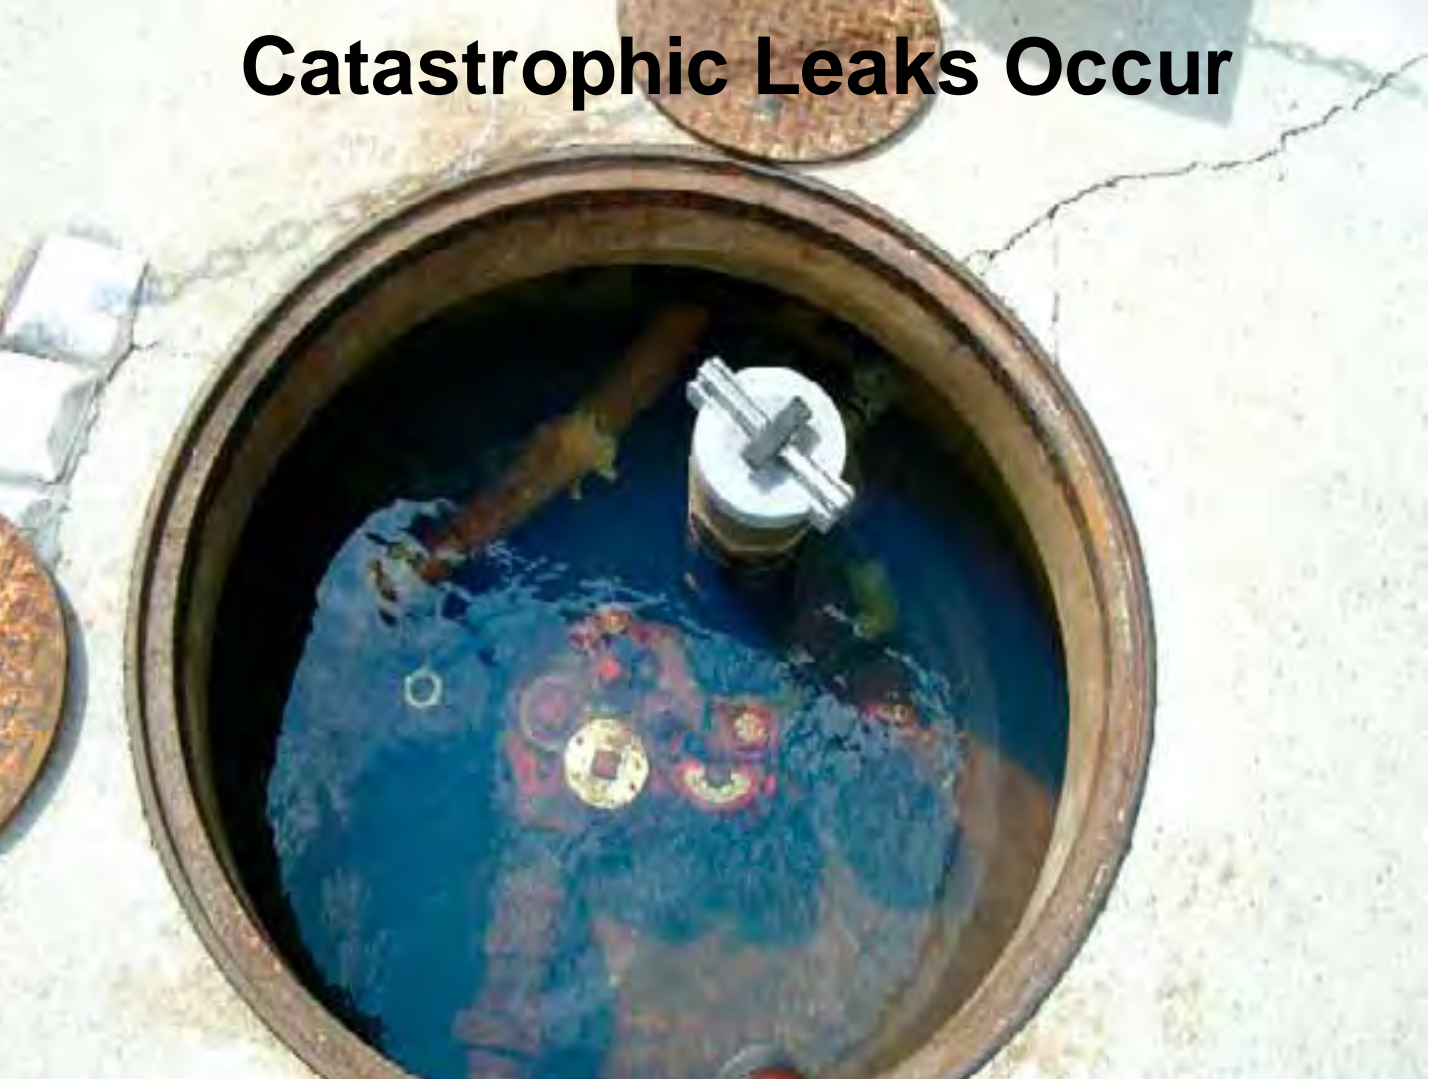
Catastrophic Leaks Occur

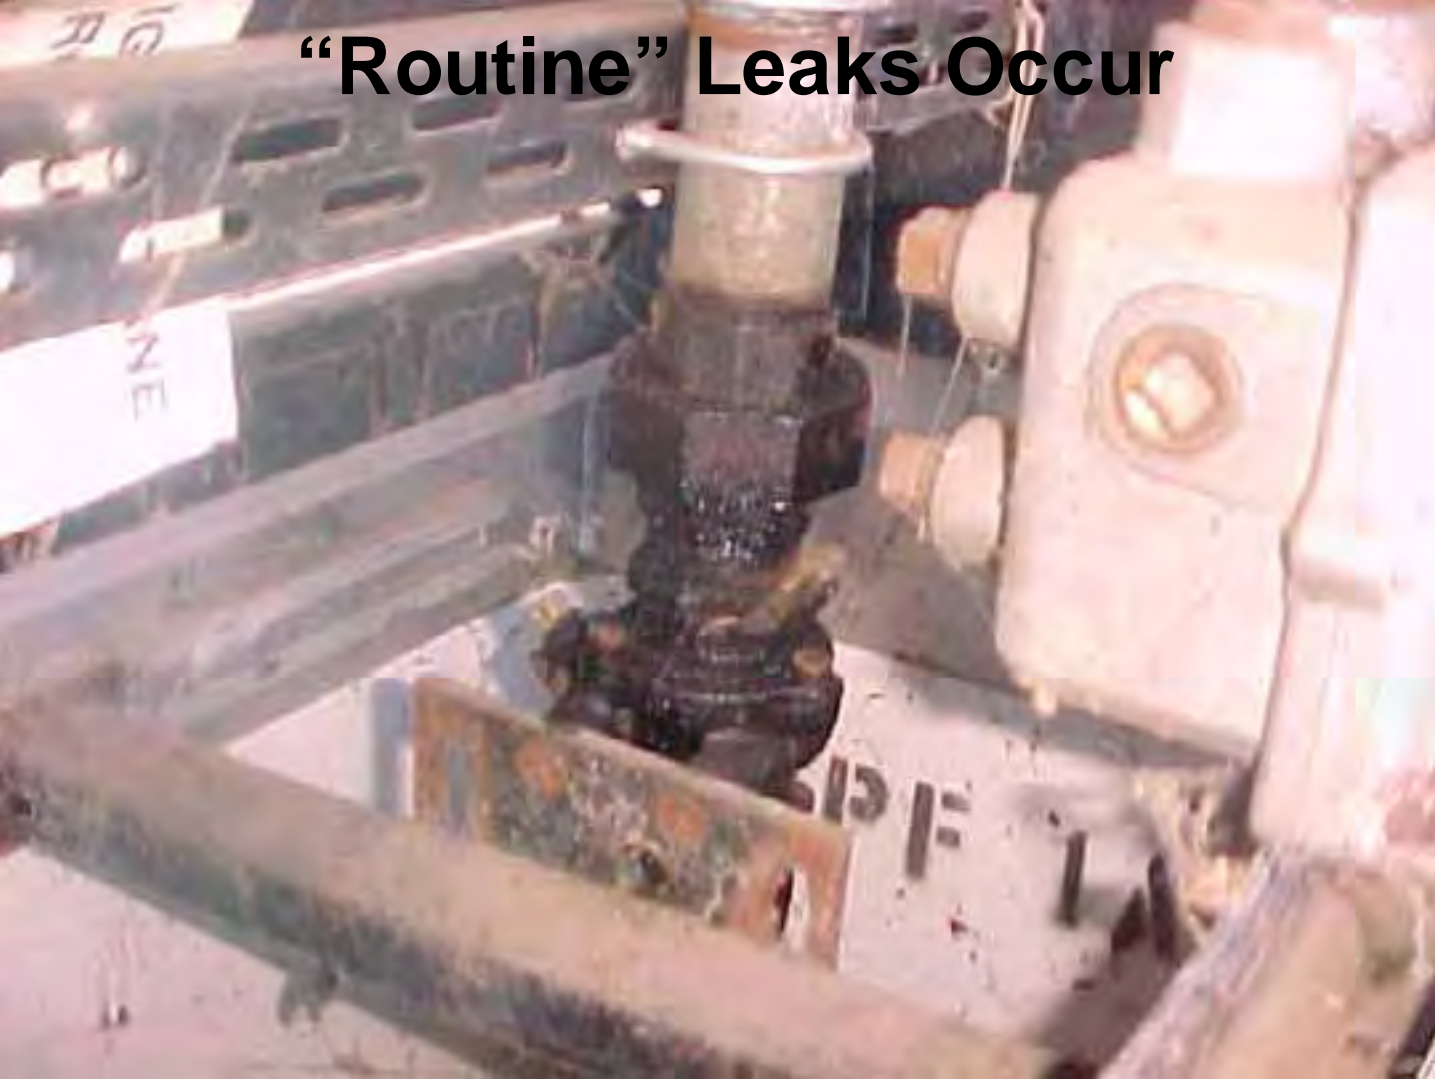
“Routine” Leaks Occur

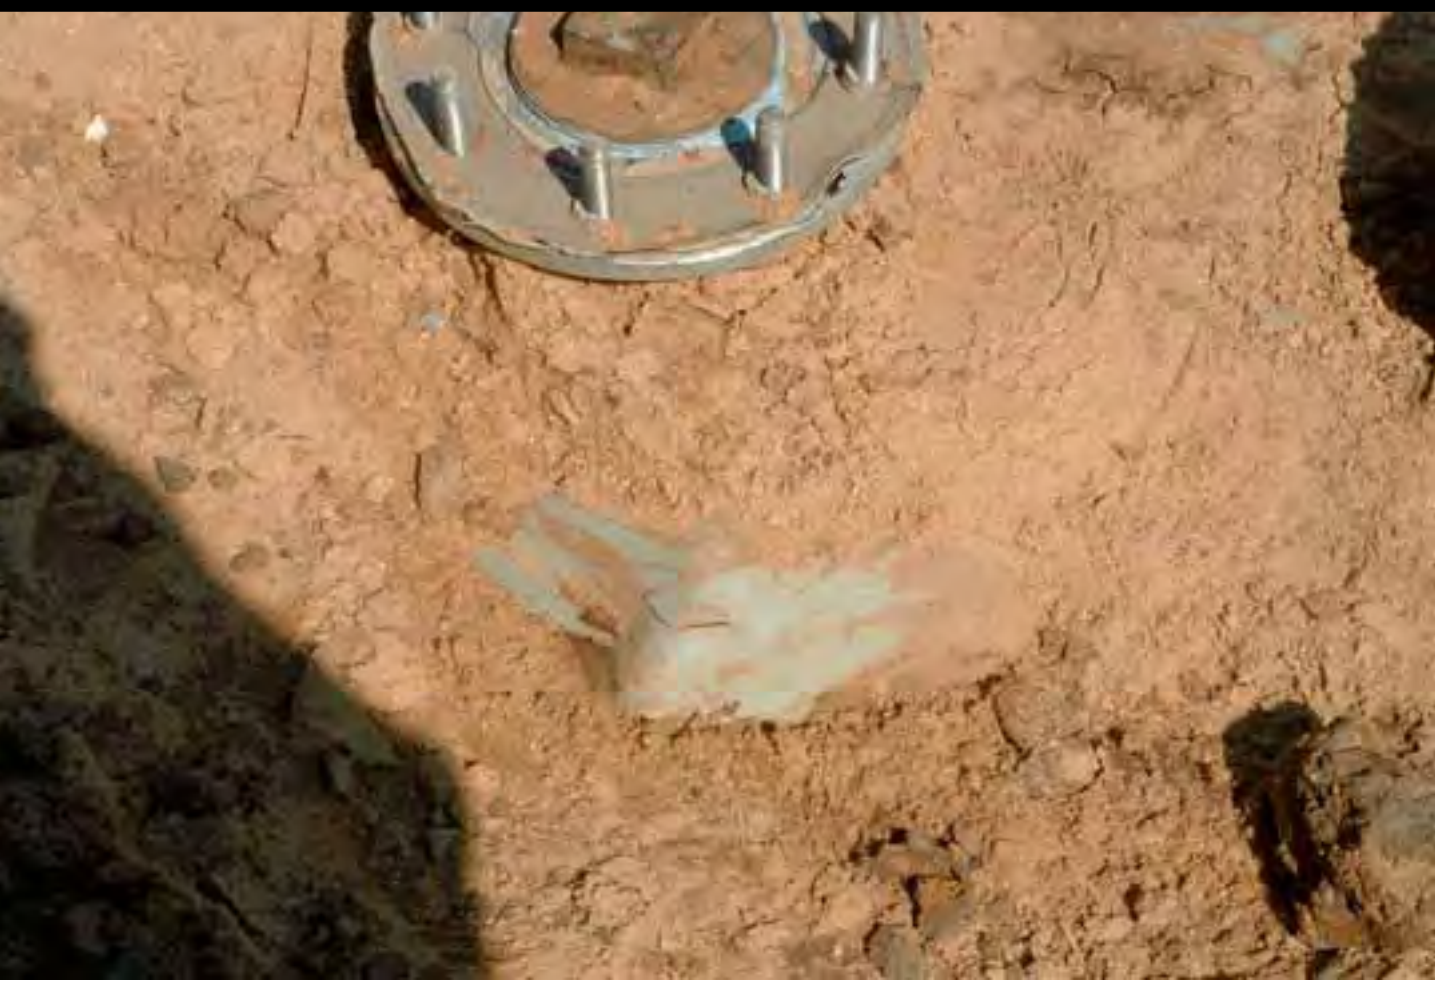
SECONDARY INTEGRITY ?

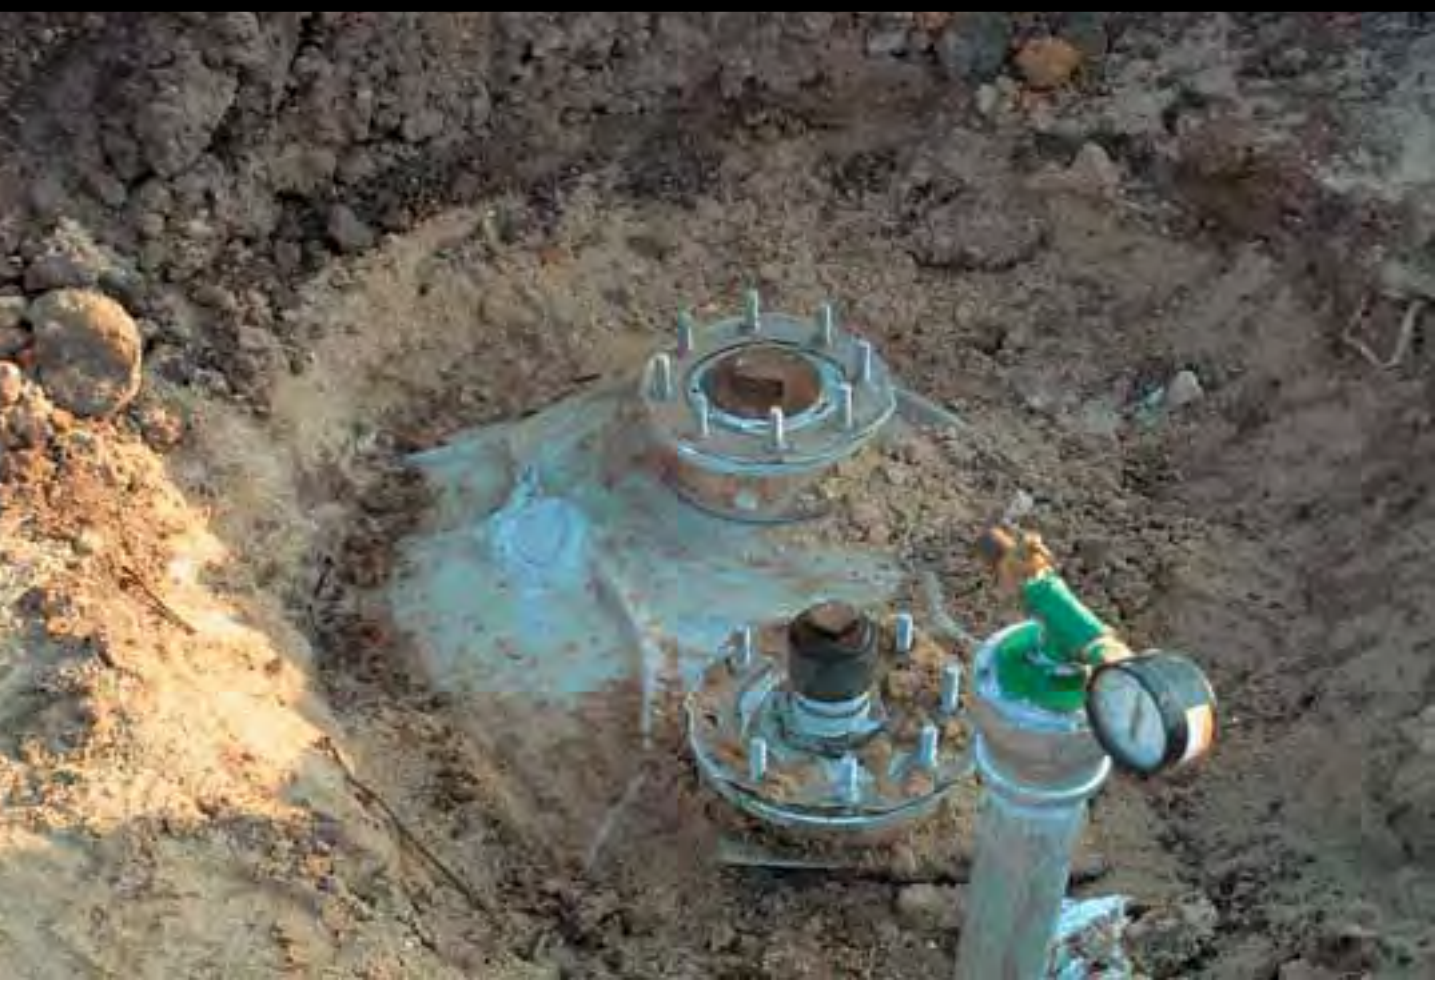
REPAIRS ?

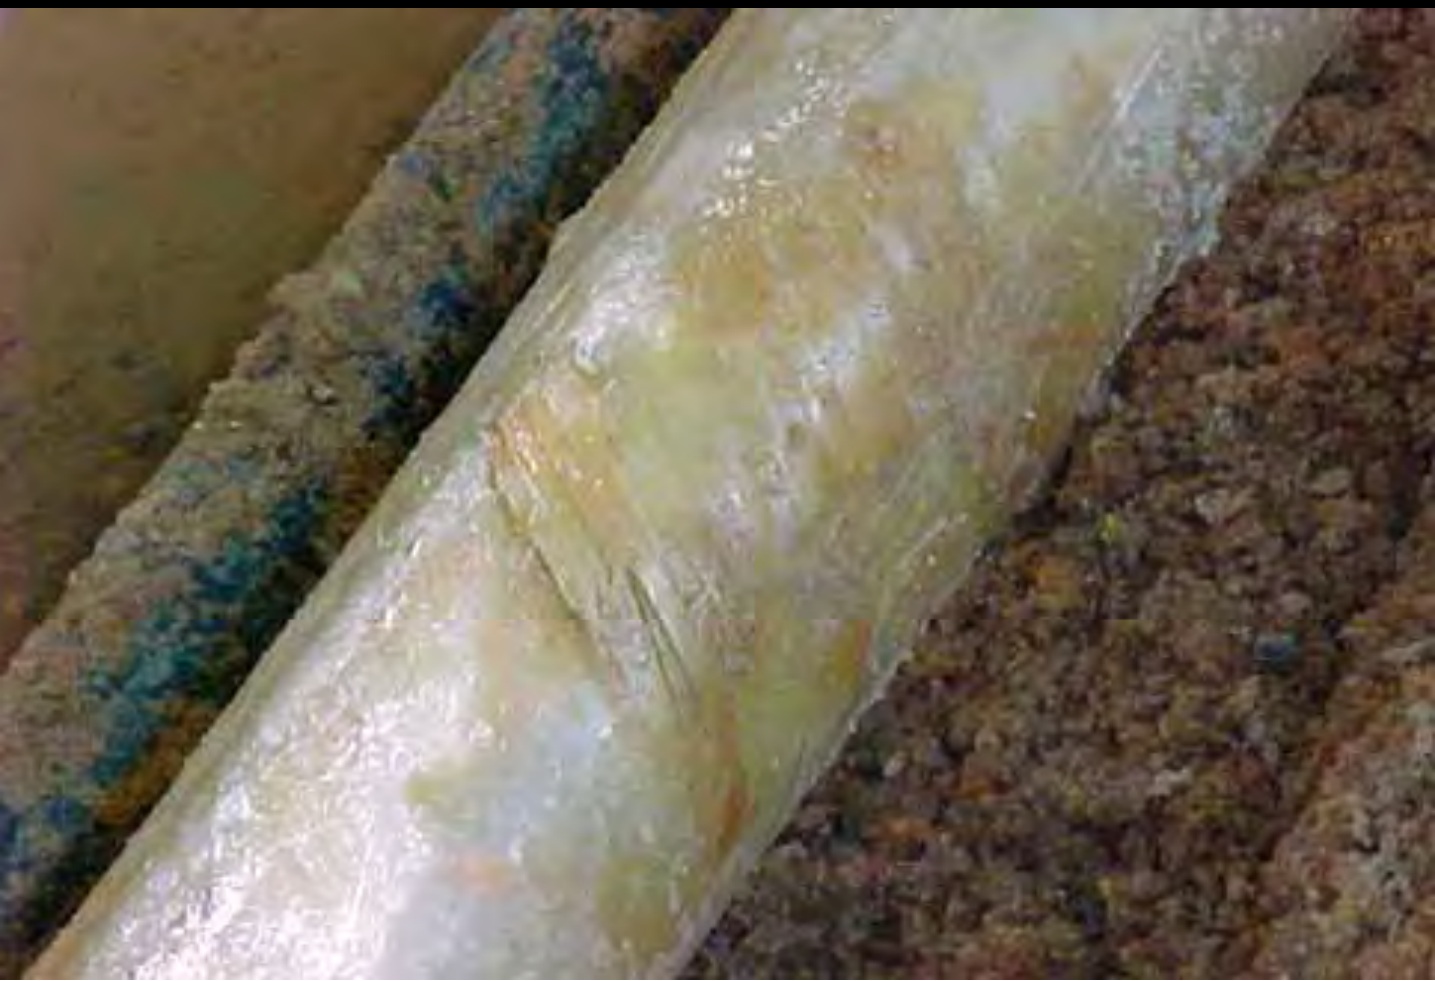
SECONDARY INTEGRITY ?

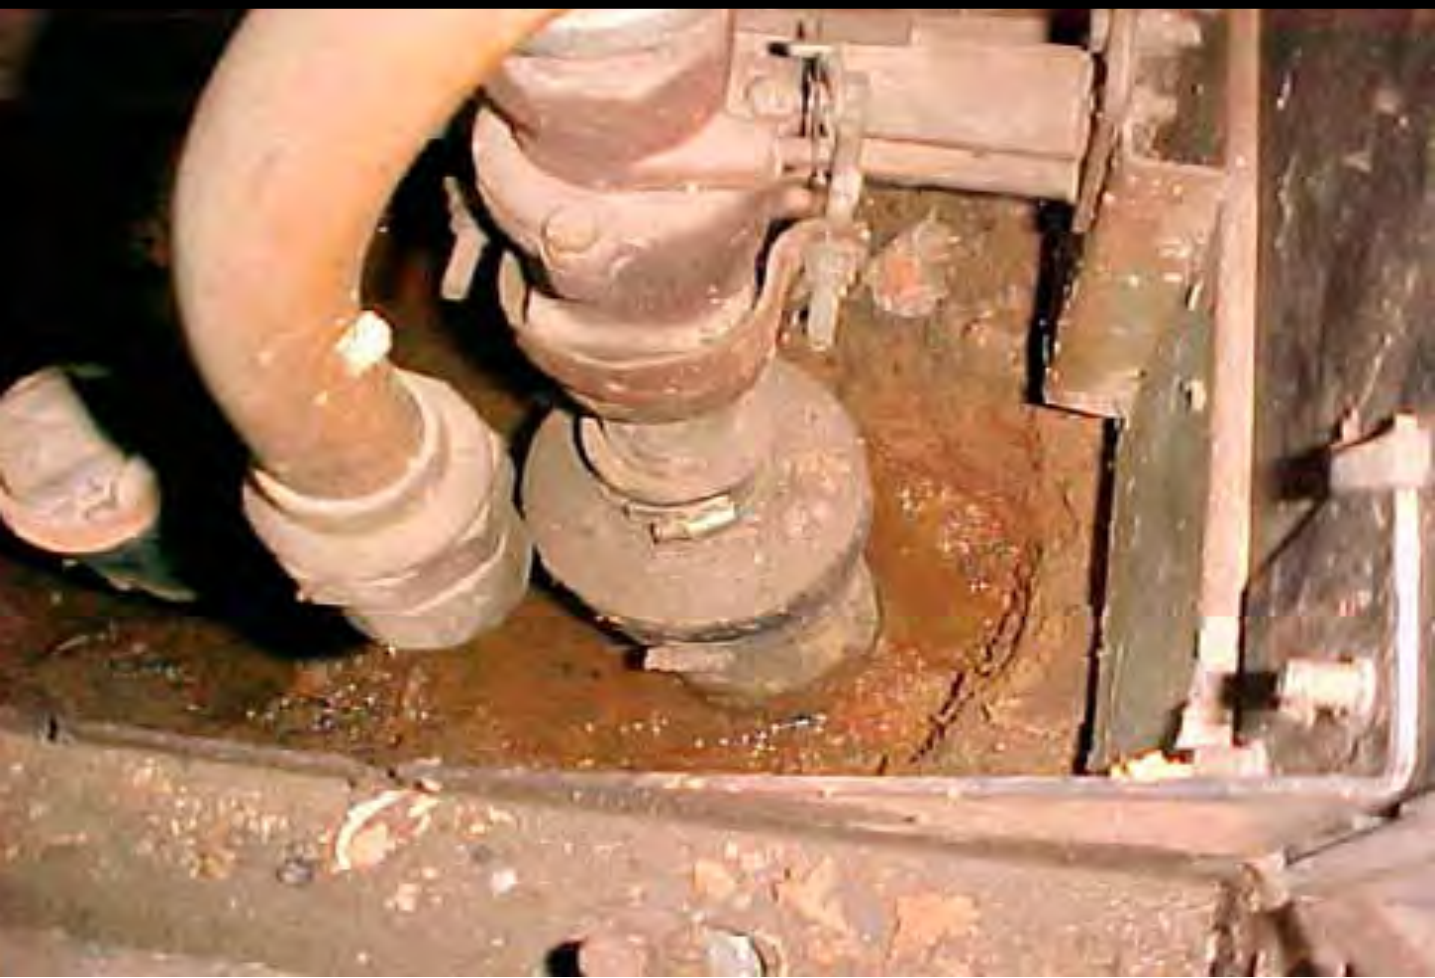
SECONDARY CONTAINMENT ?

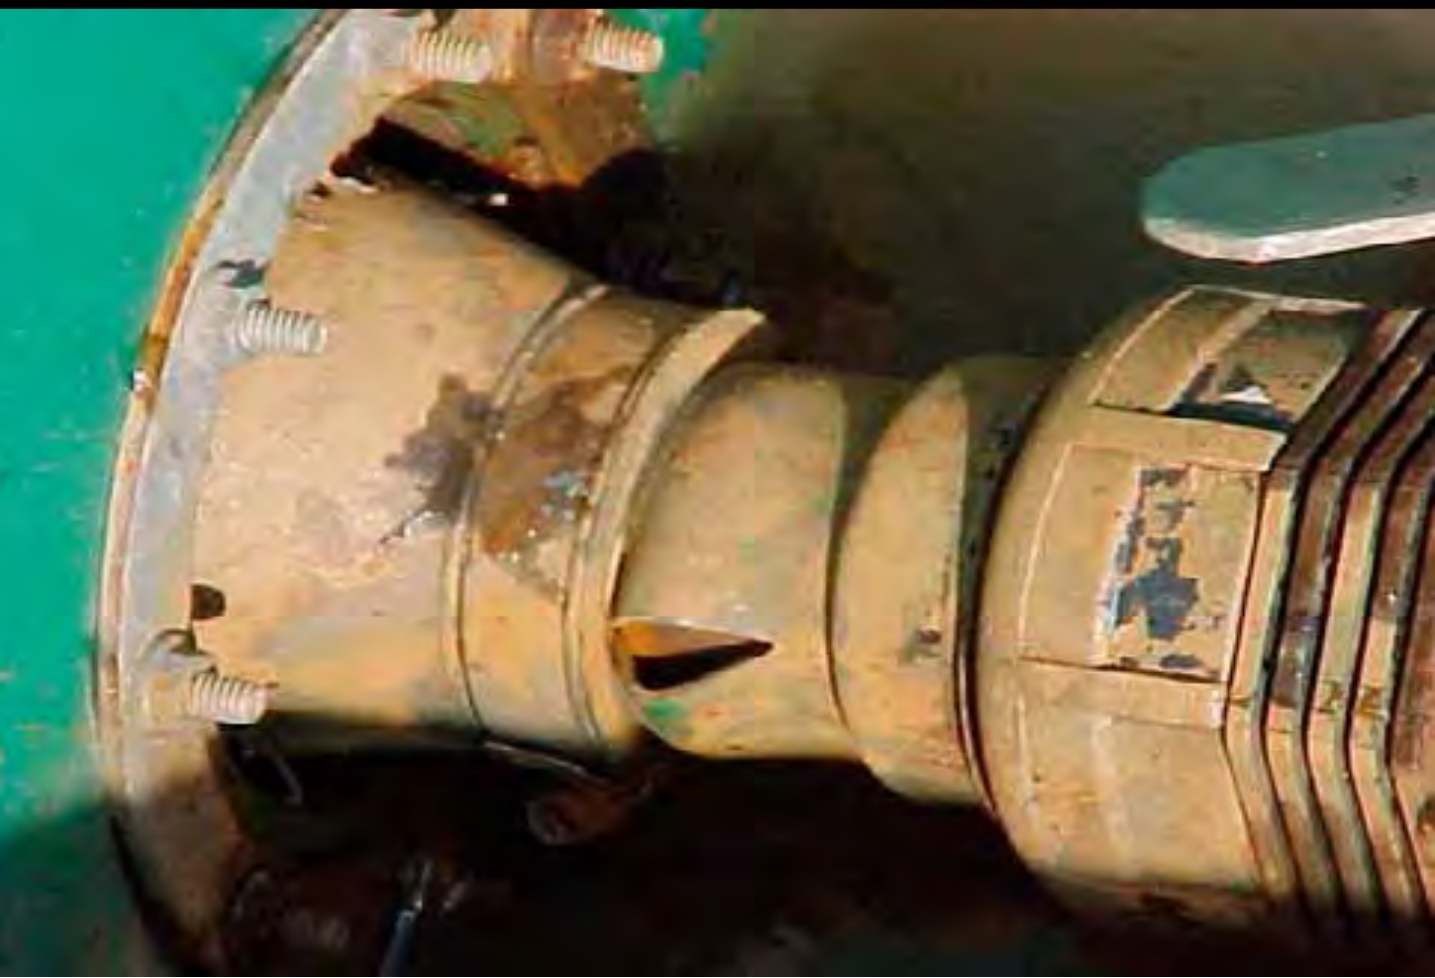
SECONDARY INTEGRITY ?

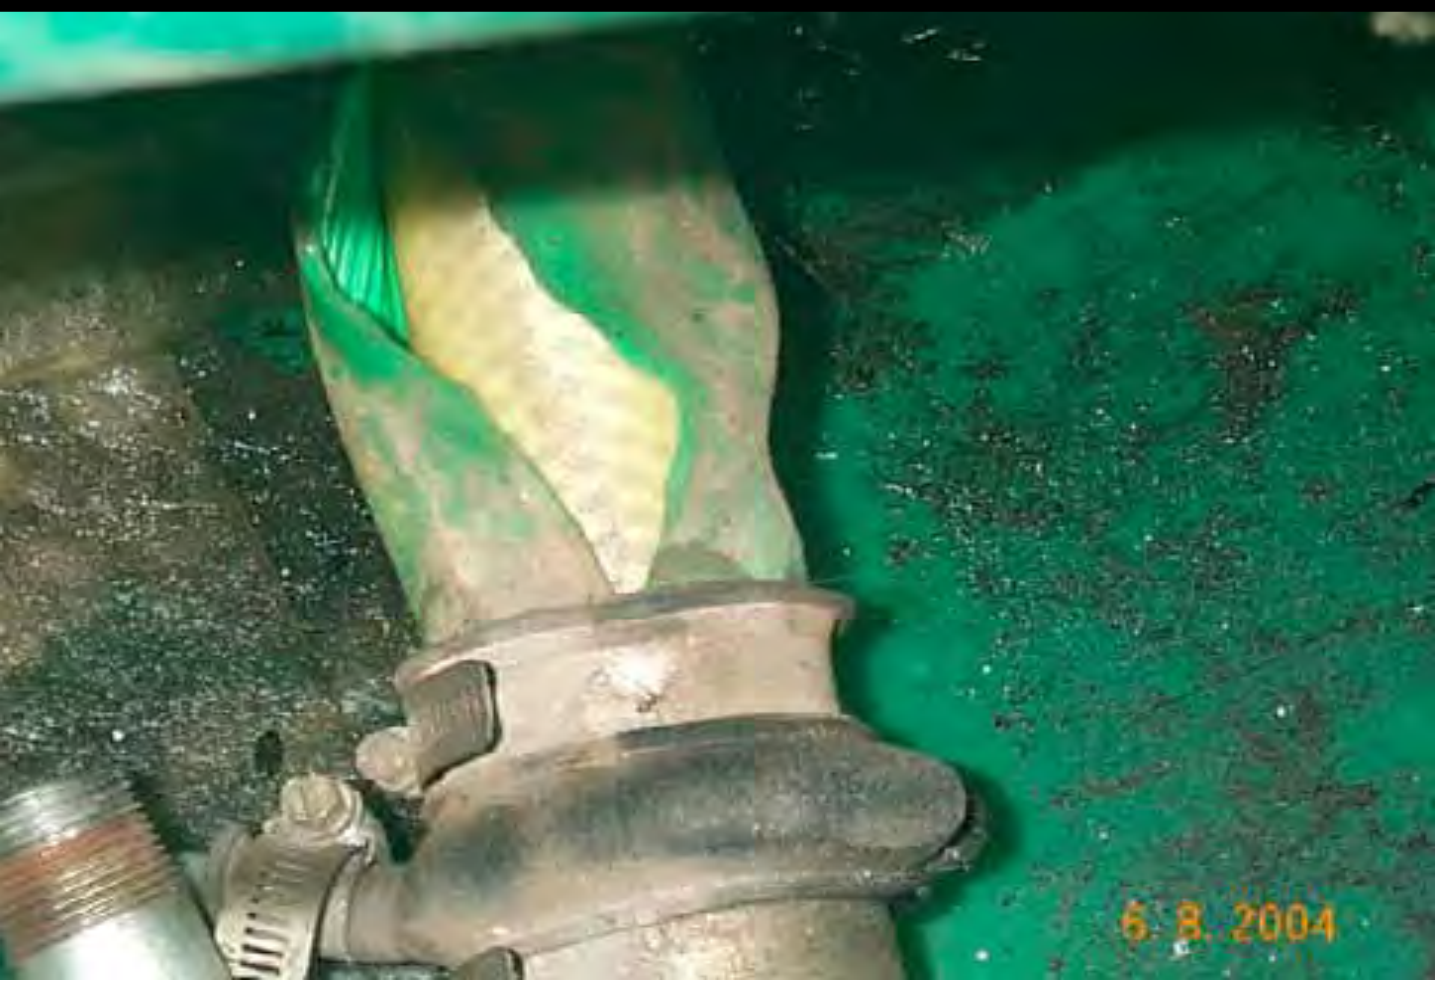
SECONDARY INTEGRITY ?

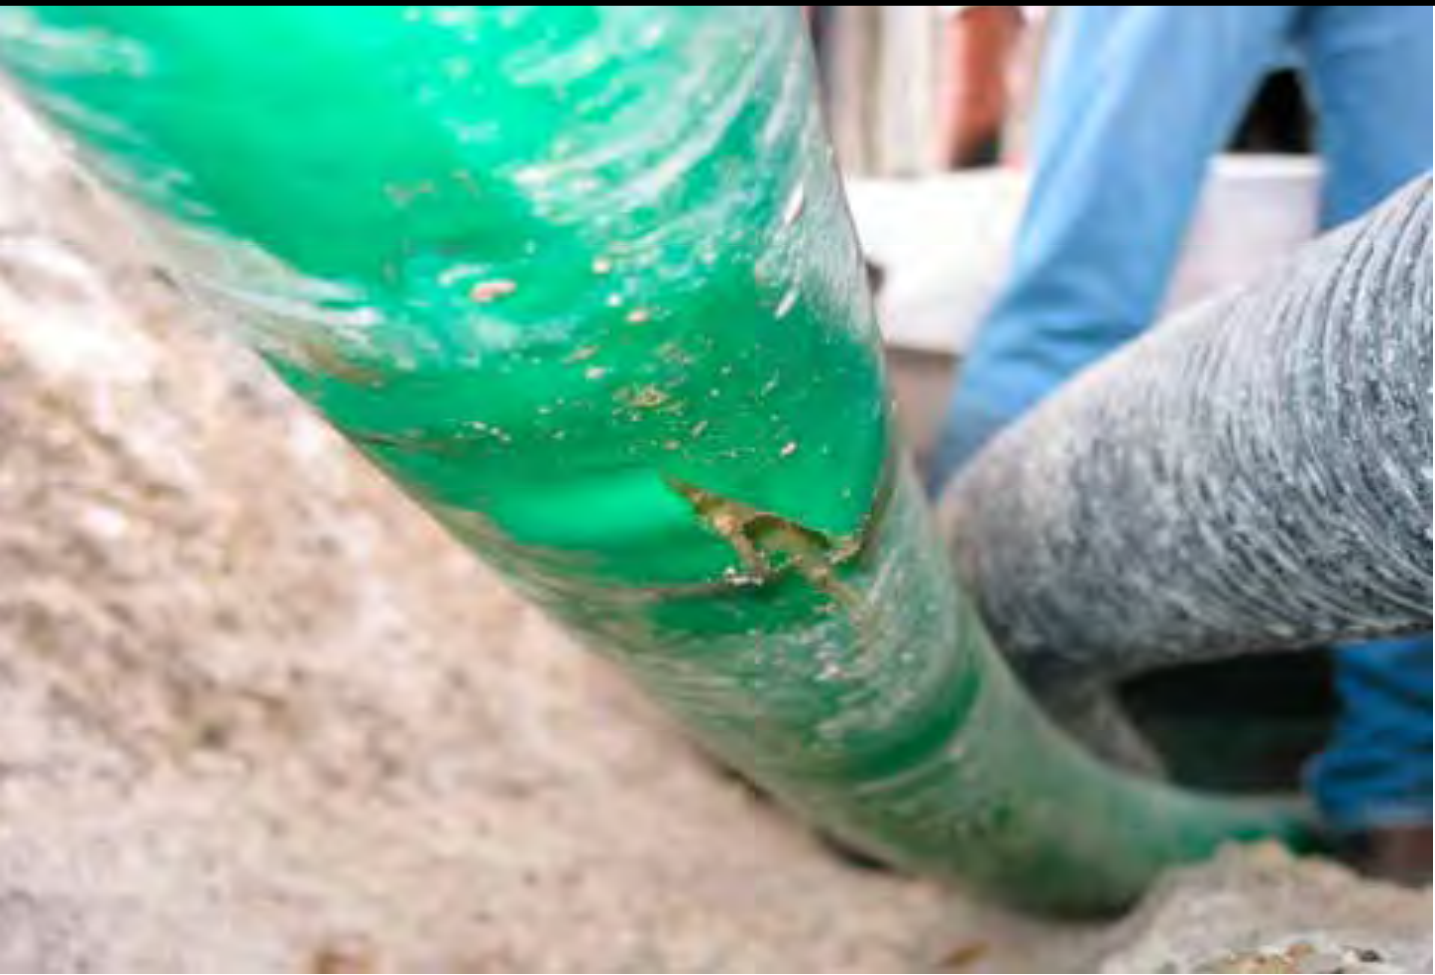
SECONDARY INTEGRITY ?

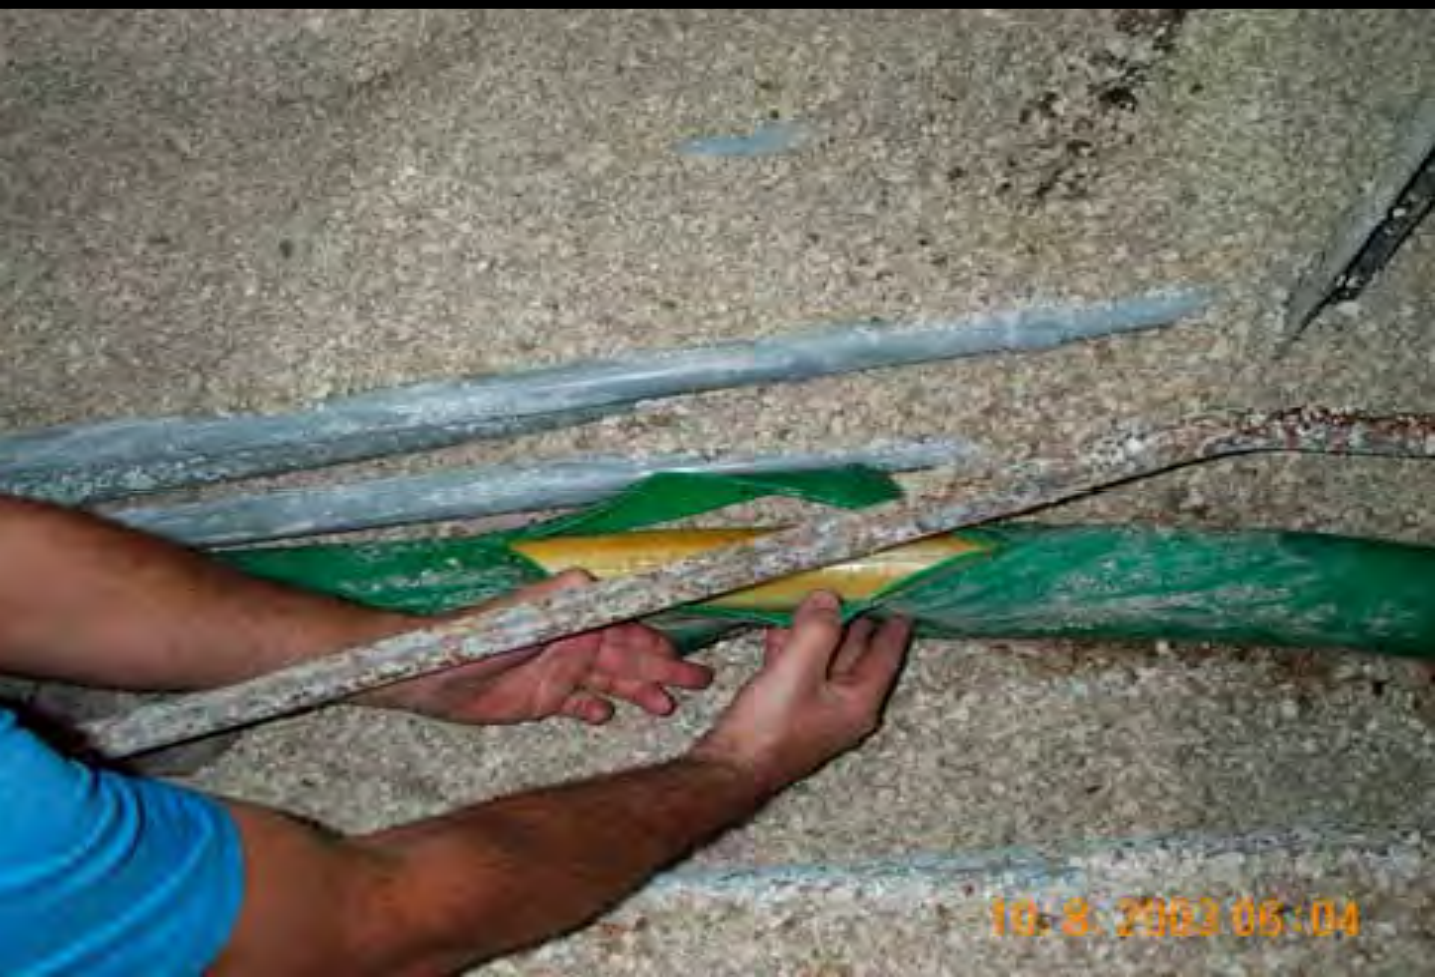
SECONDARY INTEGRITY ?

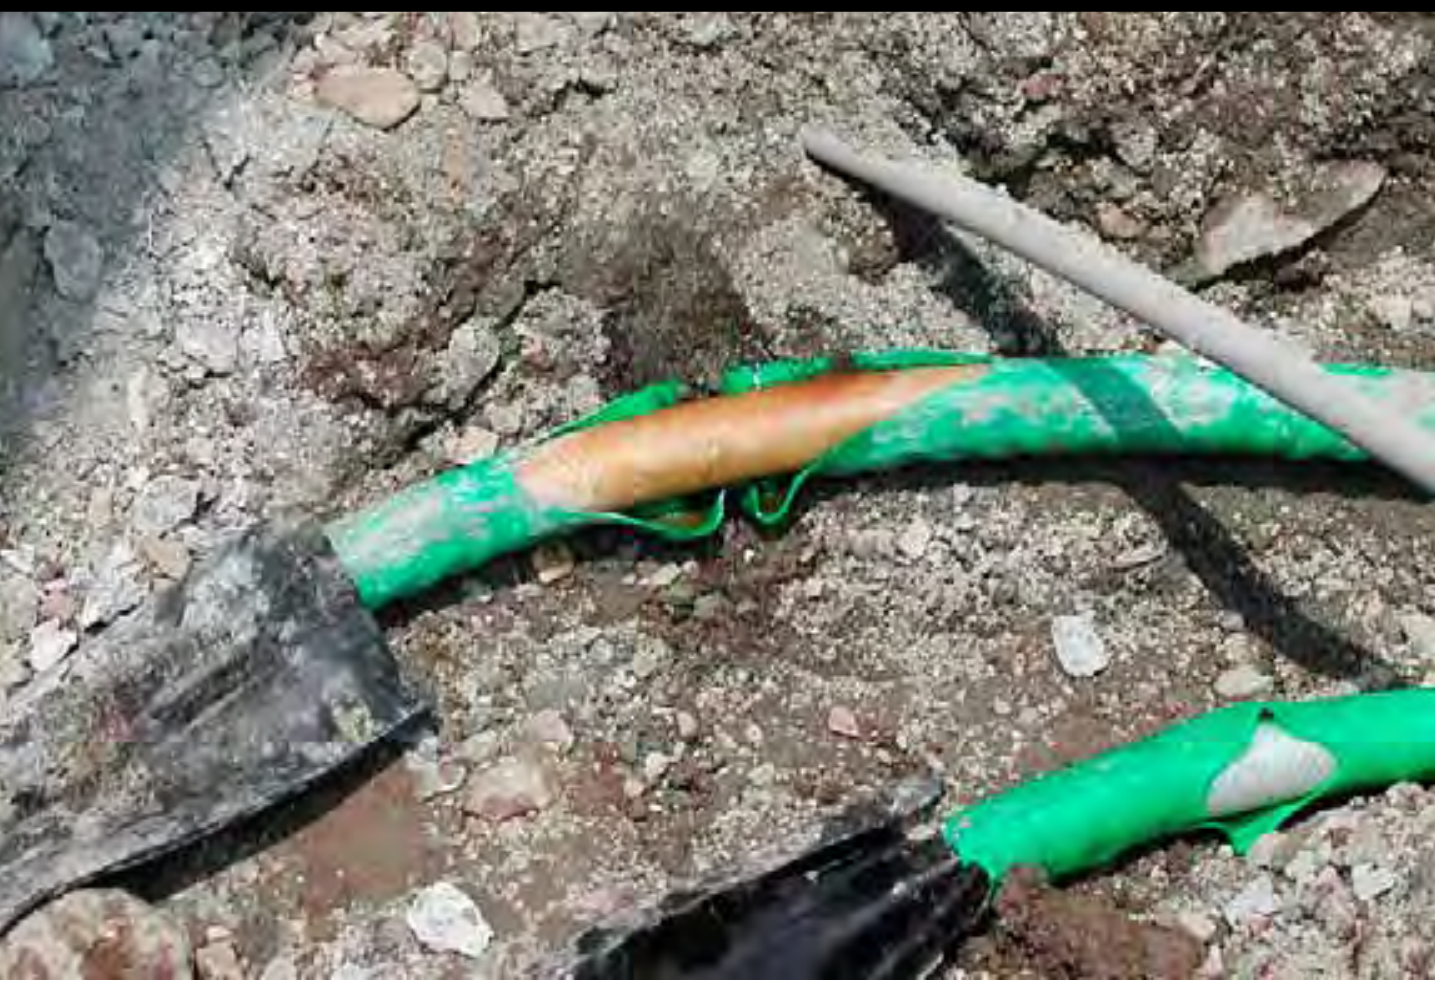
REPAIRS ?

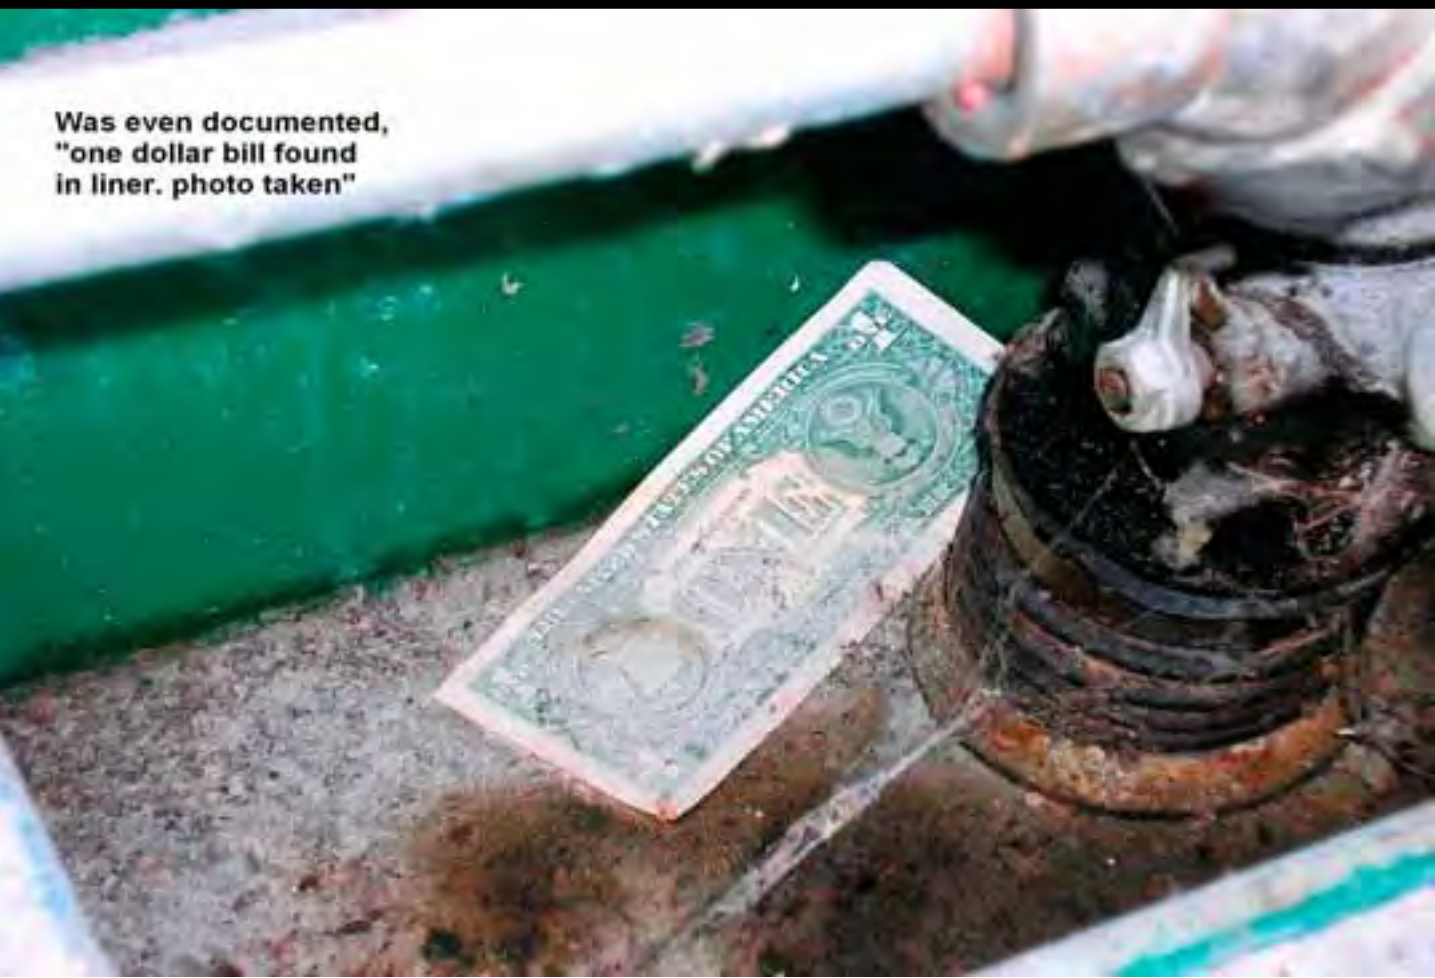
SHALLOW DISPENSER PANS

Was even documented,
"one dollar bill found
in liner. photo taken"

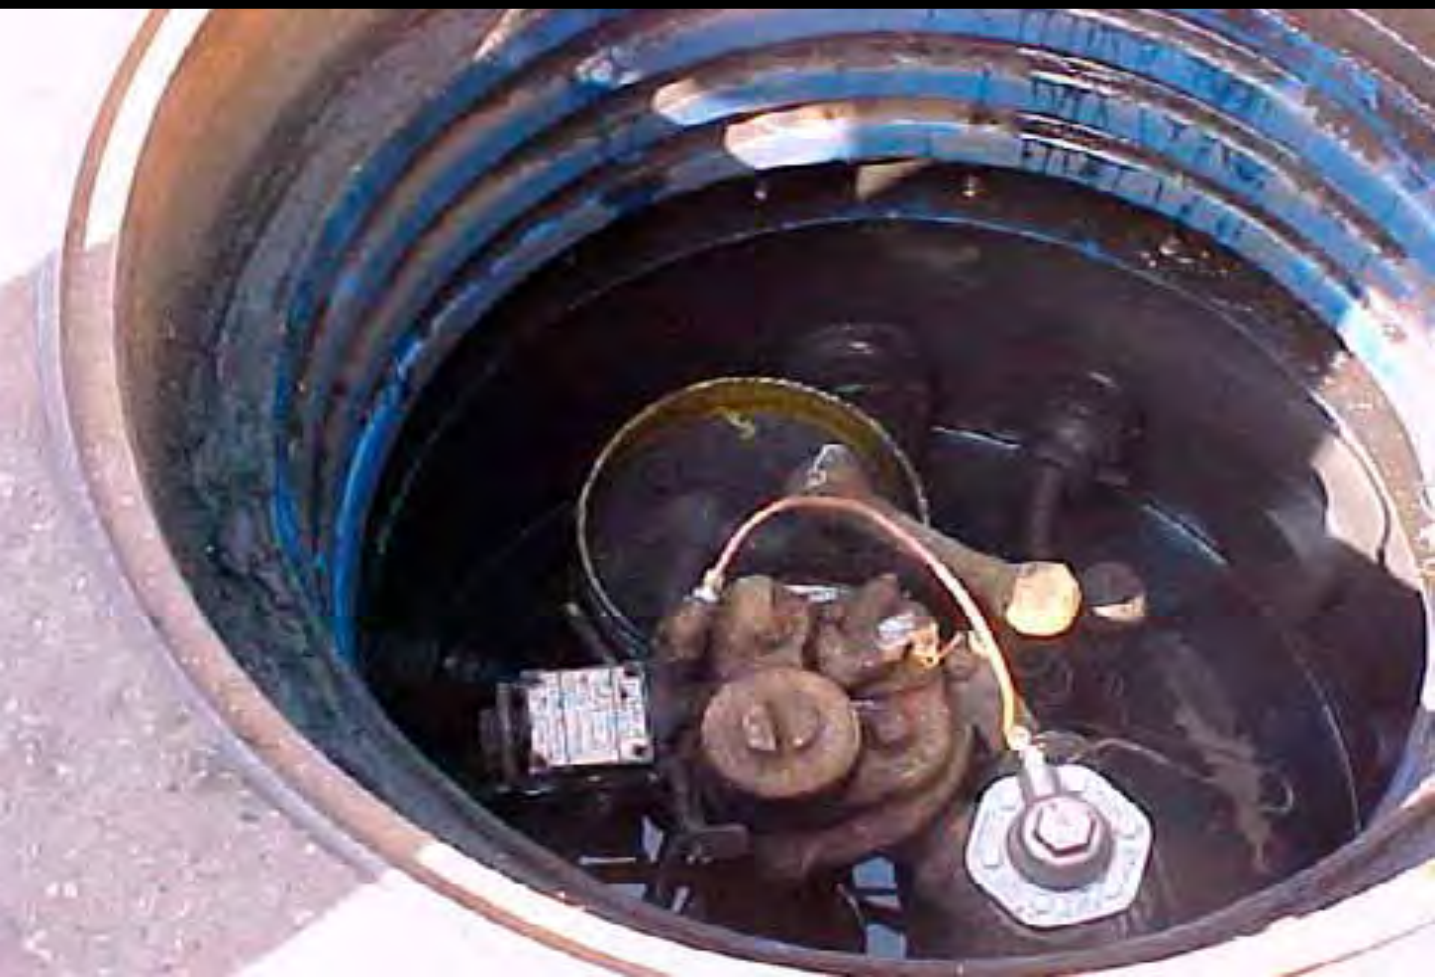
TERTIARY CONTAINMENT ?

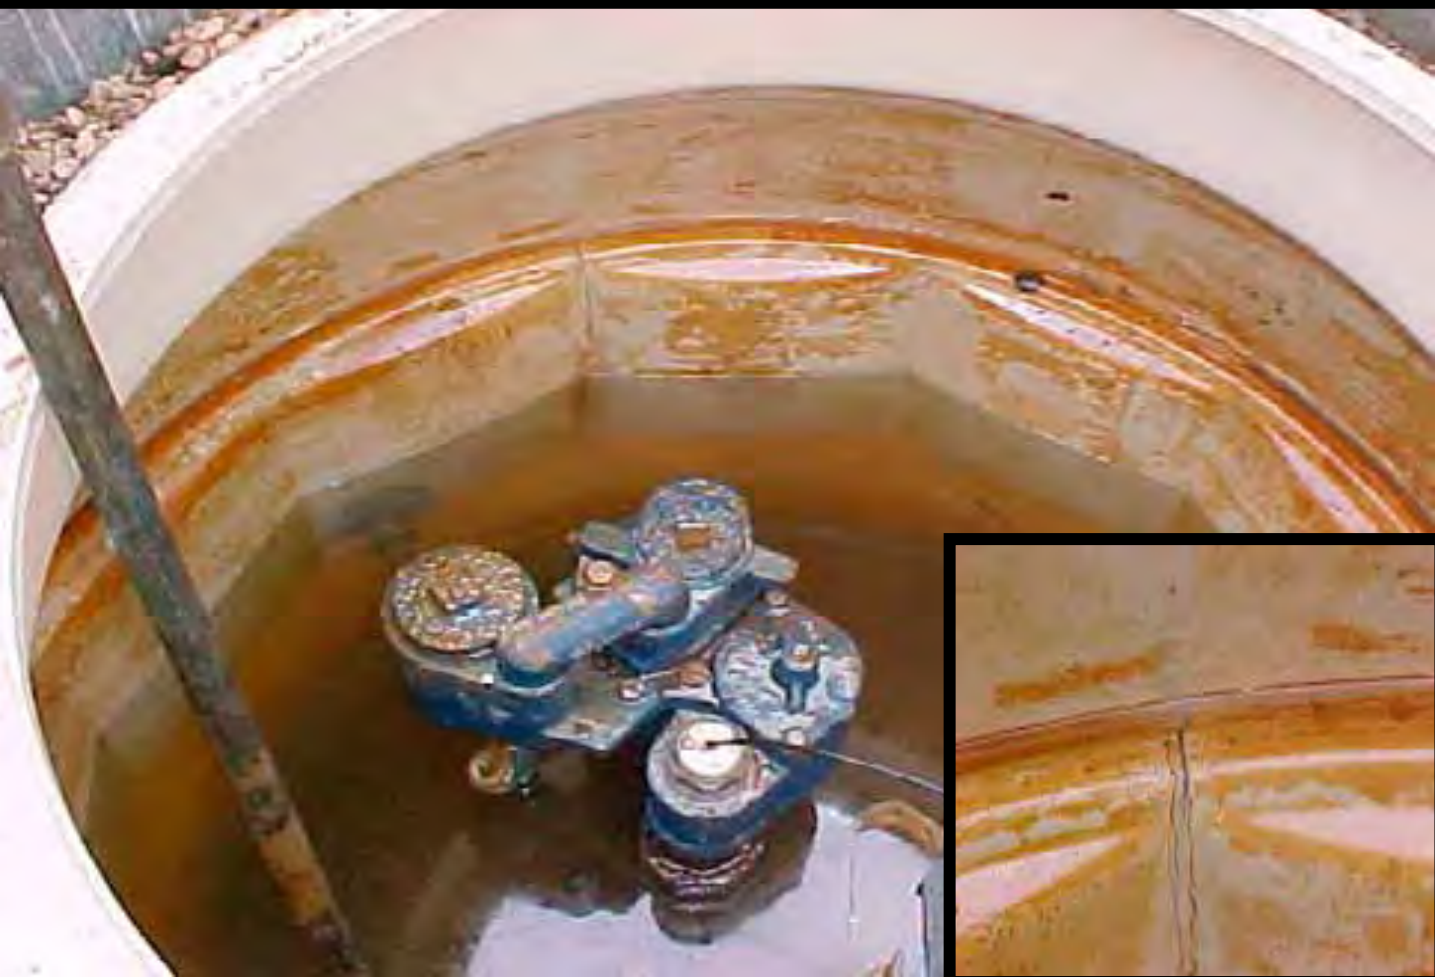
FRP SUMP INTEGRITY

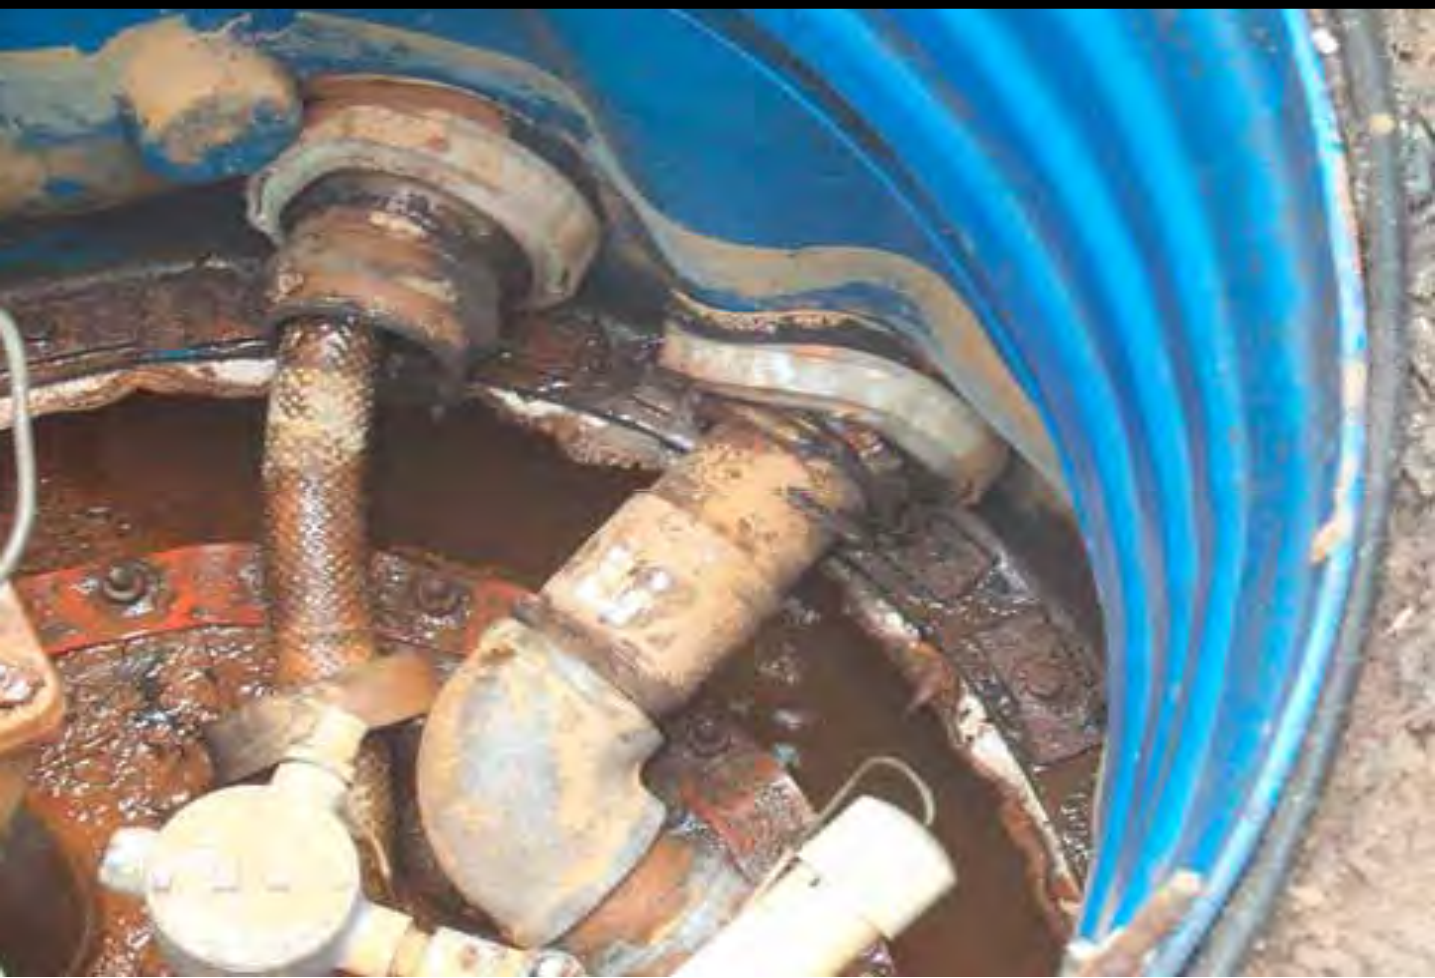
THERMOPLASTIC SUMP INTEGRITY

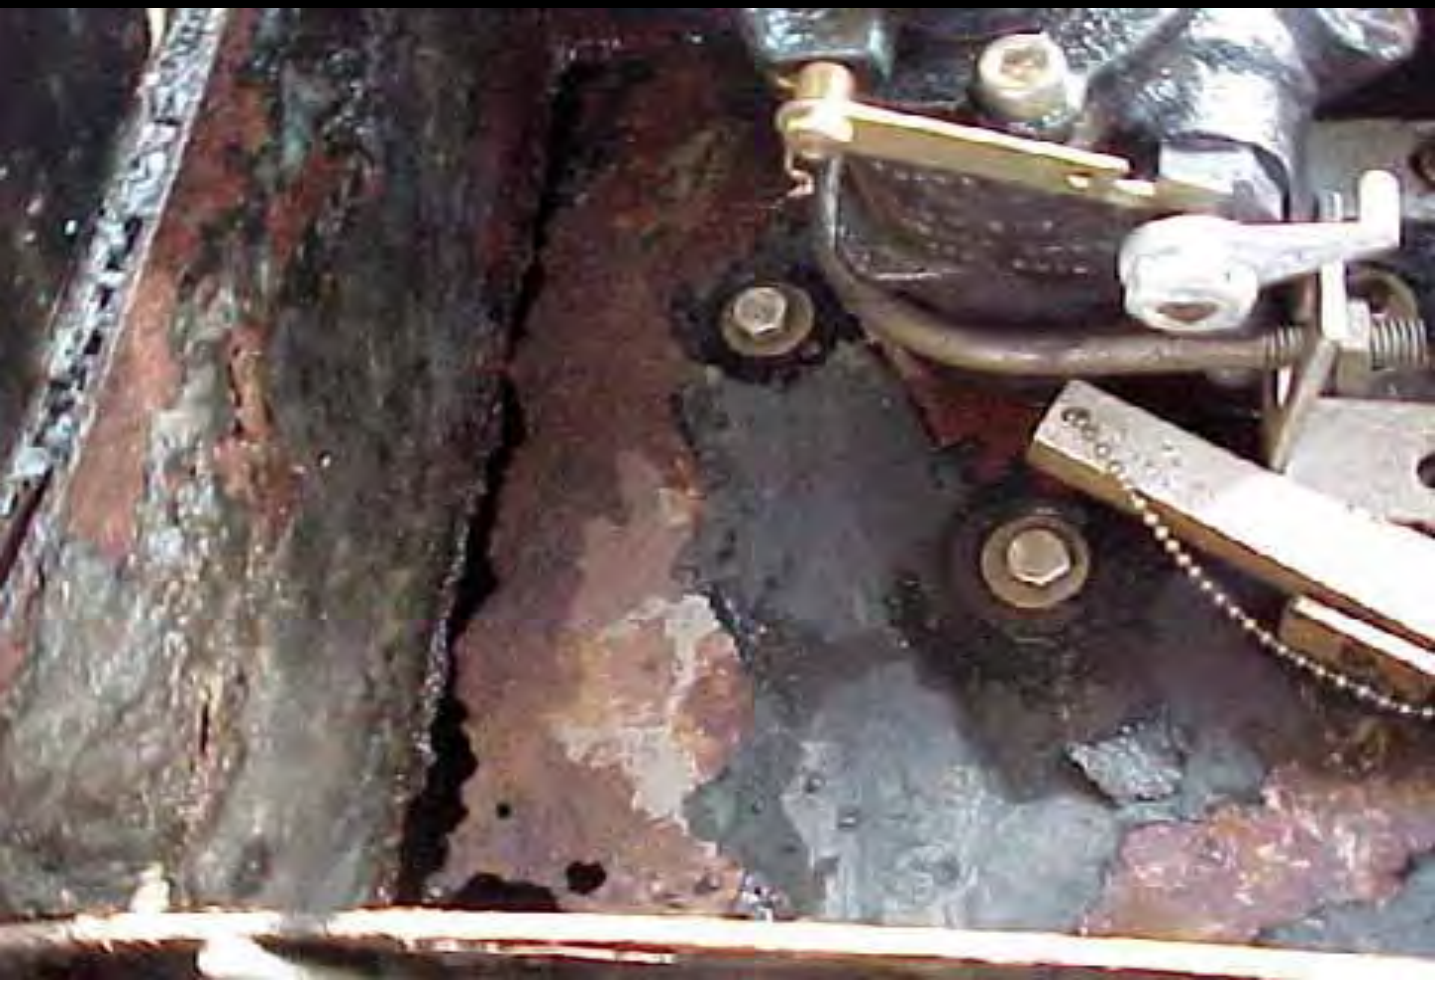
STEEL SUMP INTEGRITY
