SECONDARY CONTAINMENT - DOUBLE TROUBLE ?

KEVIN HENDERSON

**17th ANNUAL UST/LUST NATIONAL CONFERENCE
SEATTLE, WASHINGTON**

MARCH 15, 2005

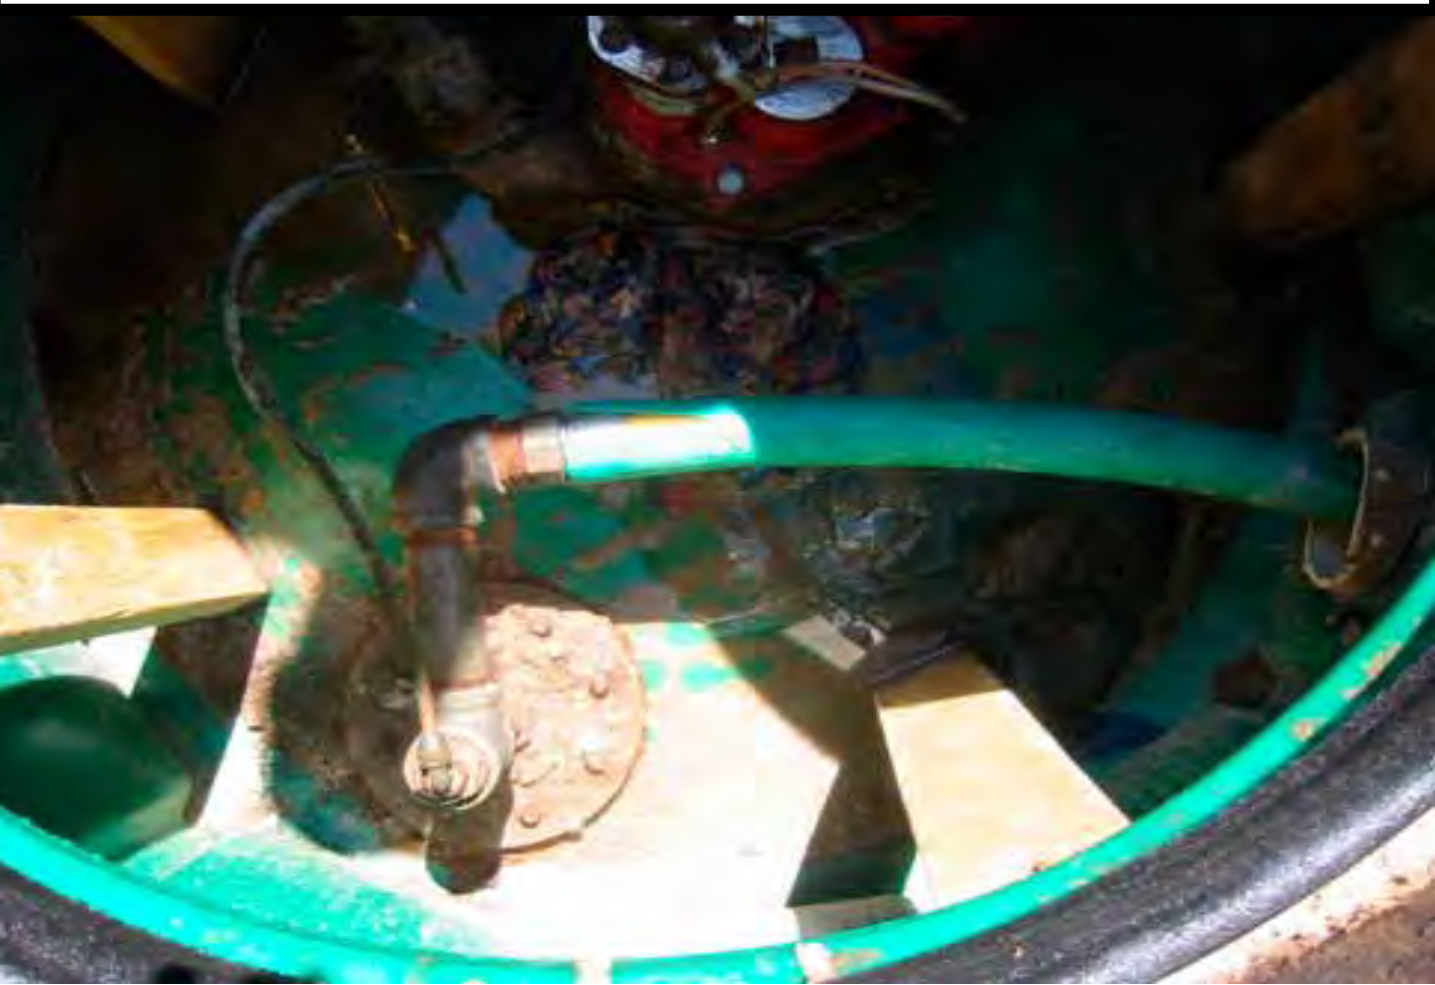
SUMP BRACING ?

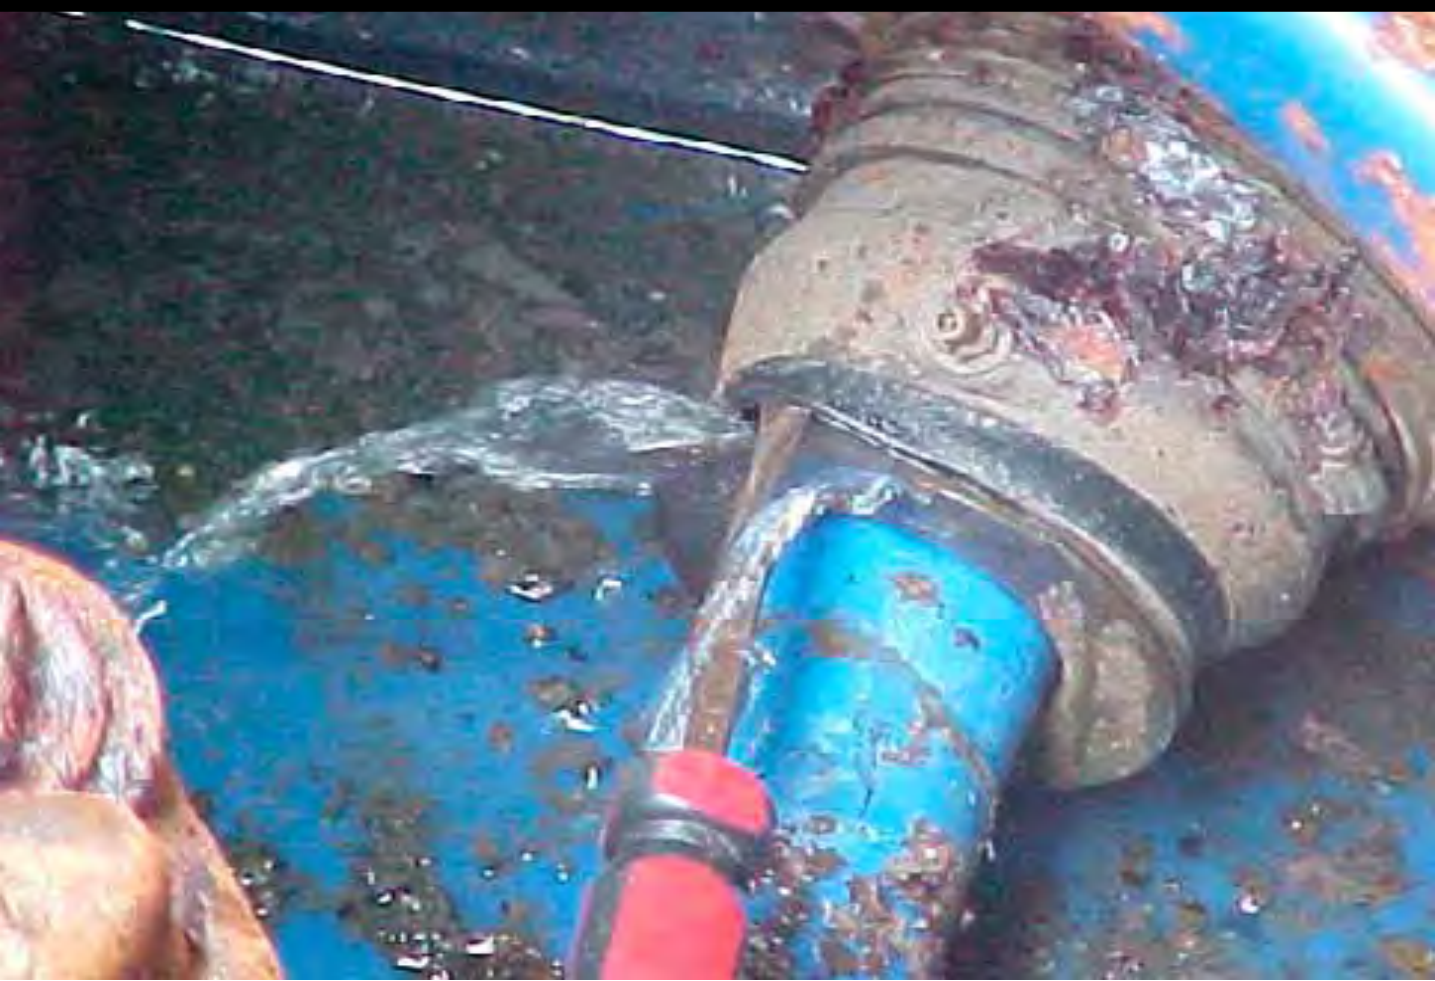
“CHASE” PIPE INTEGRITY

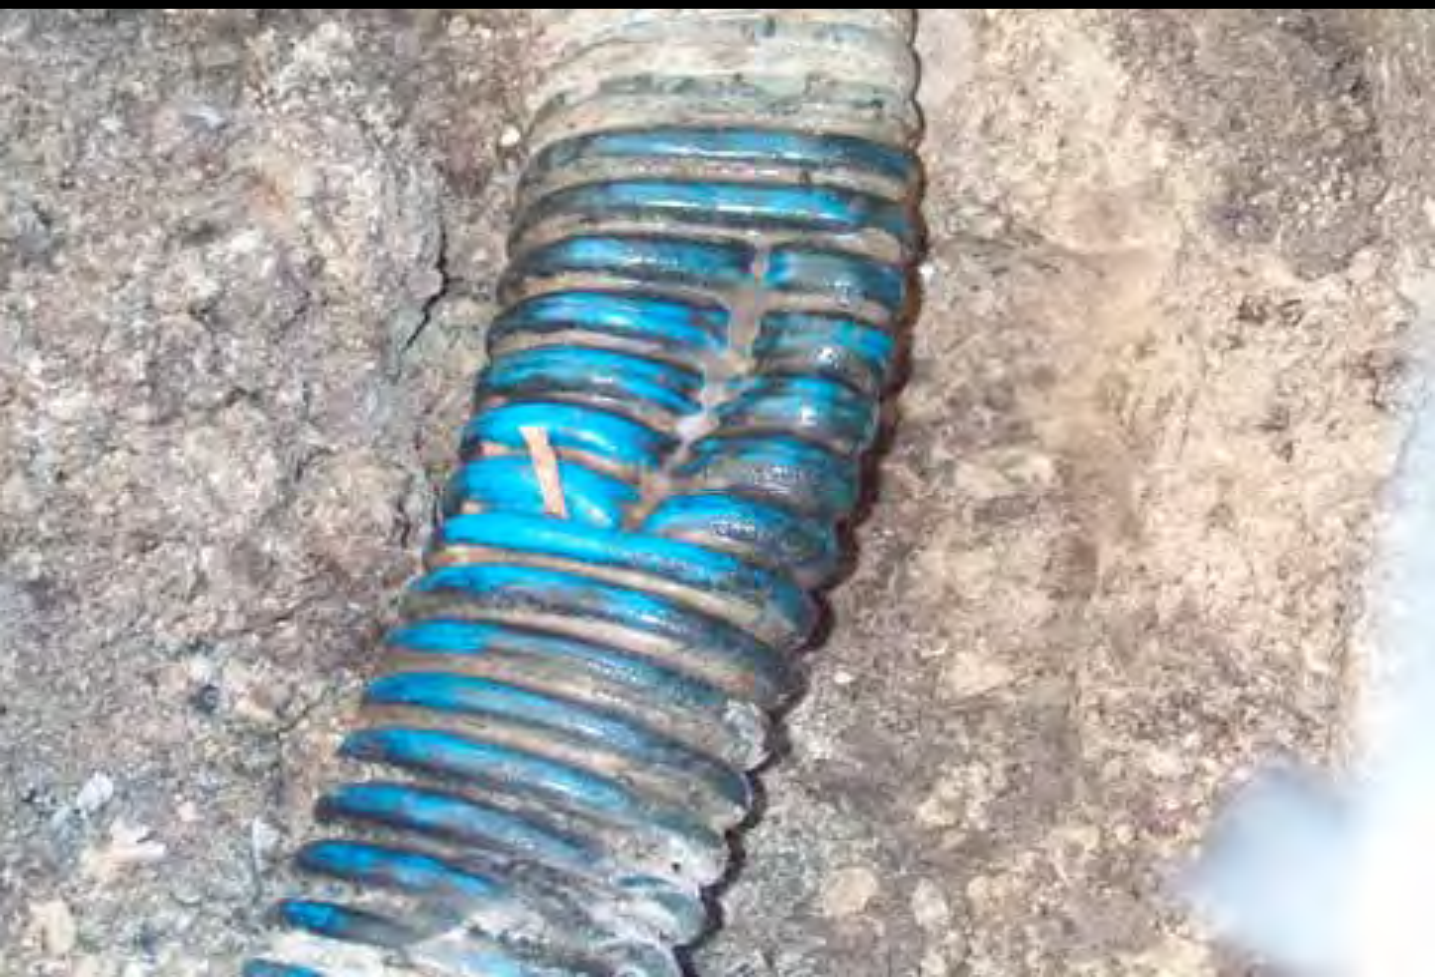
“CHASE” PIPE INTEGRITY

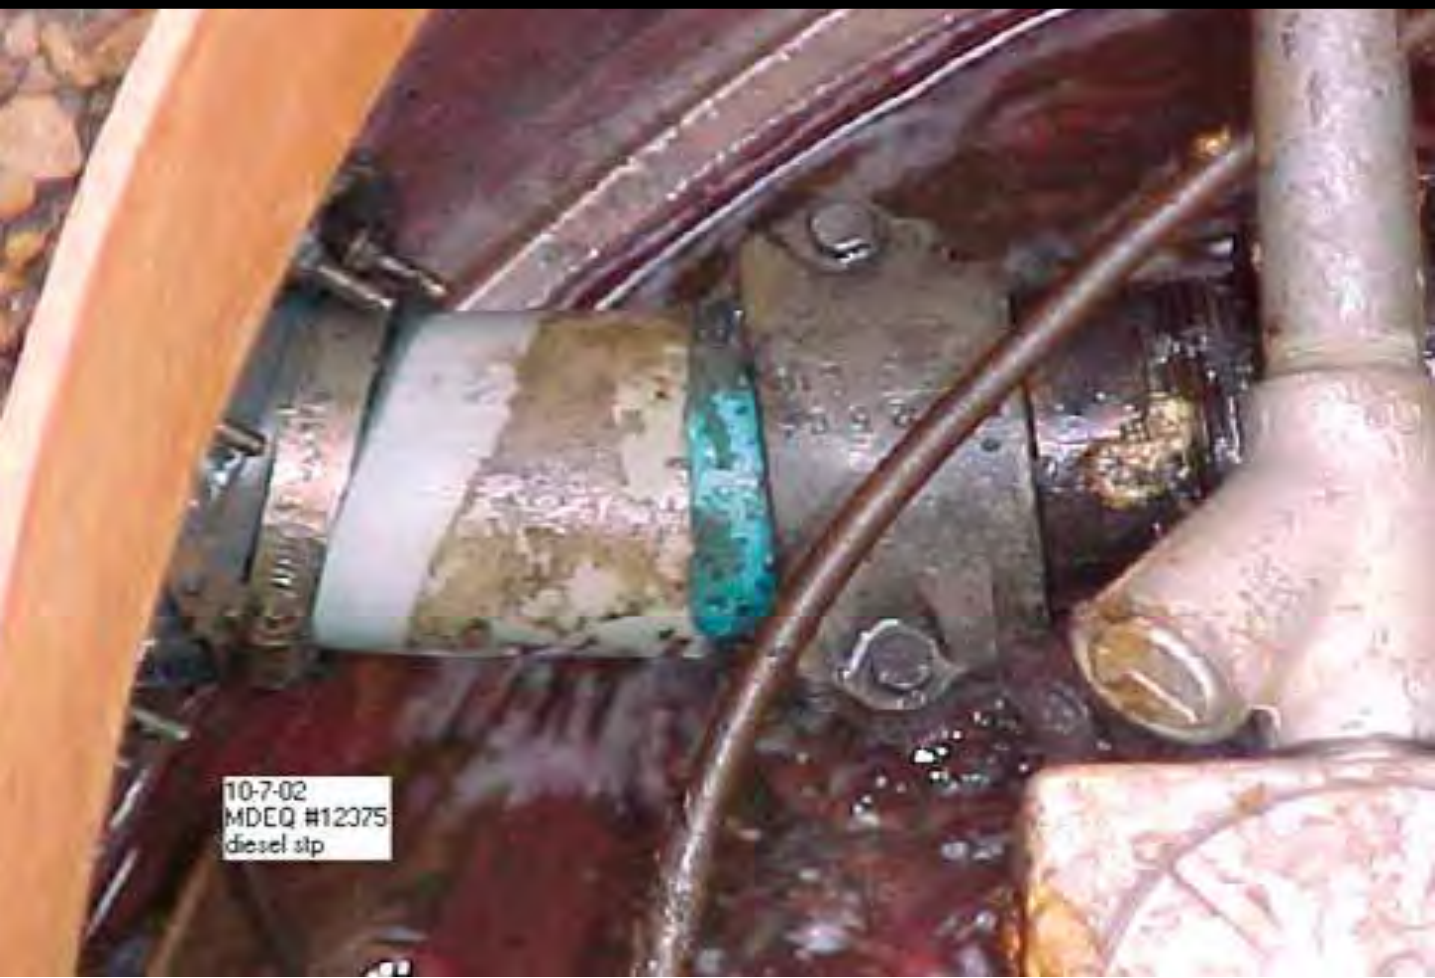
BOOT SEAL INTEGRITY

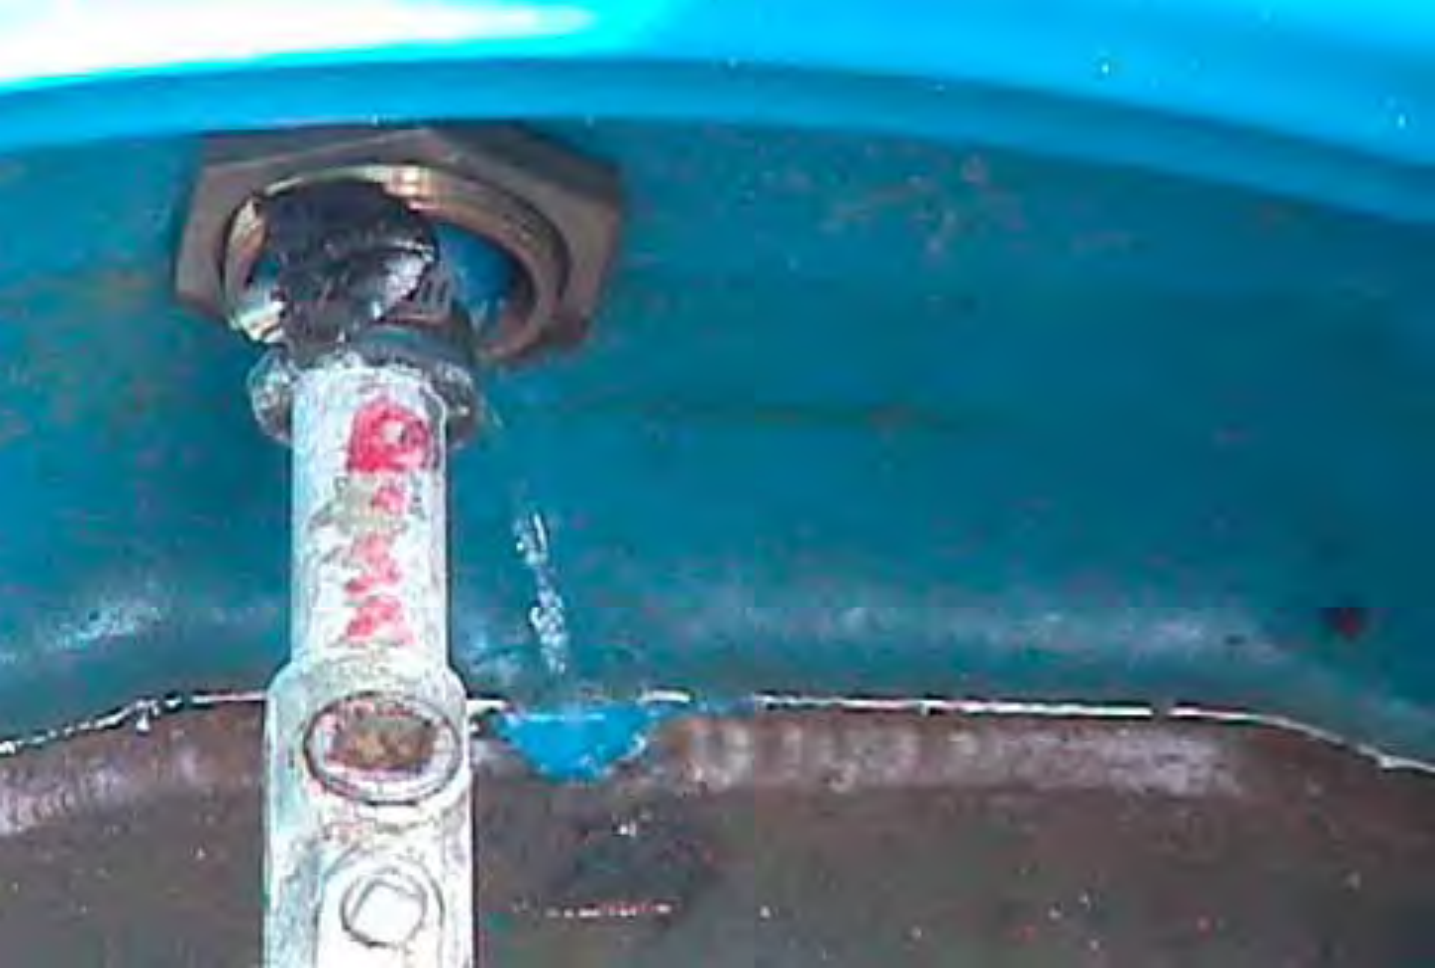
CONDUIT BOOT INTEGRITY

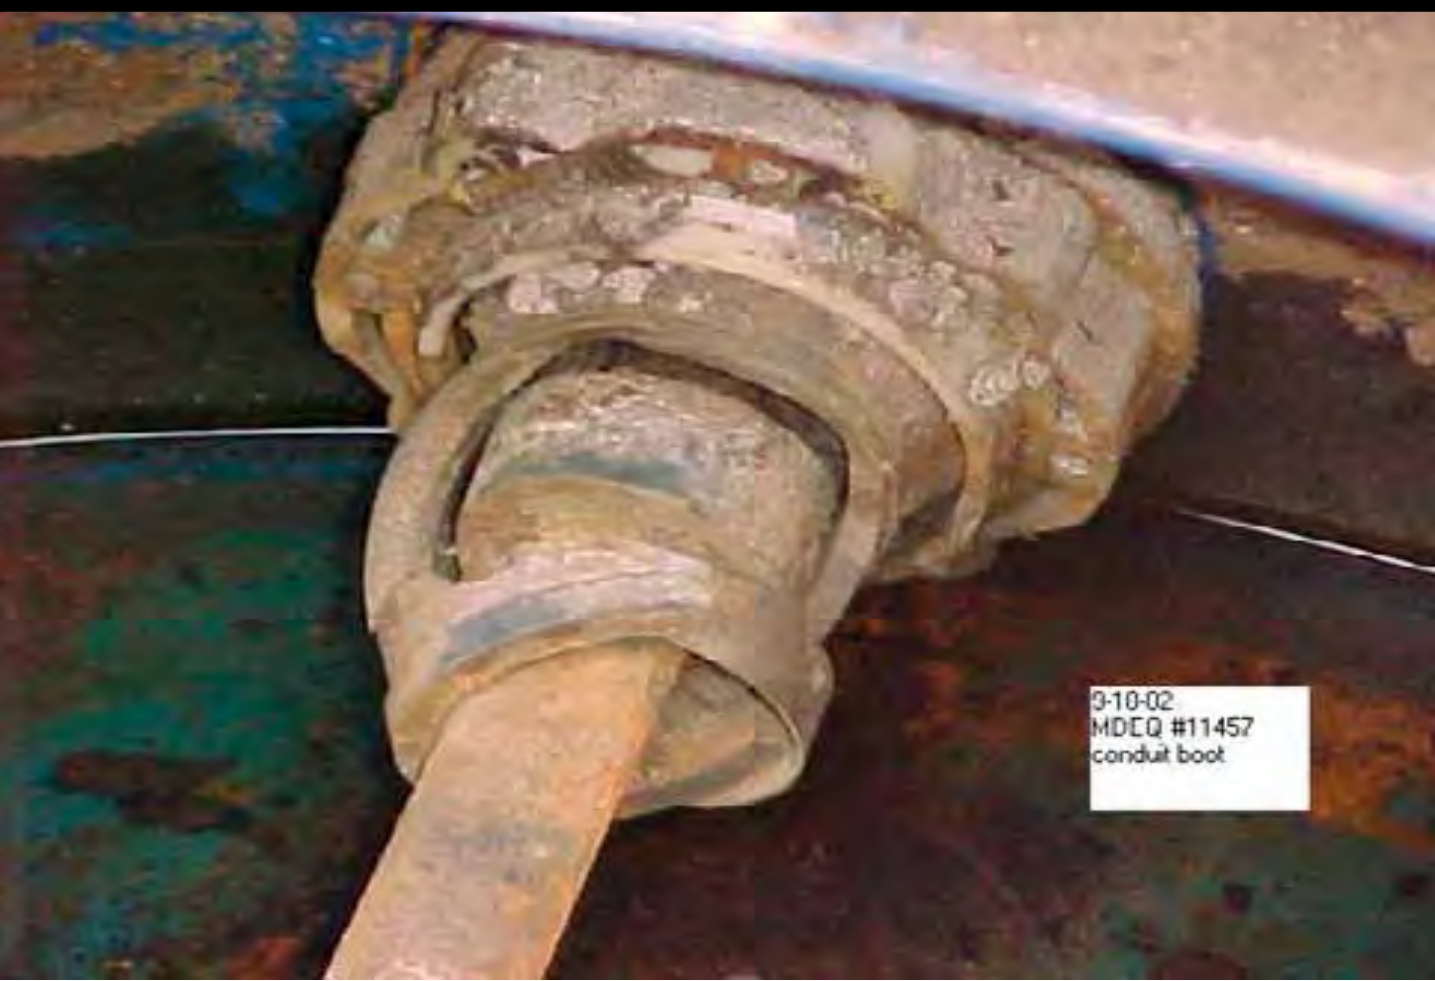
CONDUIT BOOT INTEGRITY

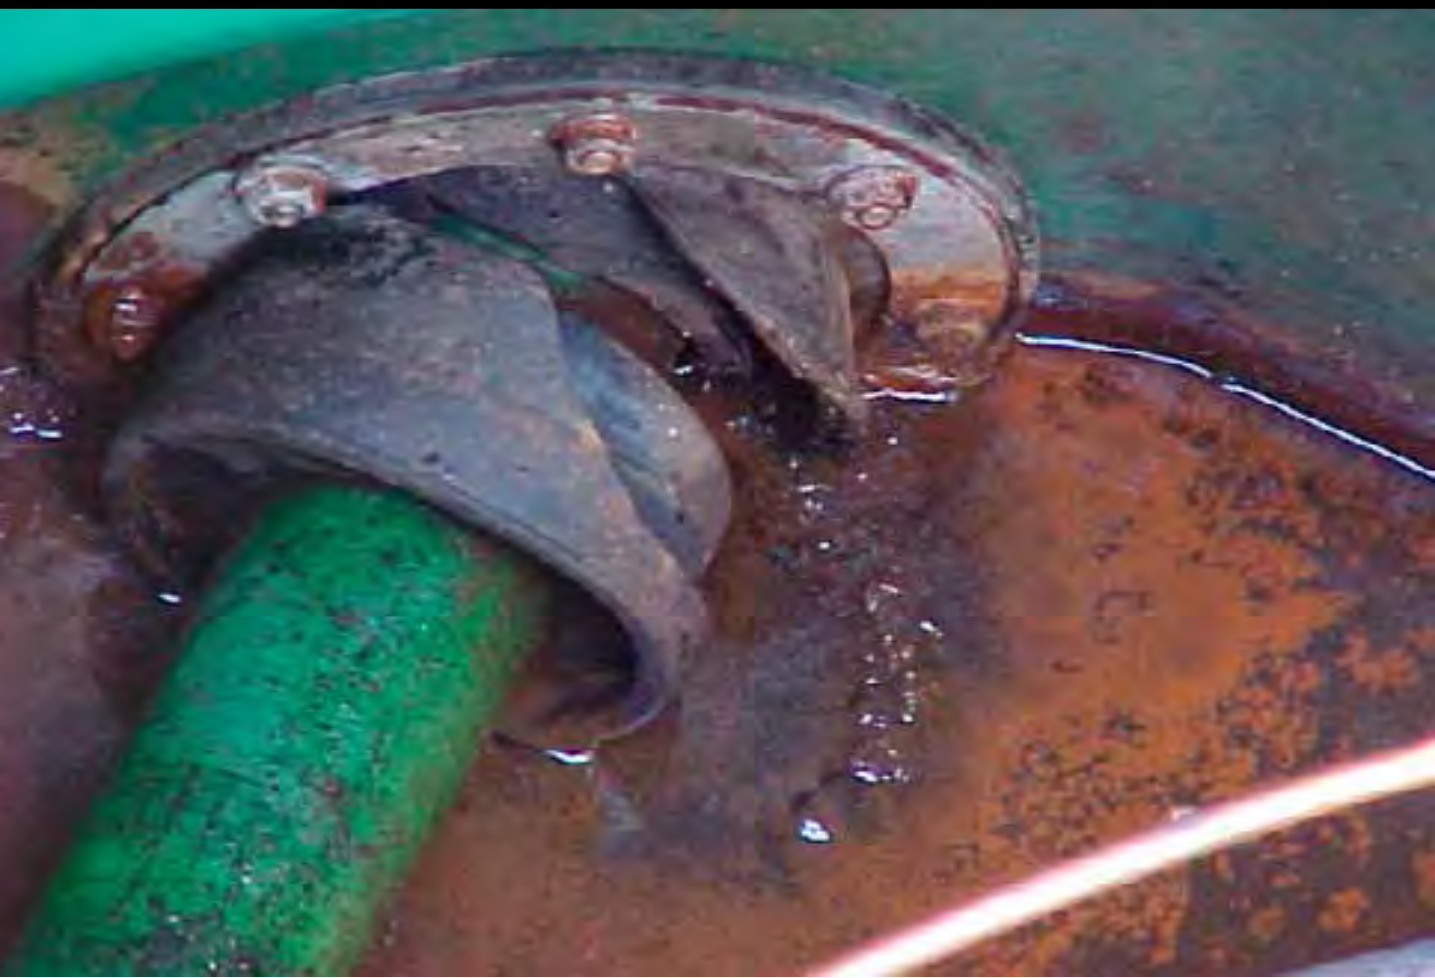
PIPE BOOT INTEGRITY

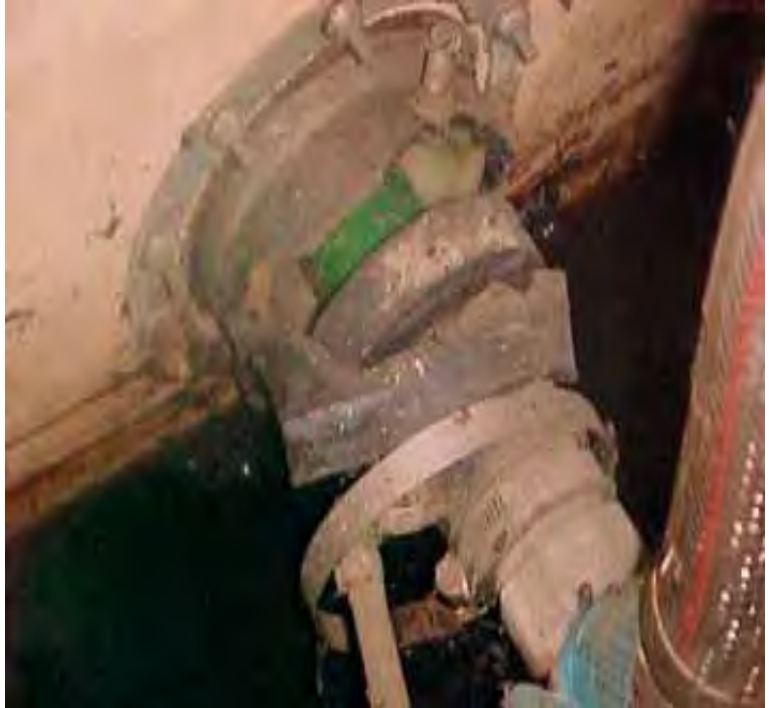
- Under dispenser containment (UDCs)
 - 79% of all UDCs failed in 2001 and 50% of all UDCs failed in 2004
 - Penetration fittings were determined to be the primary cause of failure

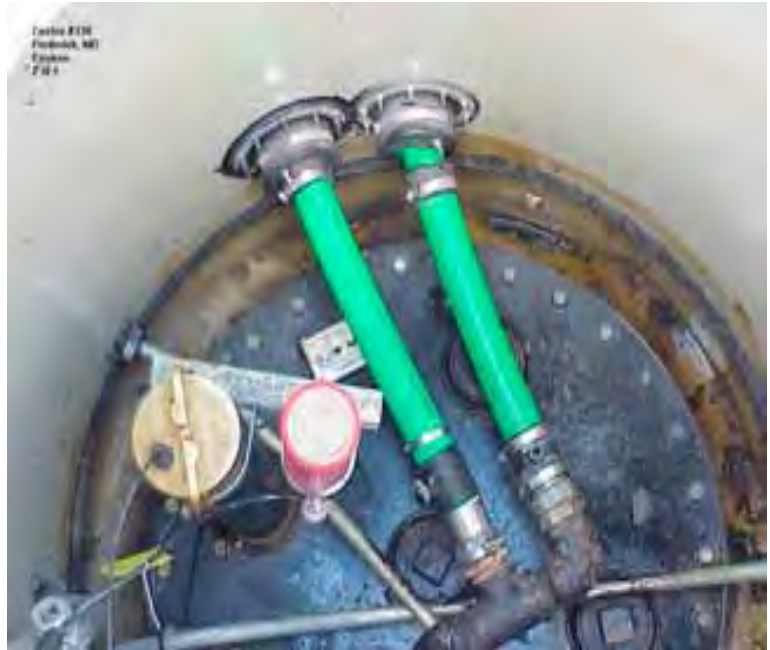
- Tank top containment sumps
 - 53% of all containment sumps failed in 2001 and 28% in 2004
 - Penetration fittings were determined to be the primary cause of failure
 - 100% of HDPE sumps failed the testing in 2001

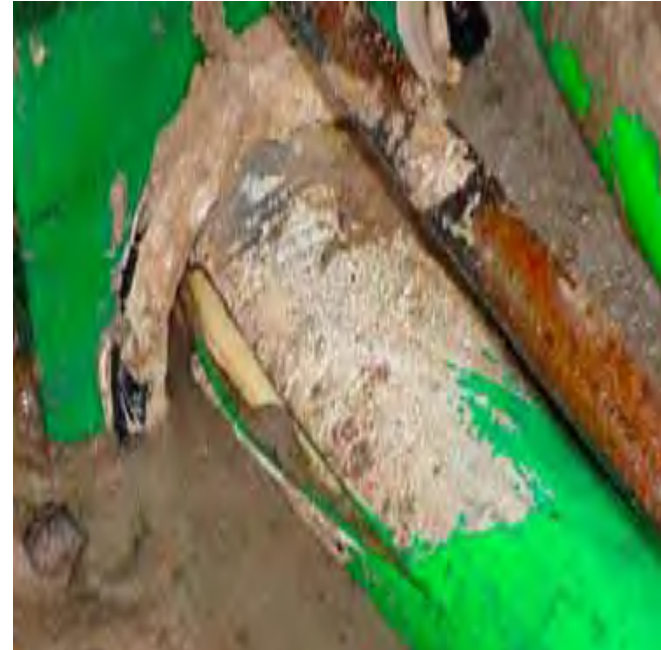
- SB898 (2001) & AB2481 (2003) test results:
 - 93% of all locations tested failed at least one secondary containment component
