Cyanobacteria in Surface Drinking Waters: An Ecologist's View

Jim Haney

UNH Center for Freshwater Biology

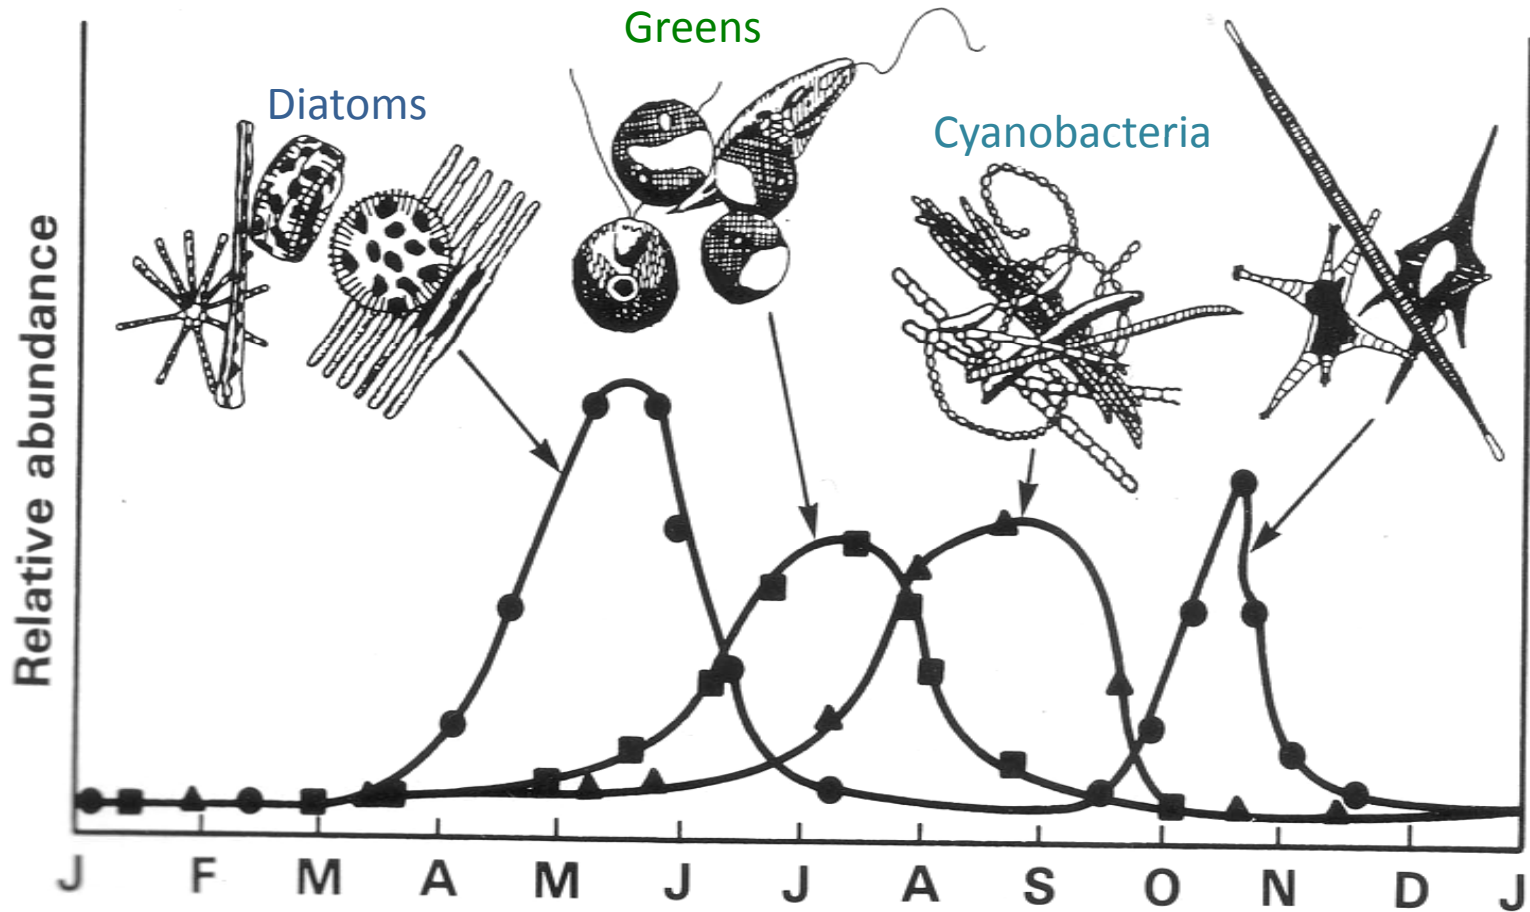
Seasonal Succession General Pattern

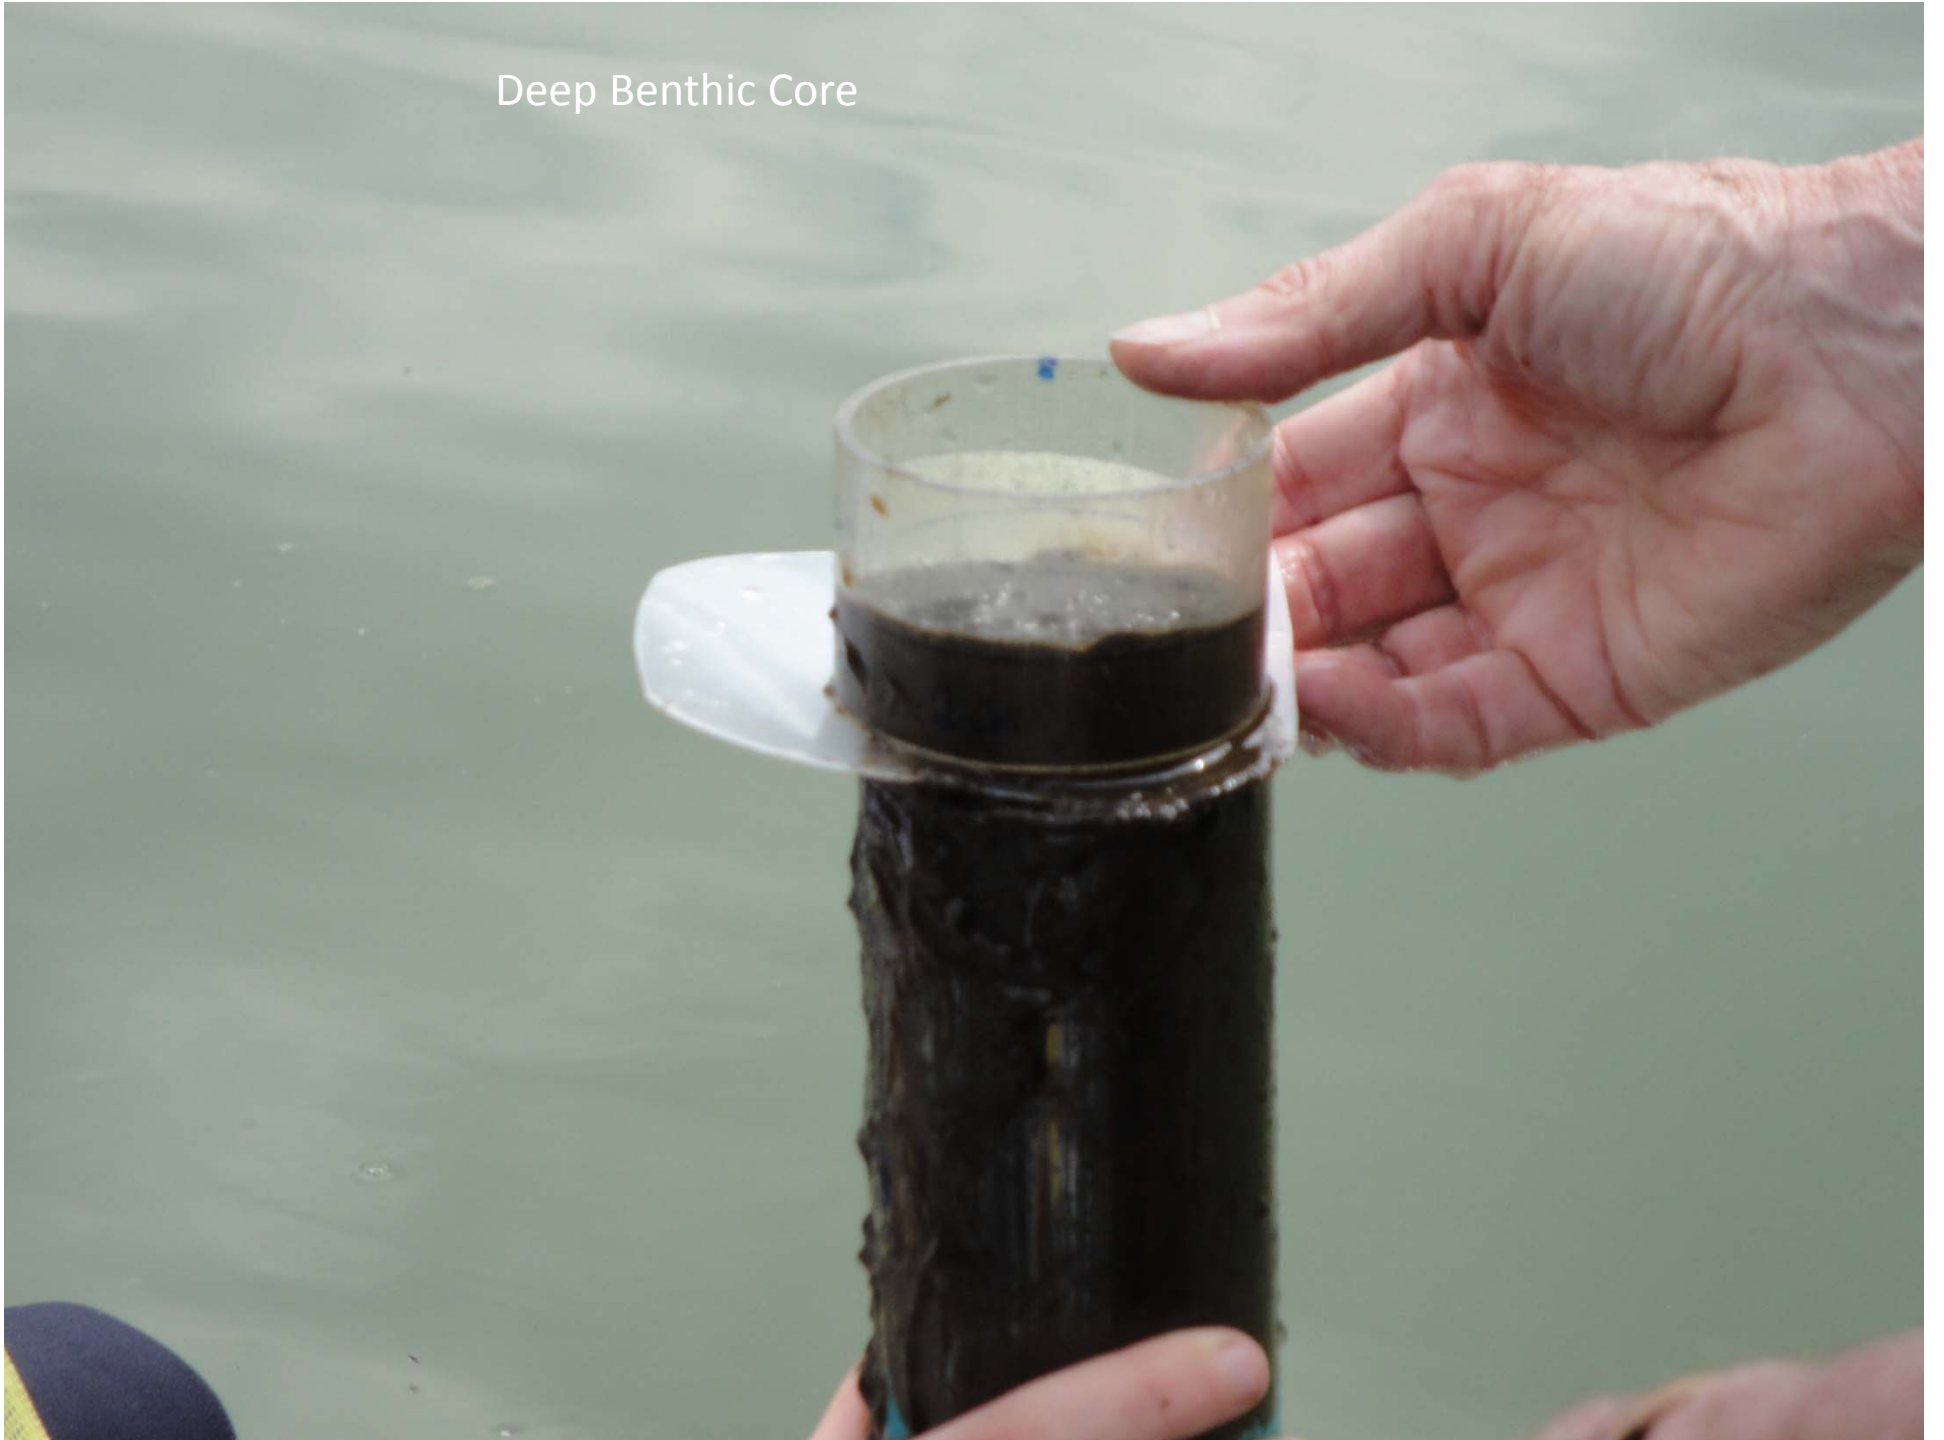
Deep Benthic Core

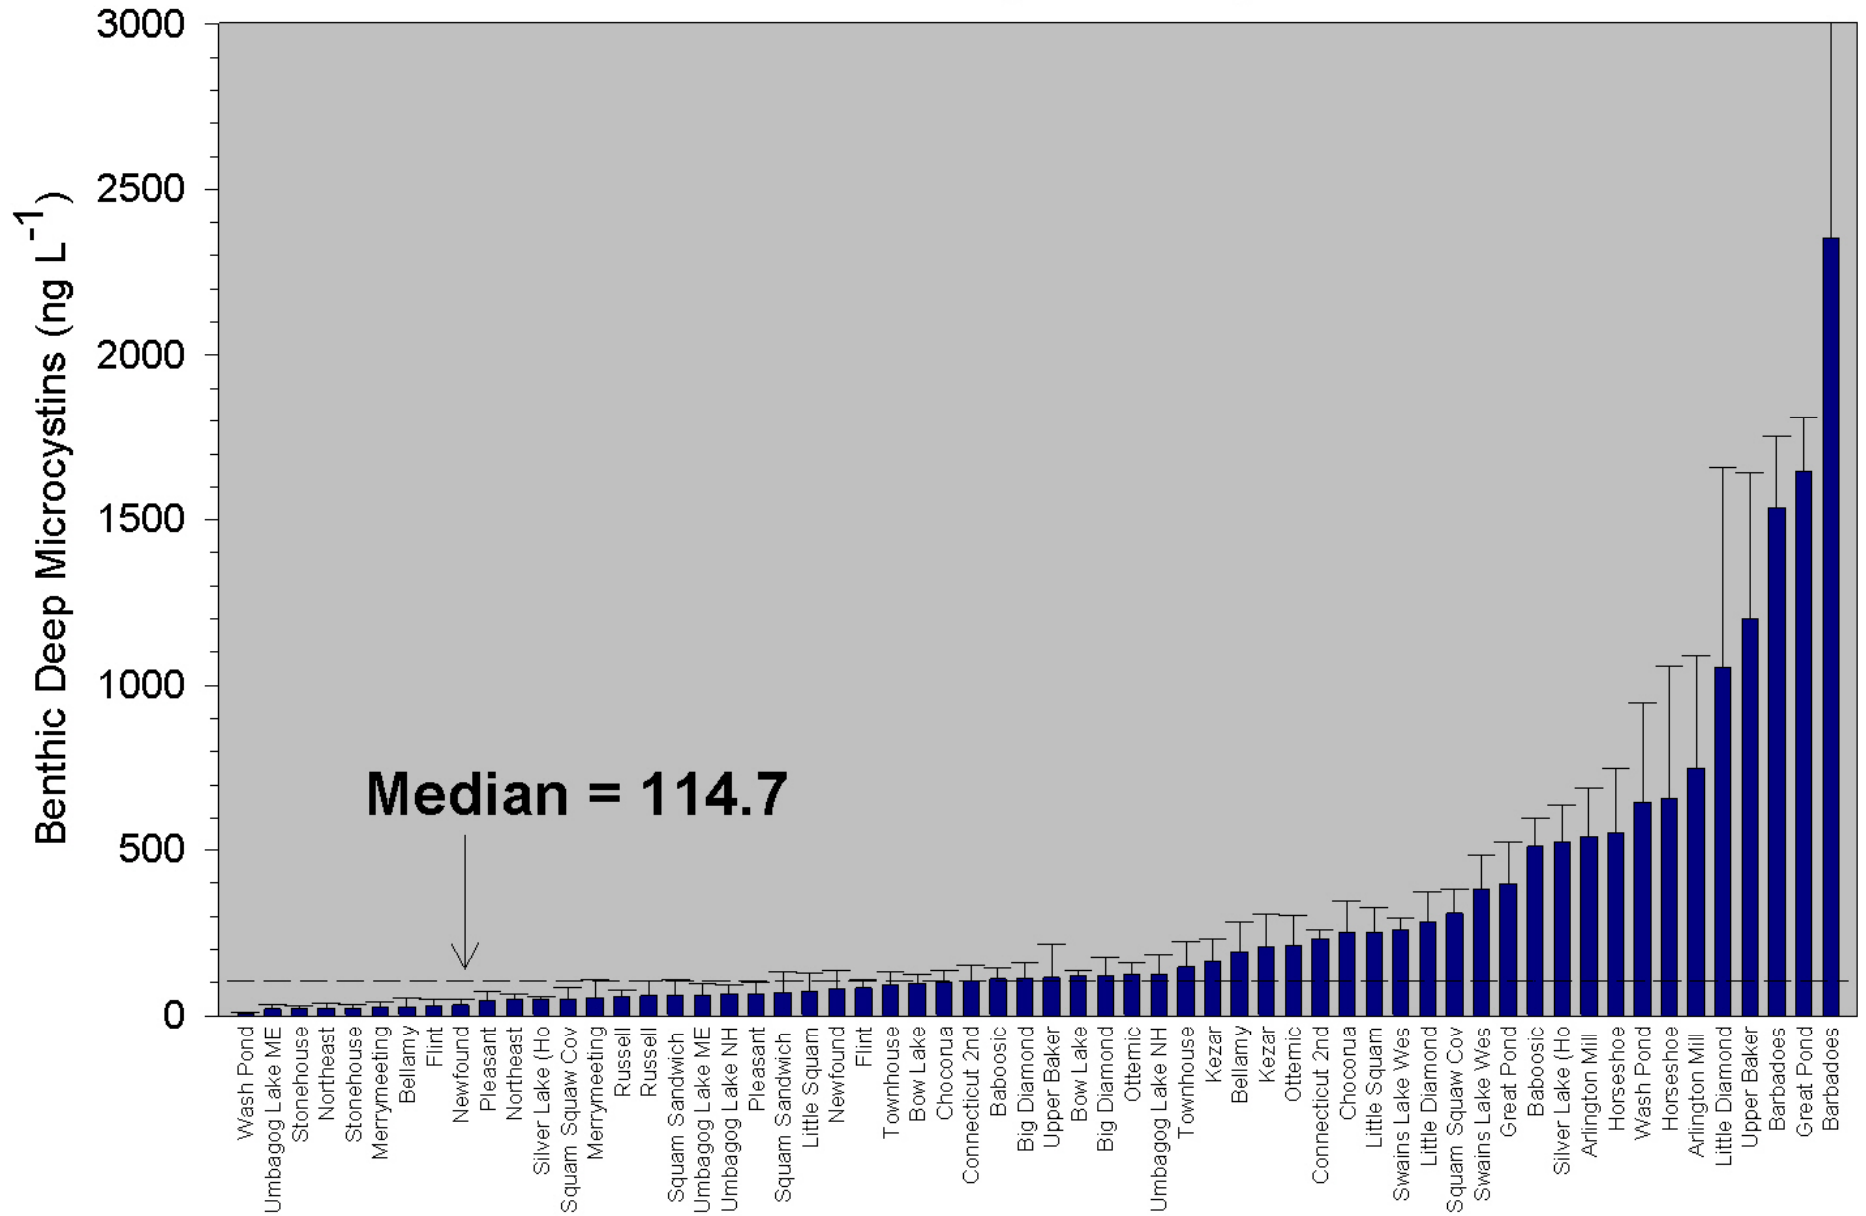
Benthic Deep Microcystins

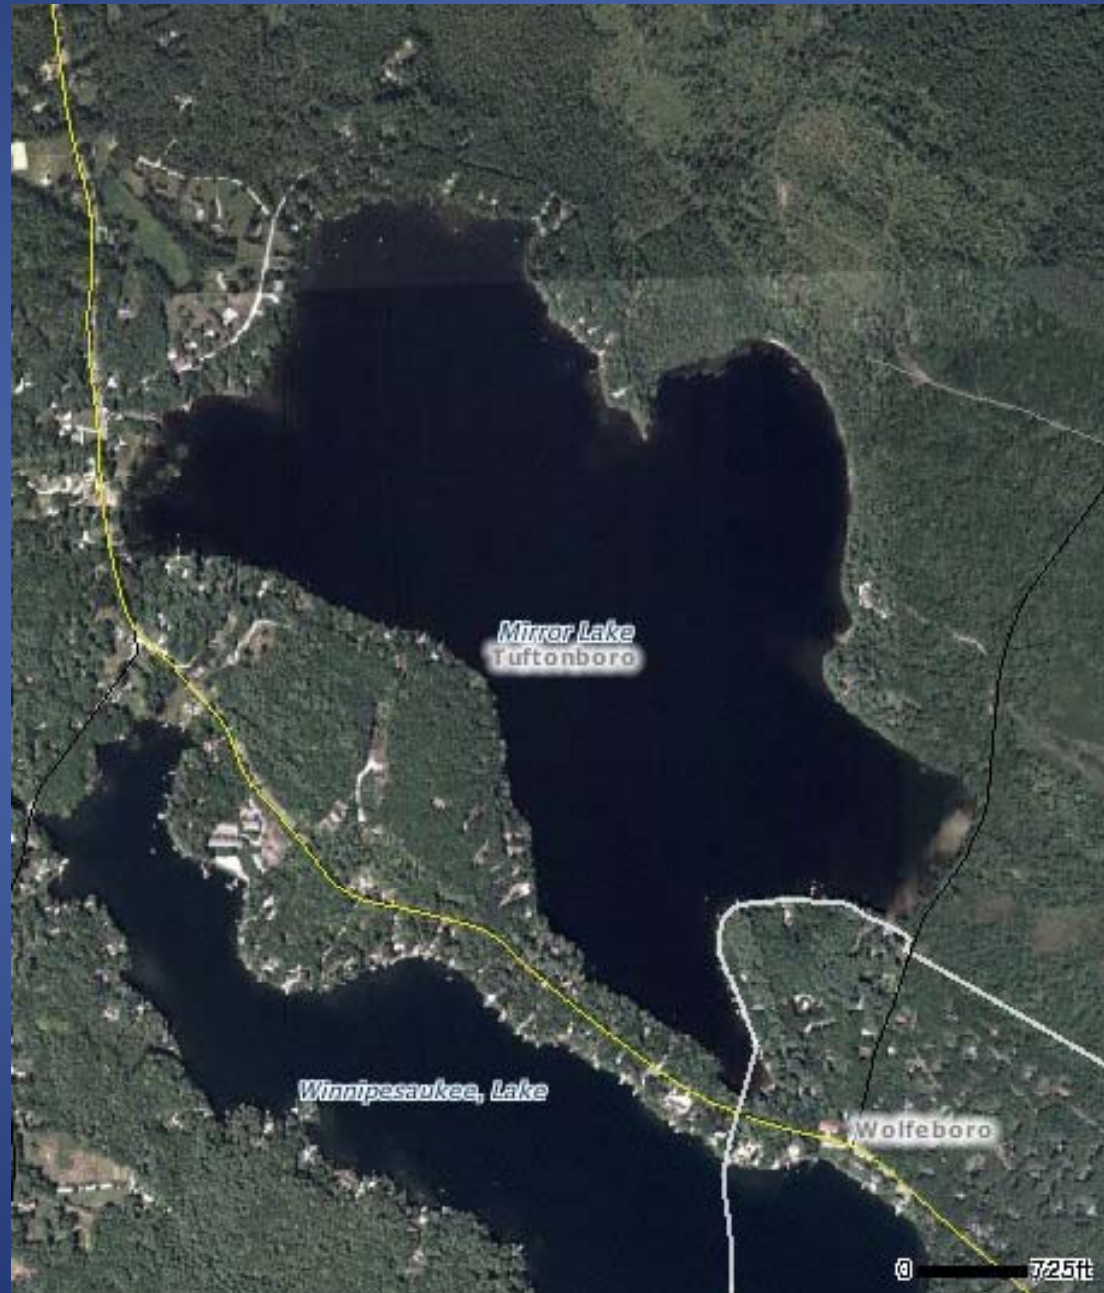
Deep (metalimnetic) Layers: Mirror Lake, NH

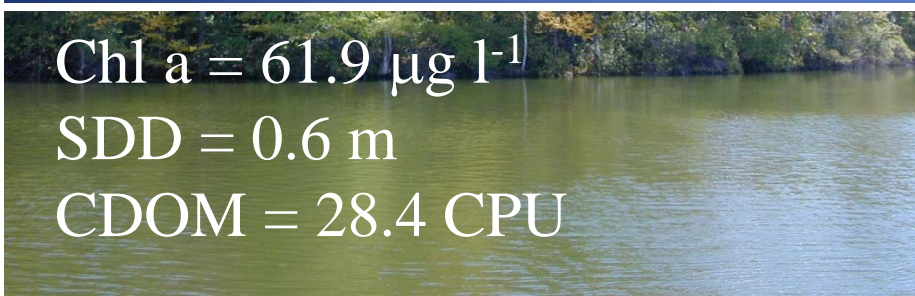
Chl a = $61.9 \mu\text{g l}^{-1}$
SDD = 0.6 m
CDOM = 28.4 CPU

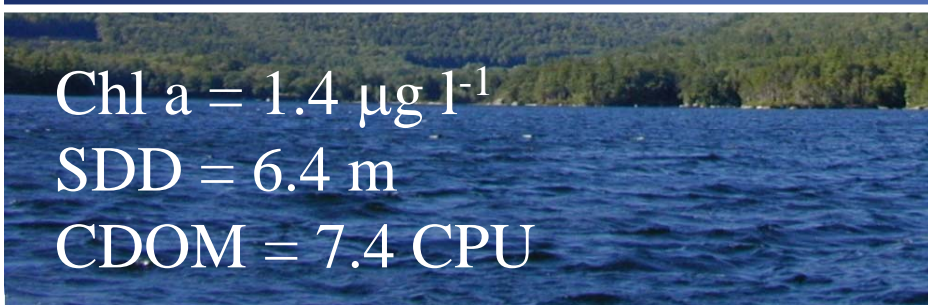
Chl a = $1.4 \mu\text{g l}^{-1}$
SDD = 6.4 m
CDOM = 7.4 CPU

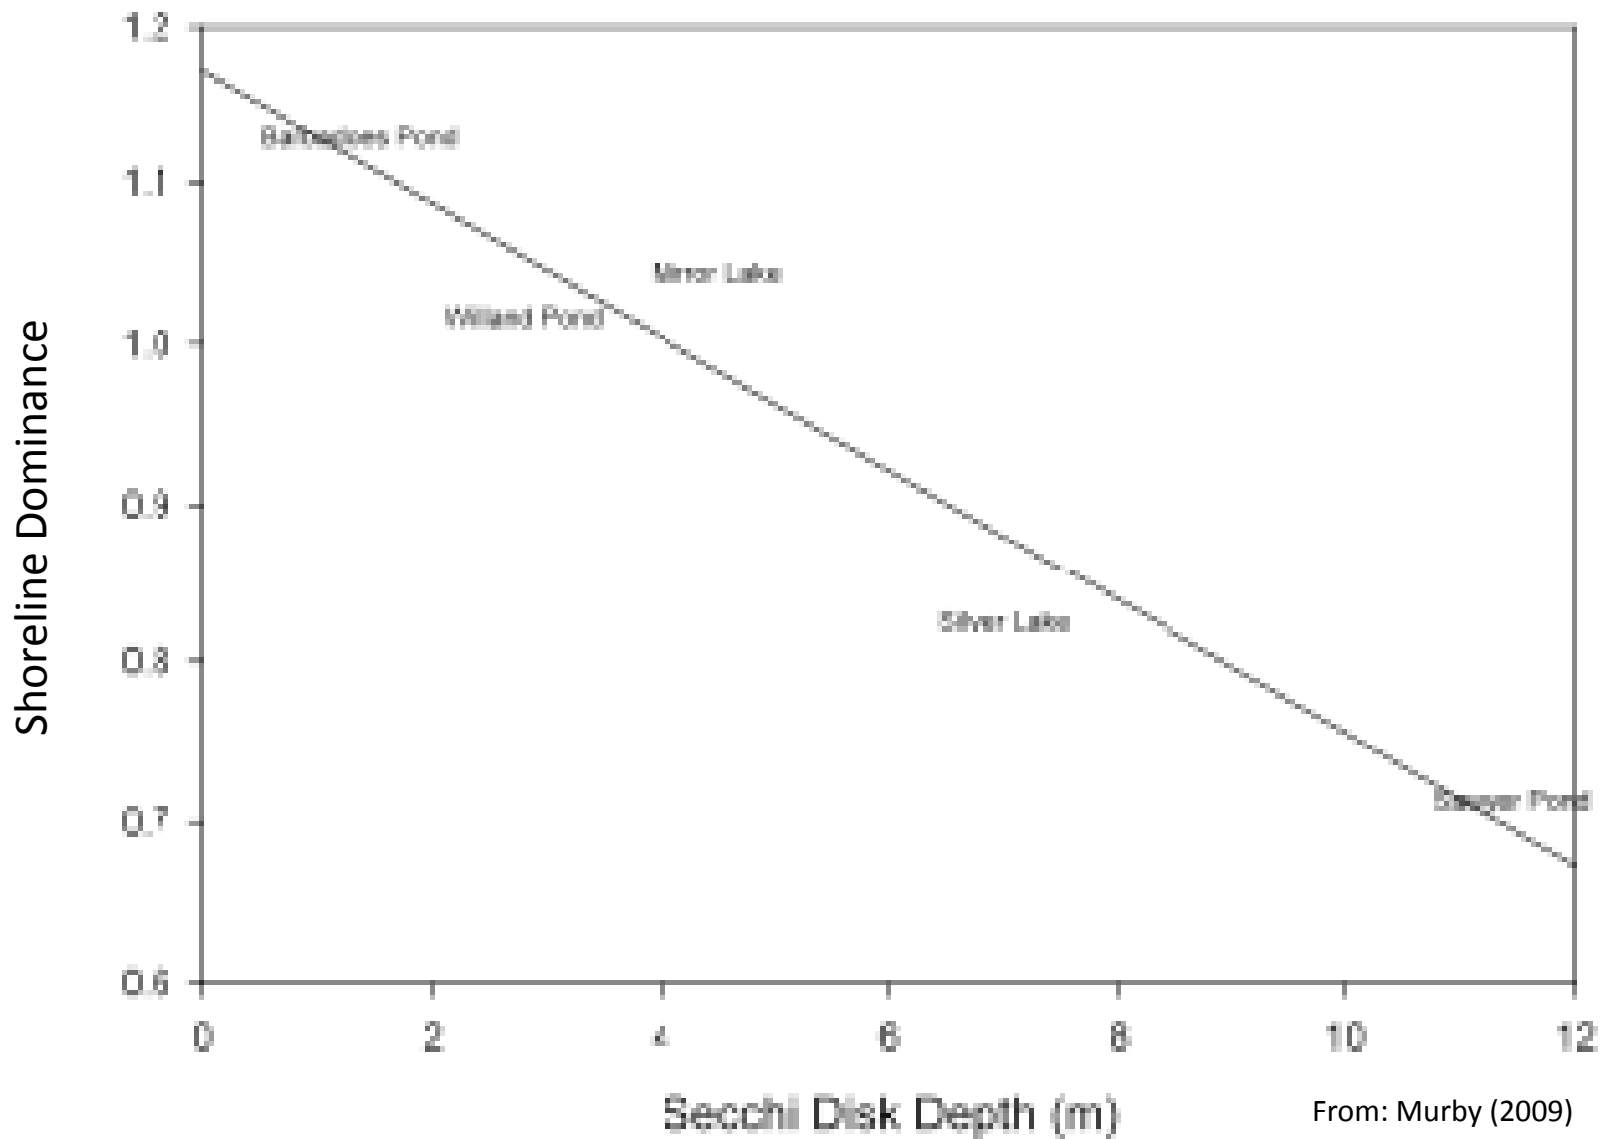
Shoreline Cyano-Dominance: Ratio of Shore:Deep PC vs Water Clarity

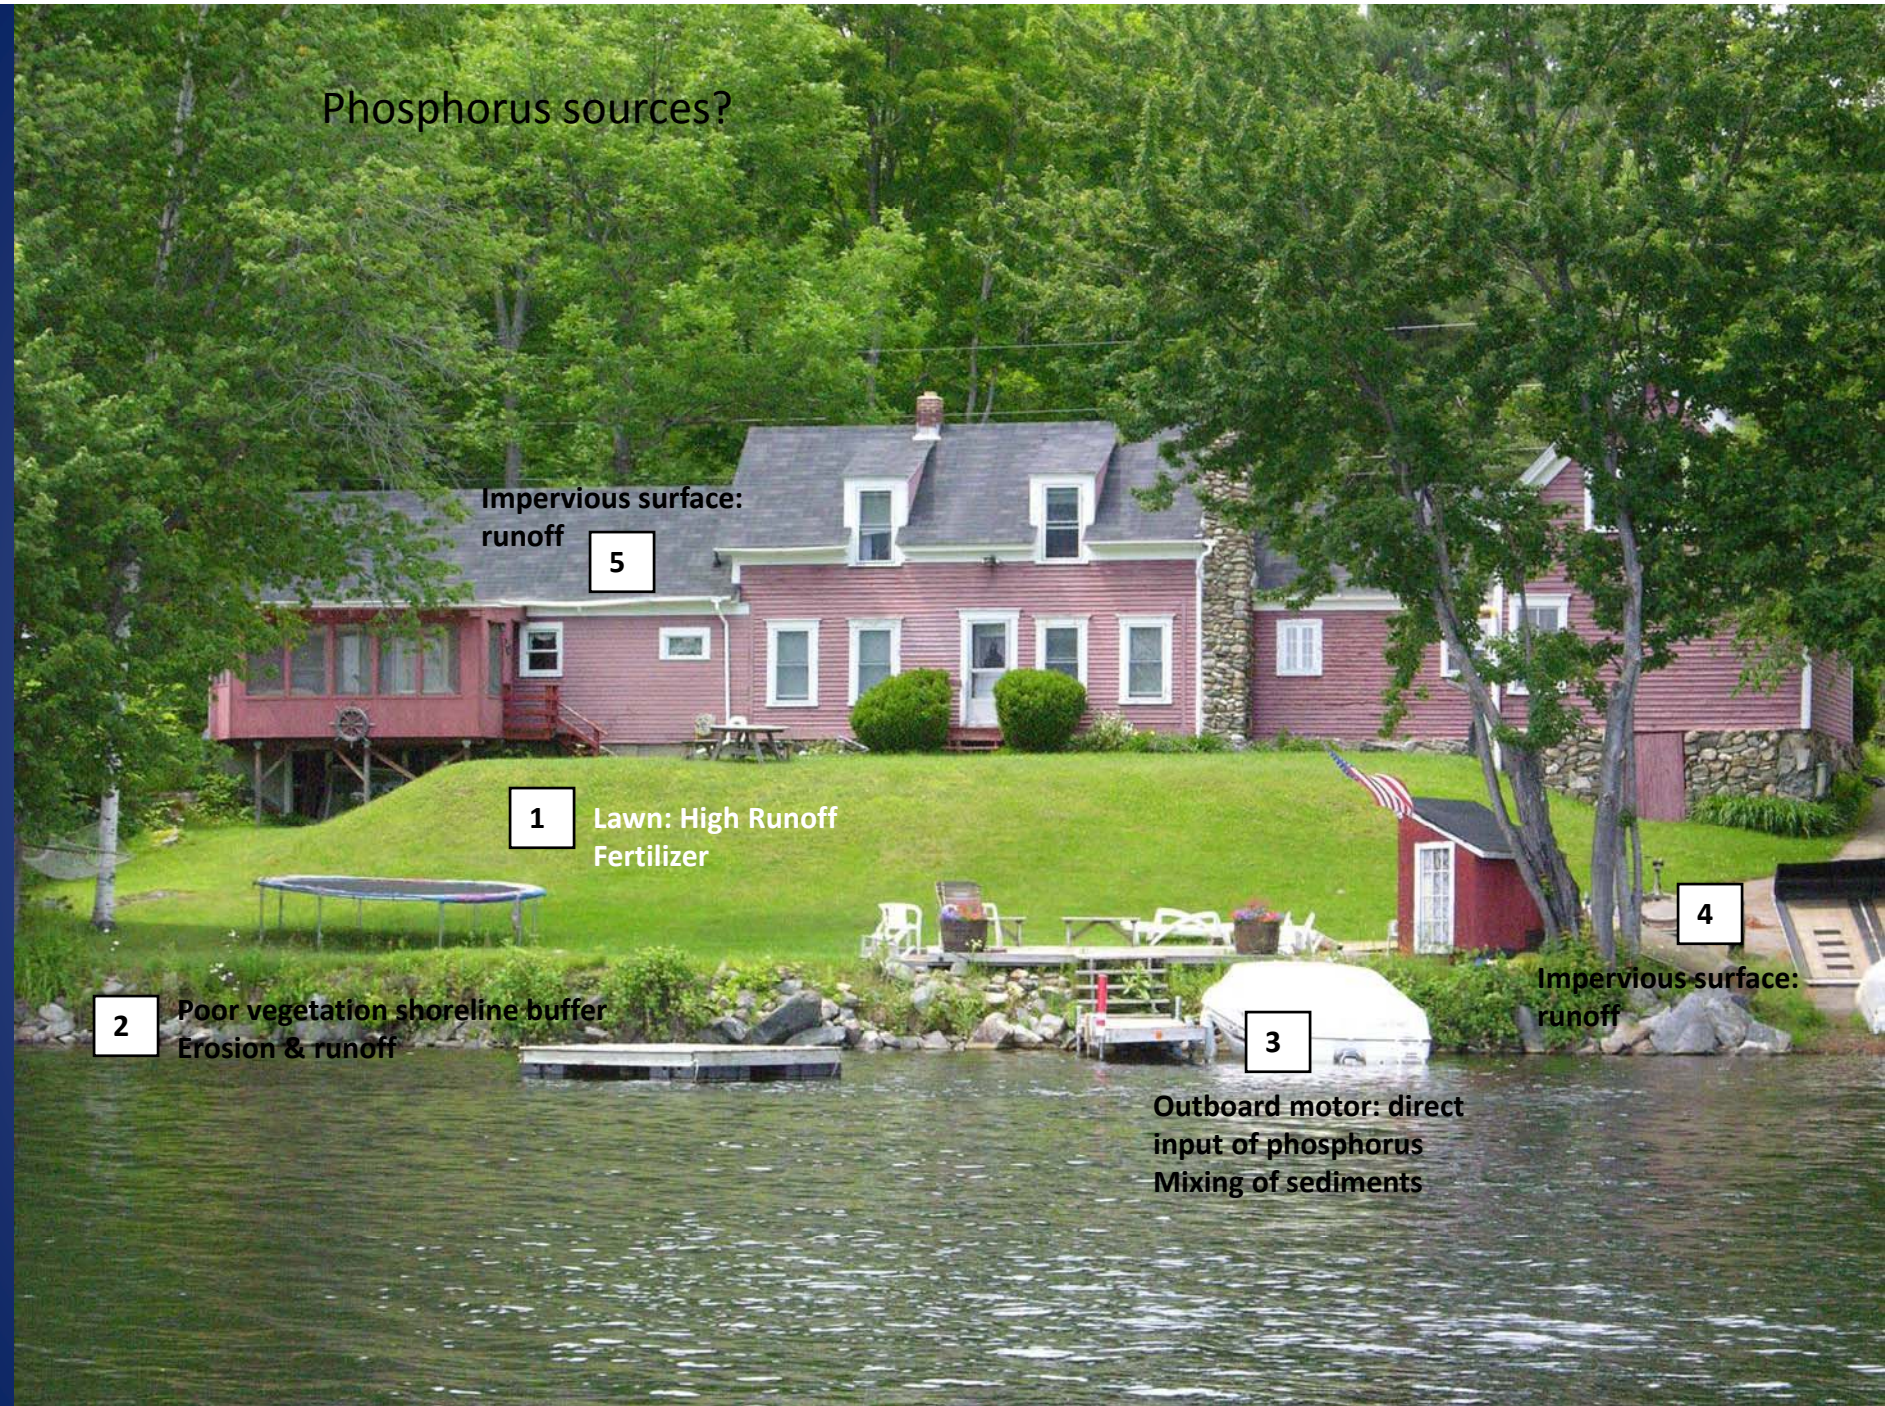
Phosphorus sources?

Impervious surface:
runoff

1 Lawn: High Runoff
Fertilizer

2 Poor vegetation shoreline buffer
Erosion & runoff

Outboard motor: direct
input of phosphorus
Mixing of sediments

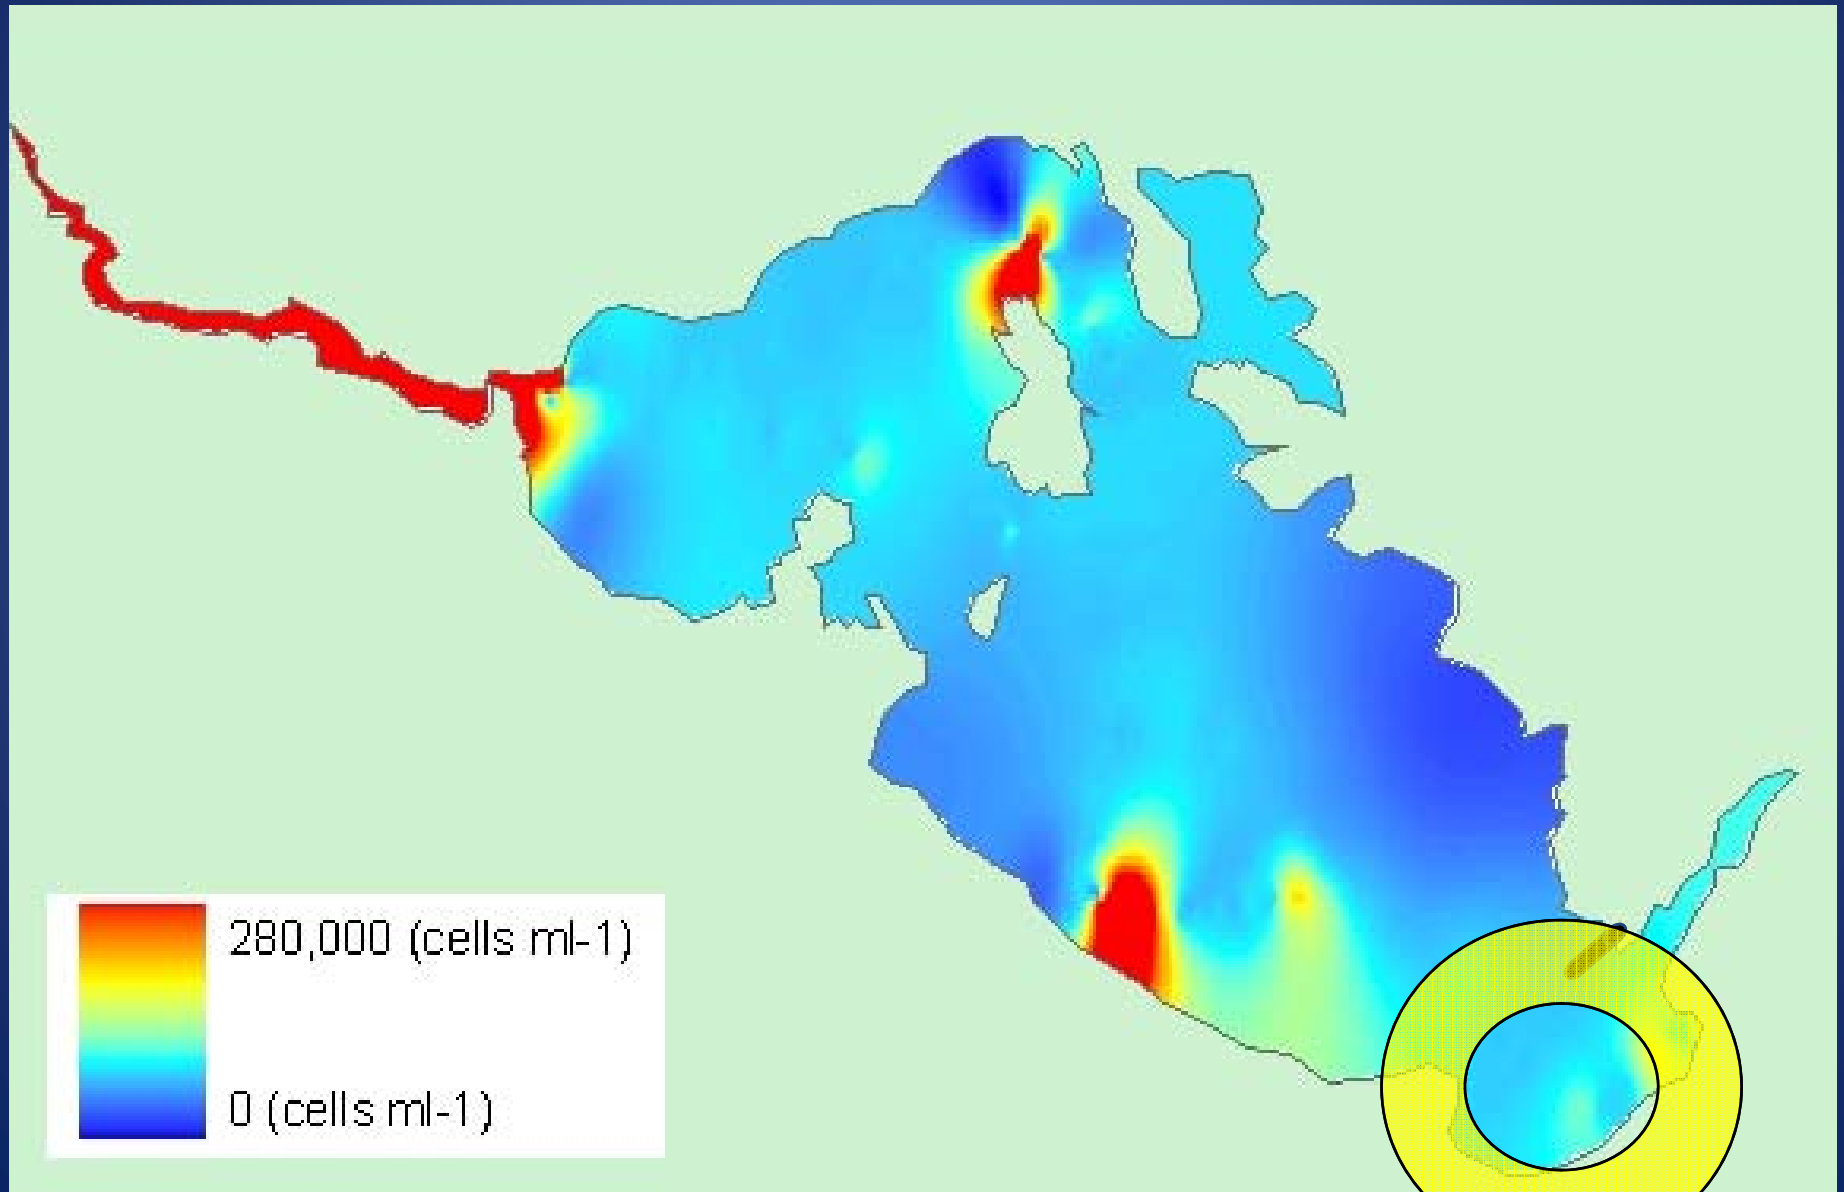
Lake Waukewan (Meredith, NH) Synoptic Survey with PC Probe

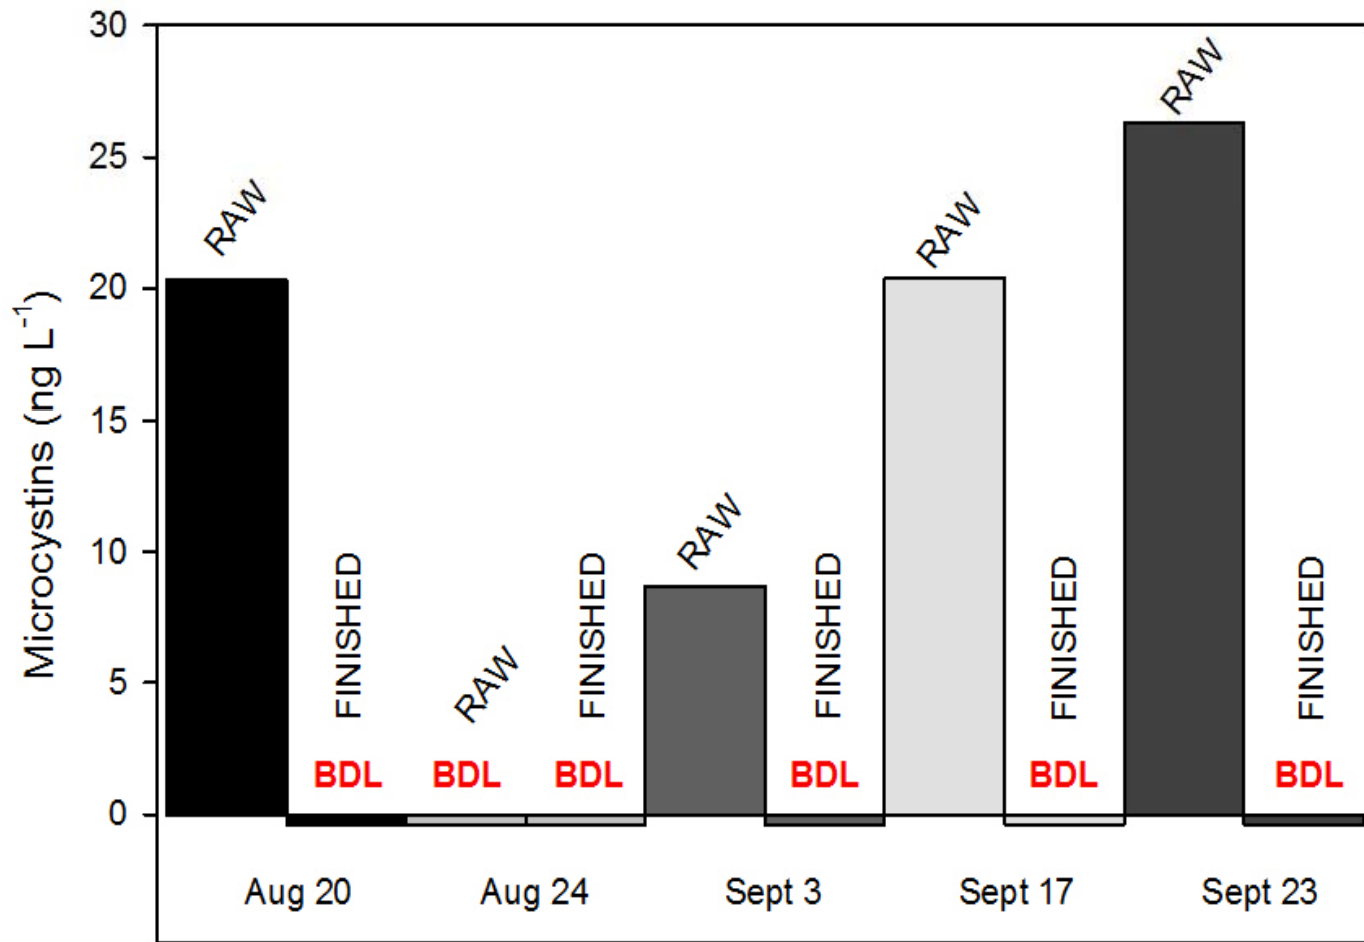
Microcystin in raw and finish water

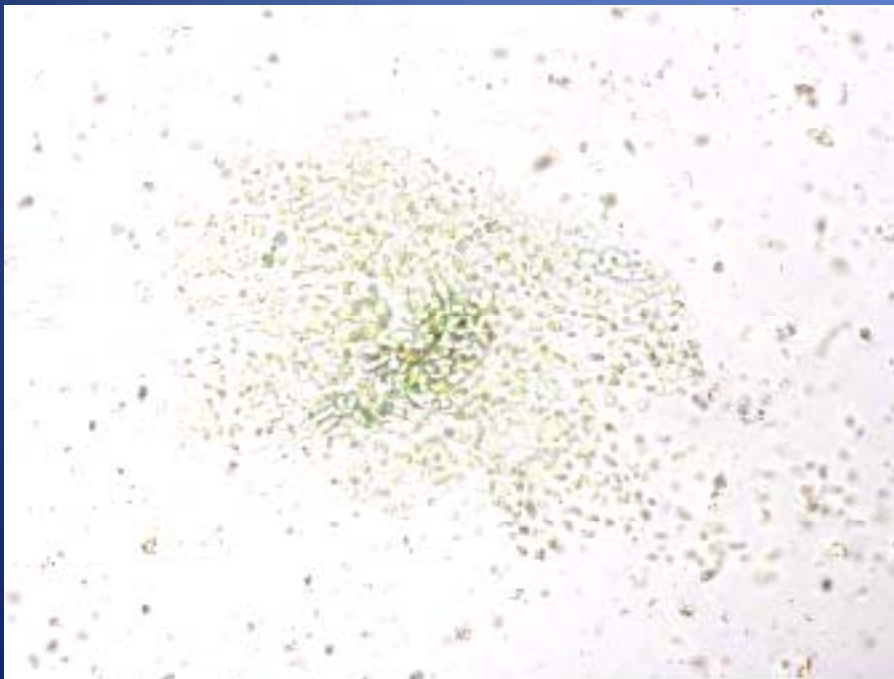
Figure 2. Chains of cyanobacteria in Moose Pond, December 2010.

- Samples of water and sand filter from Moose Hill Pond
- No detectable microcystins
- No MC=No cyanotoxins?
