Beyond Inspection Targeting: Lessons From Pascoag, RI

**Kim Schweisberg, EPA New England
UST/LUST Team**

2005 UST/LUST National Conference, Seattle, WA
Session: USTs, Ground and Source Water Protection,
& GIS

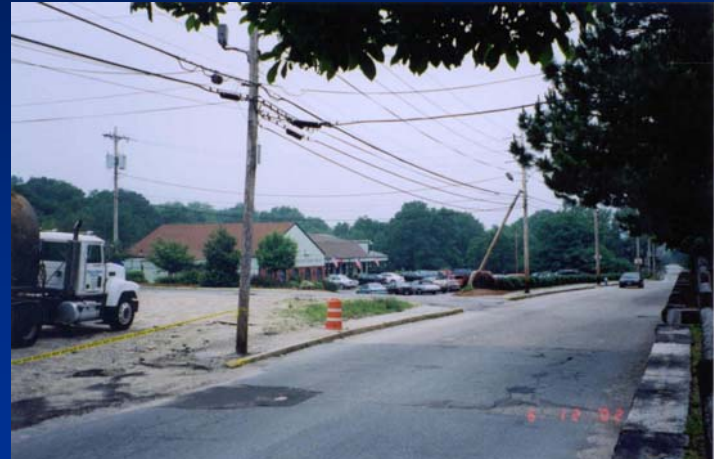
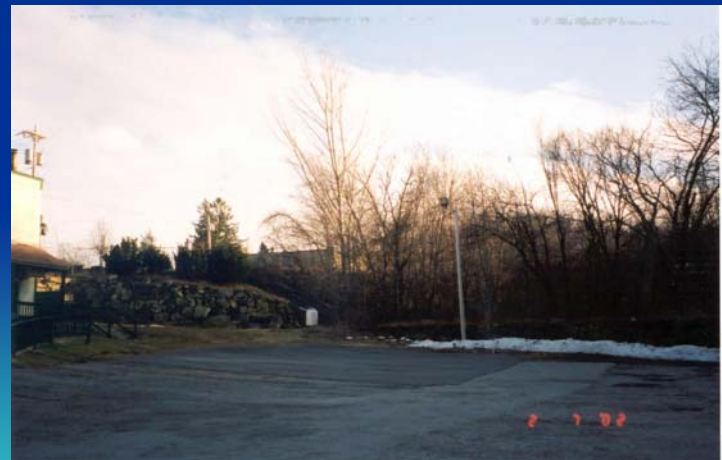
A look at the UST system

- The tank system was bare steel upgraded with lining and impressed current CP; action was pending against the facility for piping related noncompliance
- When the tank system was removed, no “smoking gun” was discovered
- I observed that the ball float cages were empty and had solid, orange drips of some polymer on them
- Spill bucket integrity was very questionable
- There was a concretion of rusted pea gravel on the tank top and the spill and overfill piping
