# Vapor Leaks: Pressure's Building

Presented by  
*Gary S. Lynn, P.E.*

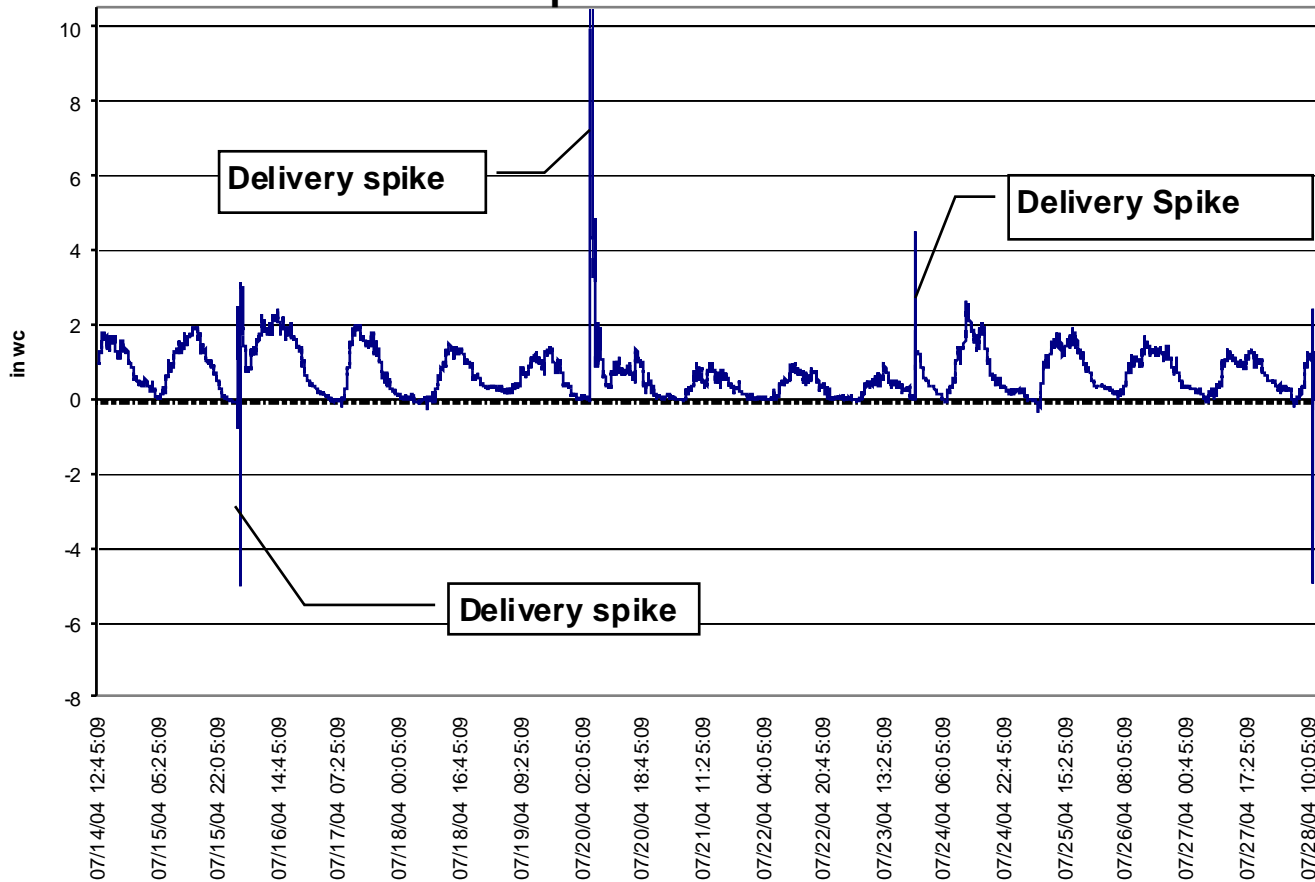
# Plaistow Citgo, New Hampshire

## UST pressure in inwc

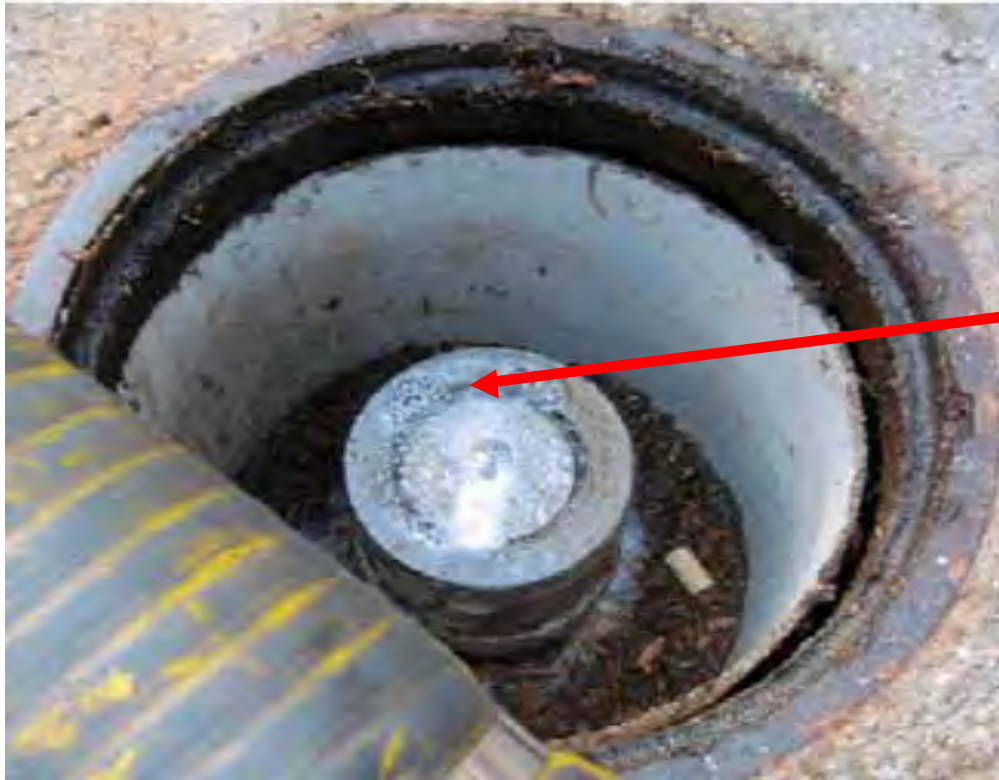
# Fremont Site Dry Break

Dry break  
vapor leak

- ▶ *Delivery Inspection by former UST Inspector, now remedial program PM*
- ▶ *Leaks found at dry break and several ATGs*
  - ▶ *Dry break may have been bypassed*
  - ▶ *Last delivery of route, 2AM deliveries*
- ▶ *SVE operation bracketing delivery (timer set for Thursday thru Sunday)*
  - ▶ *MtBE at 41ppb versus up to 1,760 ppb prior to intervention*

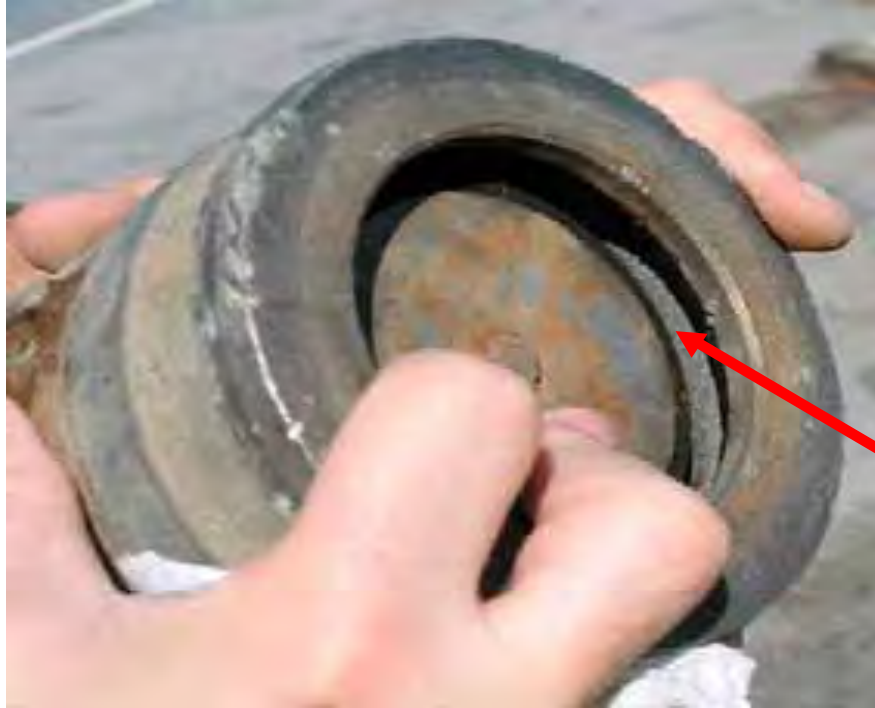
# Dry Break

**Scored by  
Screwdriver?**

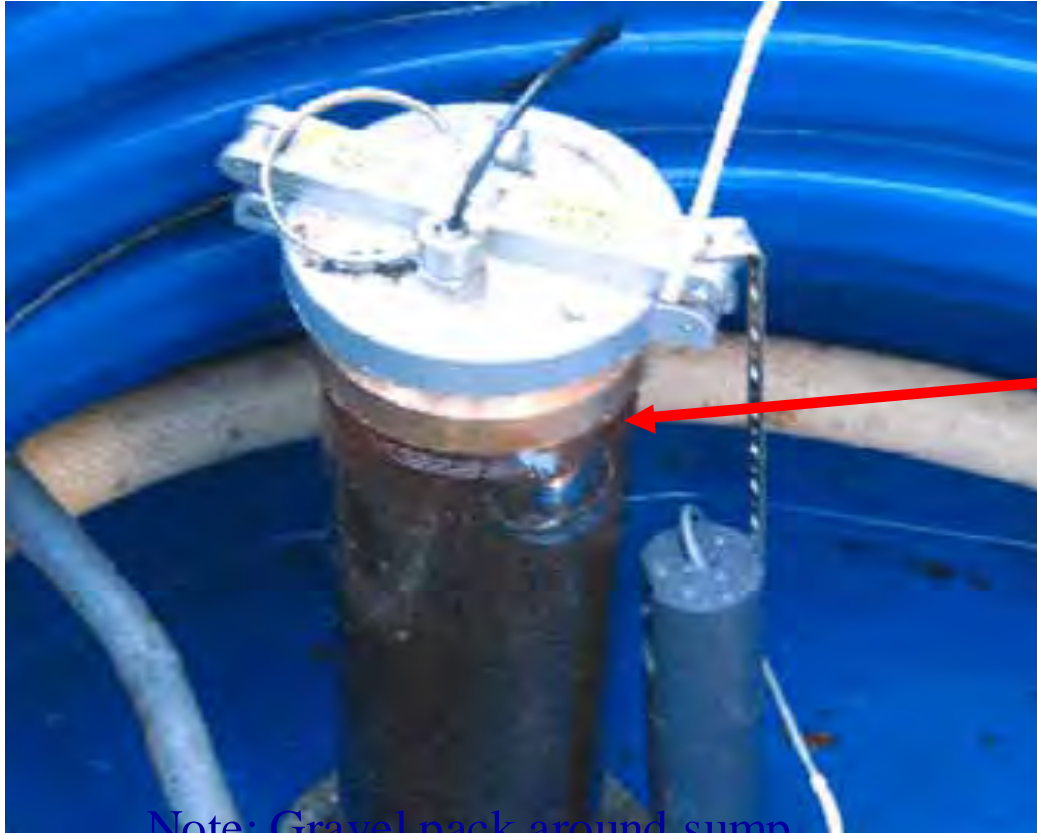
# Fremont Site ATG Cover

Leaking  
Threaded  
Connection

Note: Gravel pack around sump

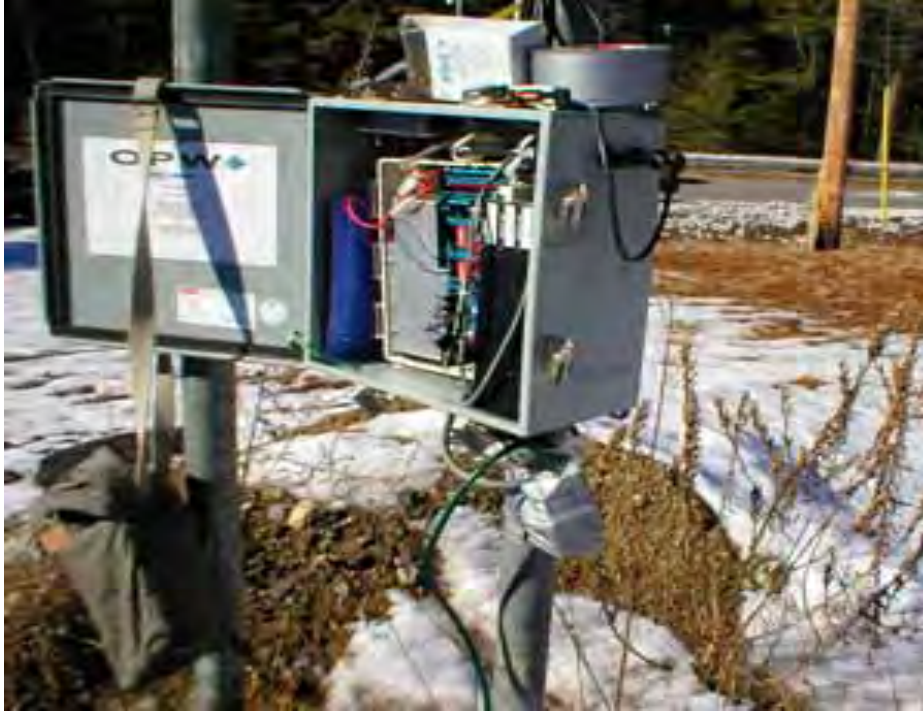
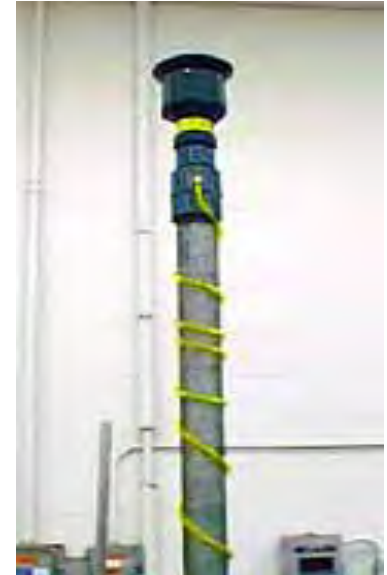
# Tank Pressure Monitoring

**Datalogger Setup**

**Vent tap for  
pressure  
monitoring**

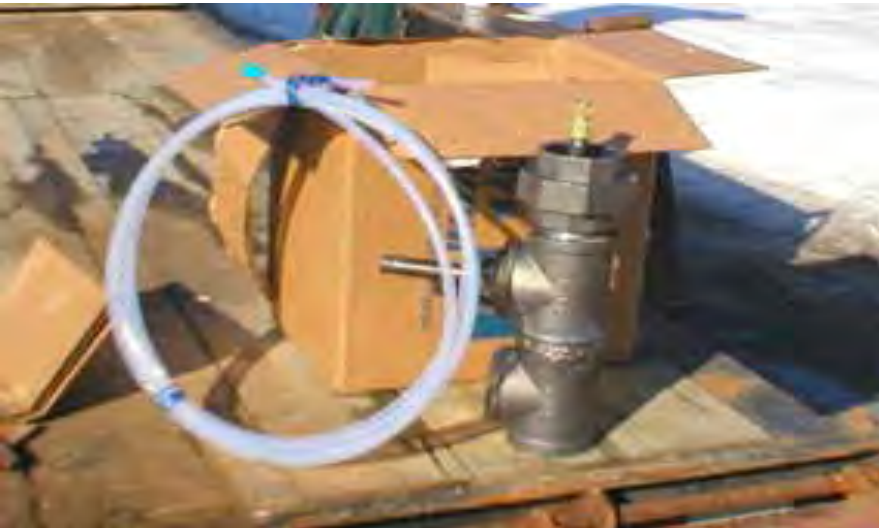
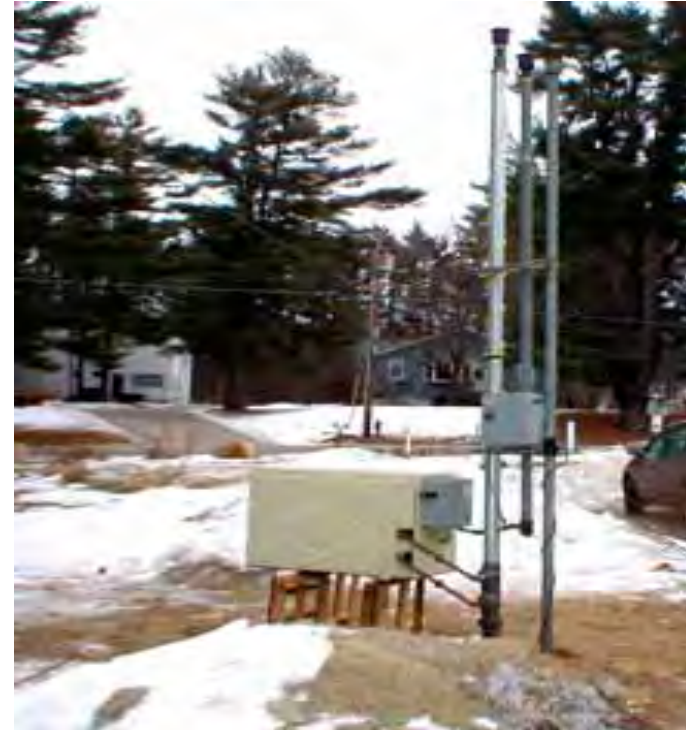
# Vaporsaver Installation

Vaporsaver and  
temporary base

Custom fitting for  
vent withdrawal  
and return

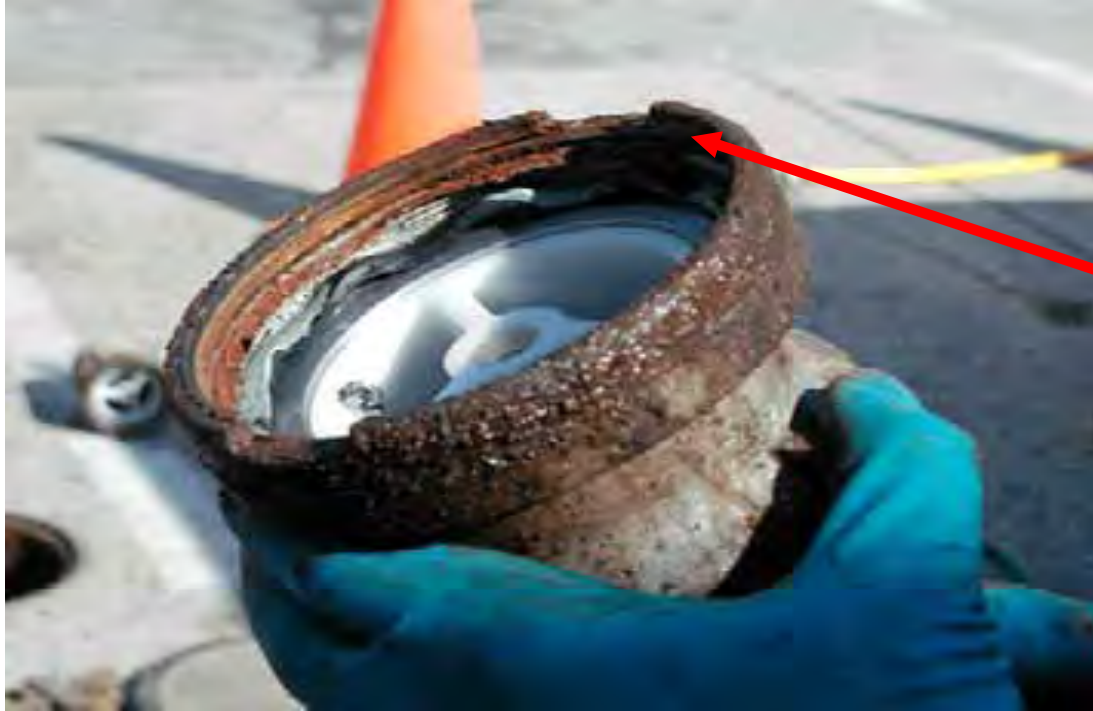
# Dry Break Leaks - Epping

Corroded  
Dry Break

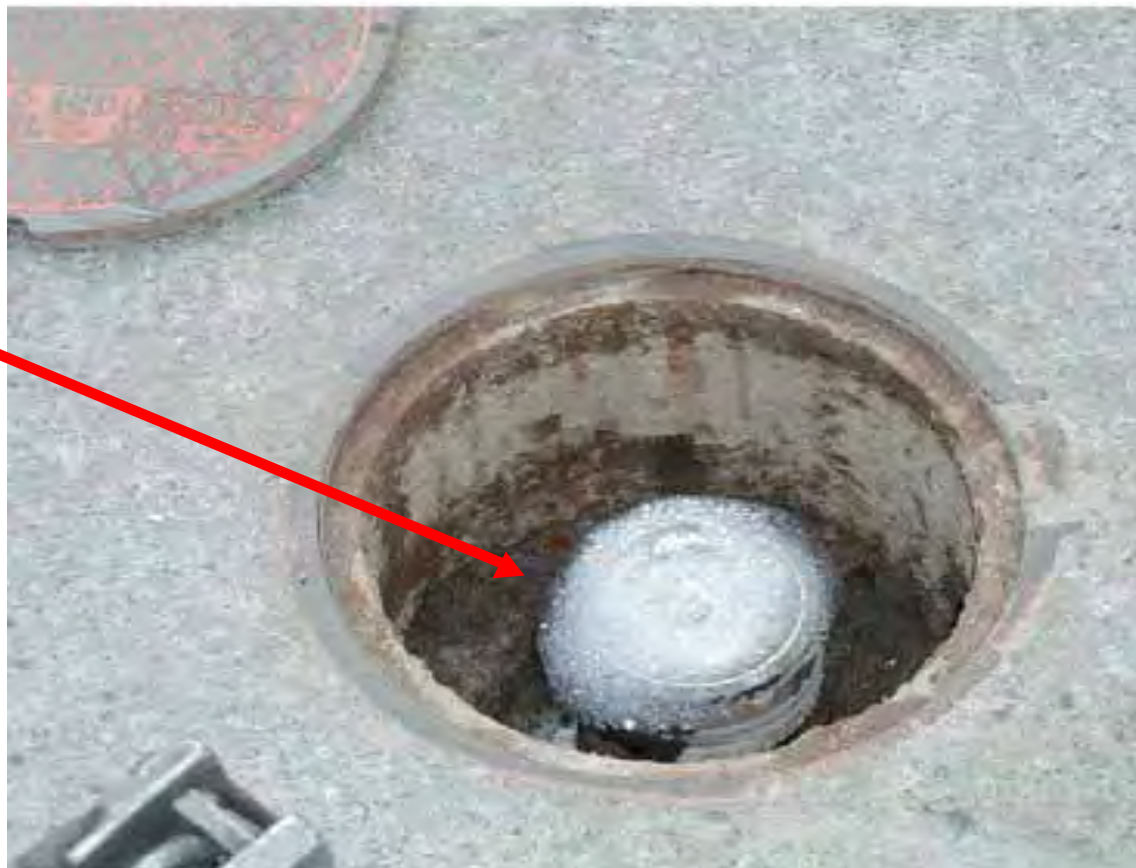
# Dry Break Leaks - Keene

Dry Break  
Vapor Release

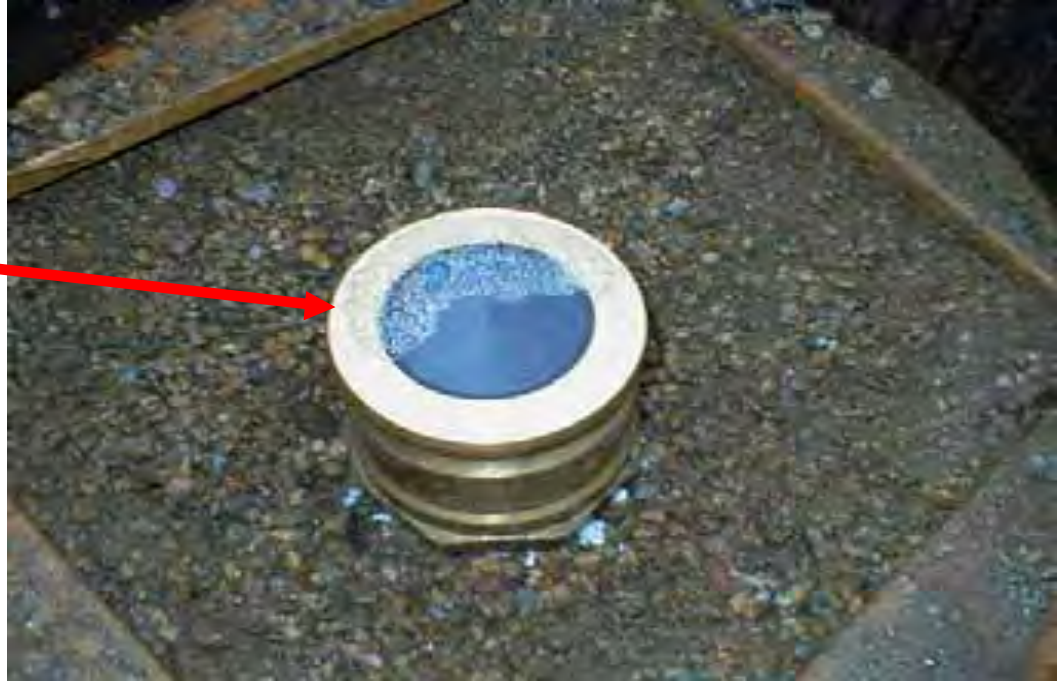
# Dry Break Leaks - Plaistow

New, just out of  
box, dry break  
leak

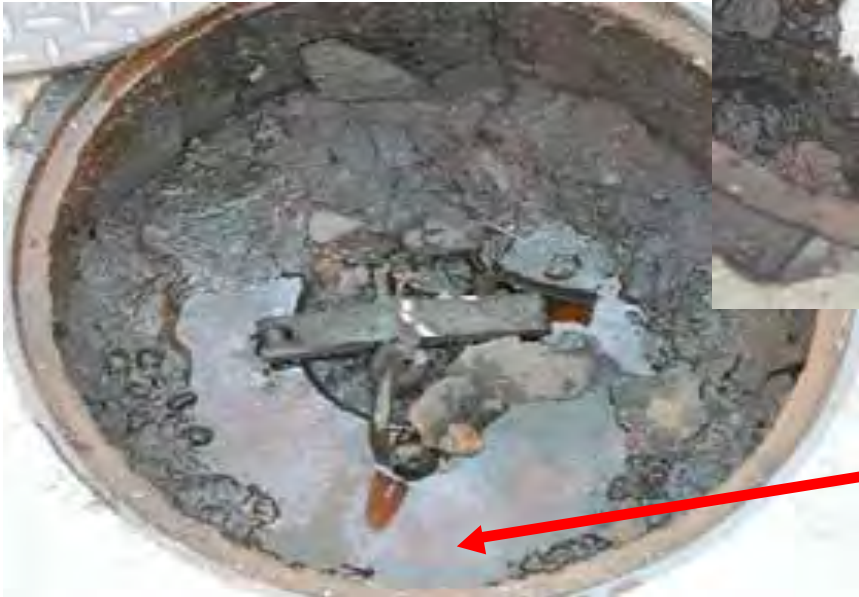
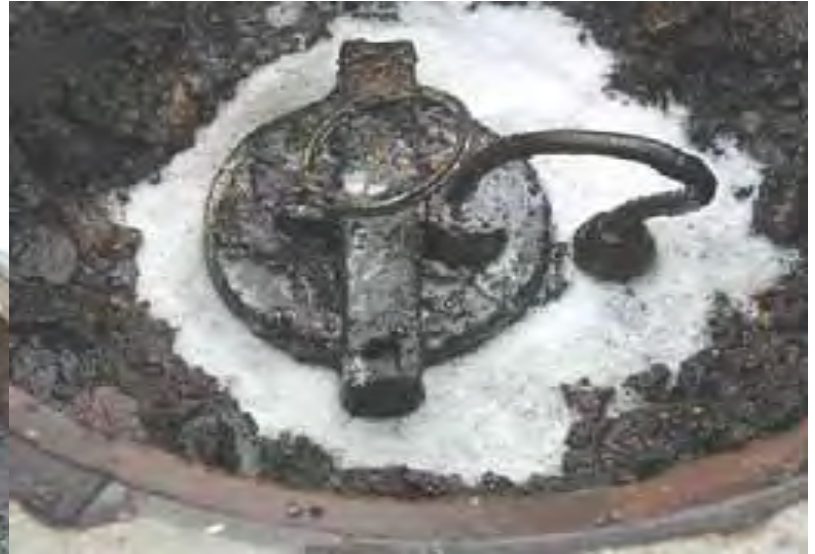
# Leaky ATG - Greenland

Sheen on water

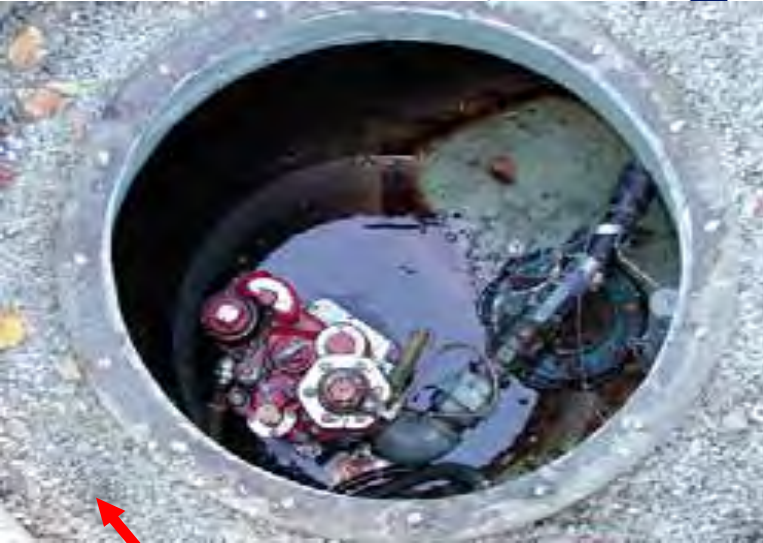
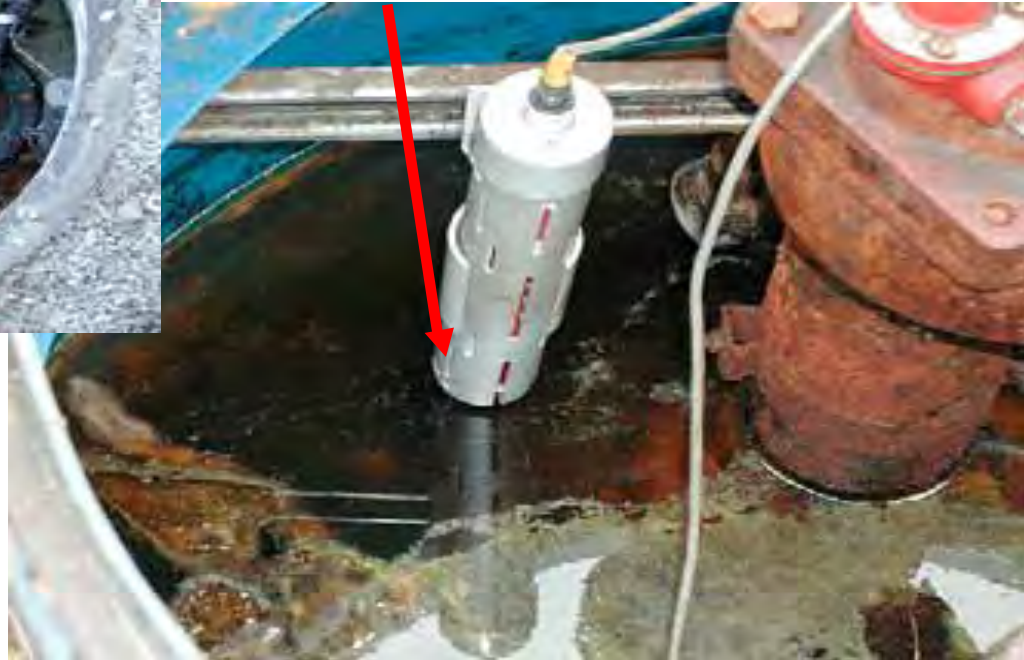
# Product Leaks – Newington/Milford

Gravel pack  
around sump

Sensor set above  
product
