# A “Hole” New Look at Corrosion

Michigan Department of  
Environmental Quality

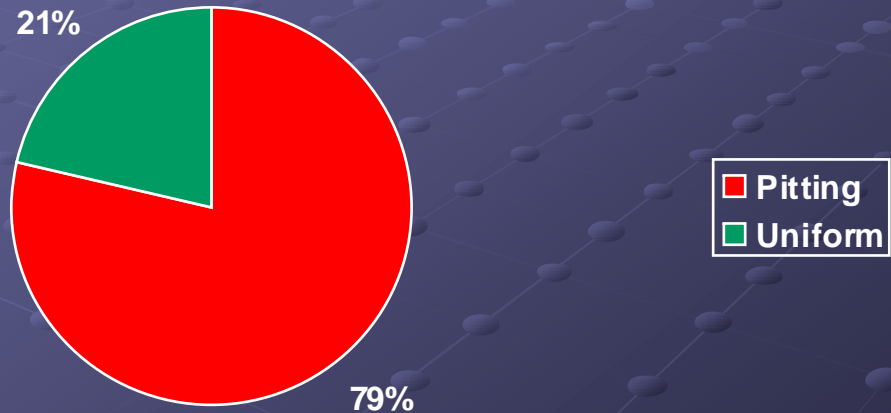
# Type of Corrosion Mechanism Present on Visually Inspected Excavated USTs

- 111 or 79% of the USTs showed evidence that pitting corrosion was the operative mechanism.
- 30 or 21% of the USTs showed evidence that uniform corrosion was the operative mechanism.
