Florida Cause of Leak Study

Summary - Florida Cause of Leak Study

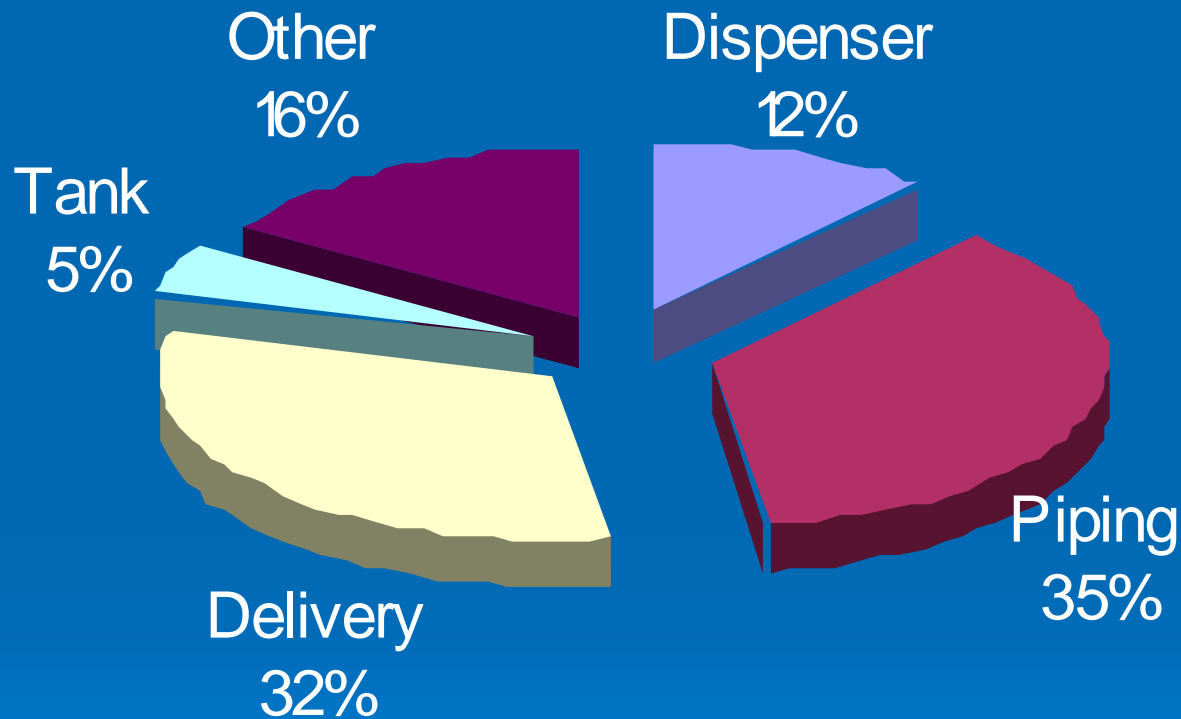
Sources of Releases

Other Sources Include: Fuel Filters, Outlet Valve, and Human Spilling

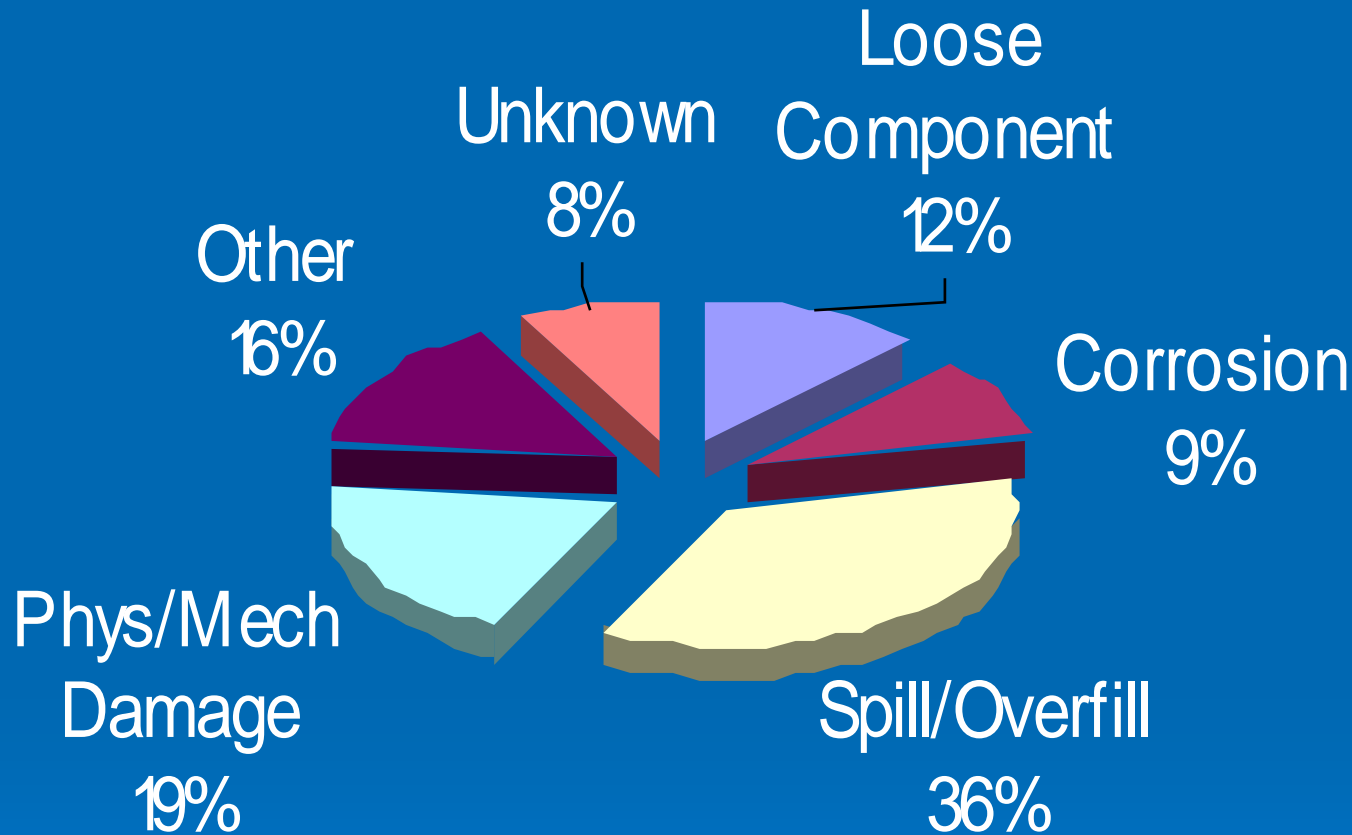
Causes of Releases

Other Causes Include: Vandalism, Valve Failure, Contractor Accident, Other Human Error

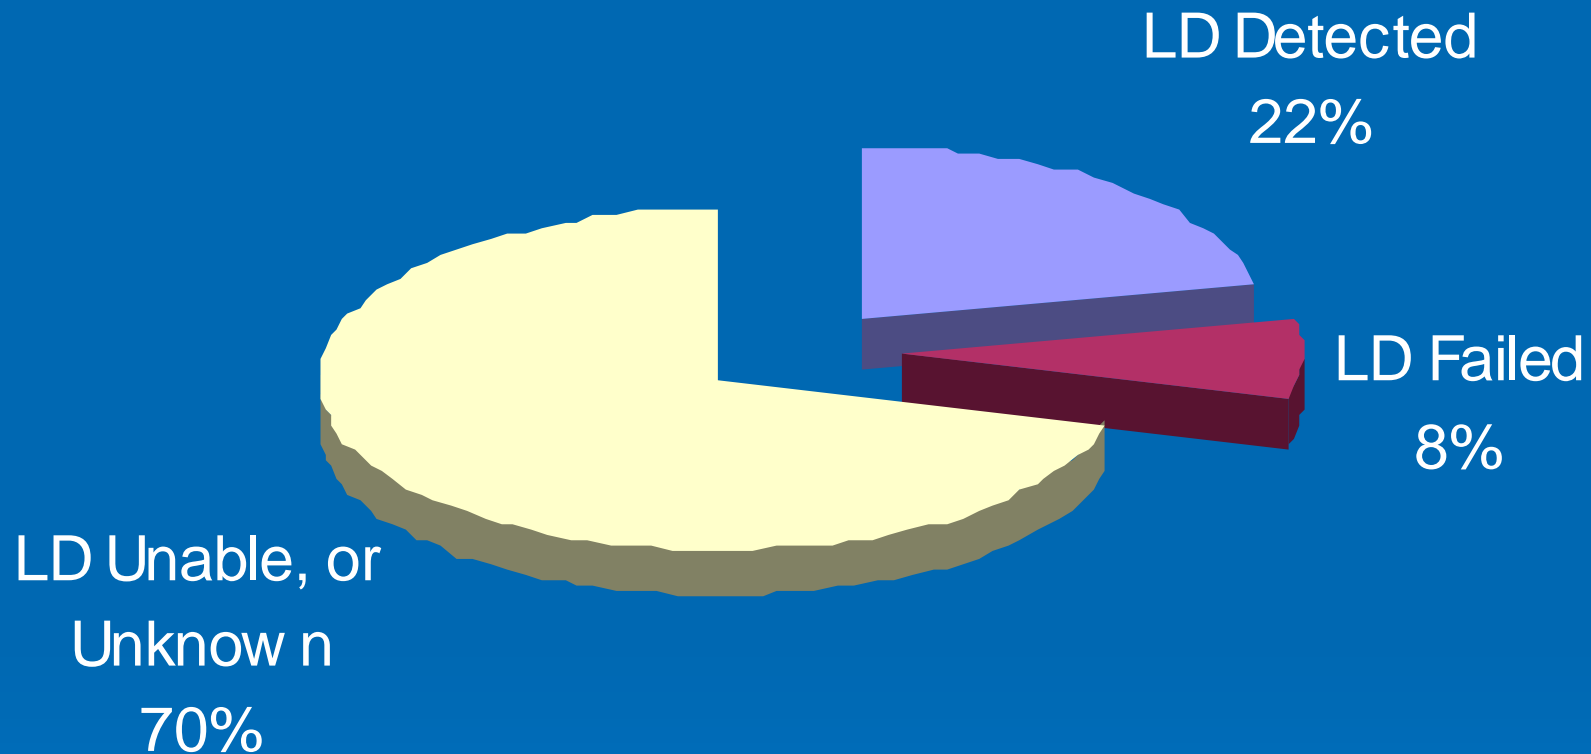
Success of Leak Detection

LD Unable, or Unknown: Either the release came from a part of the system that a LD system was not designed to detect, or the inspector could not determine whether LD failed to detect.

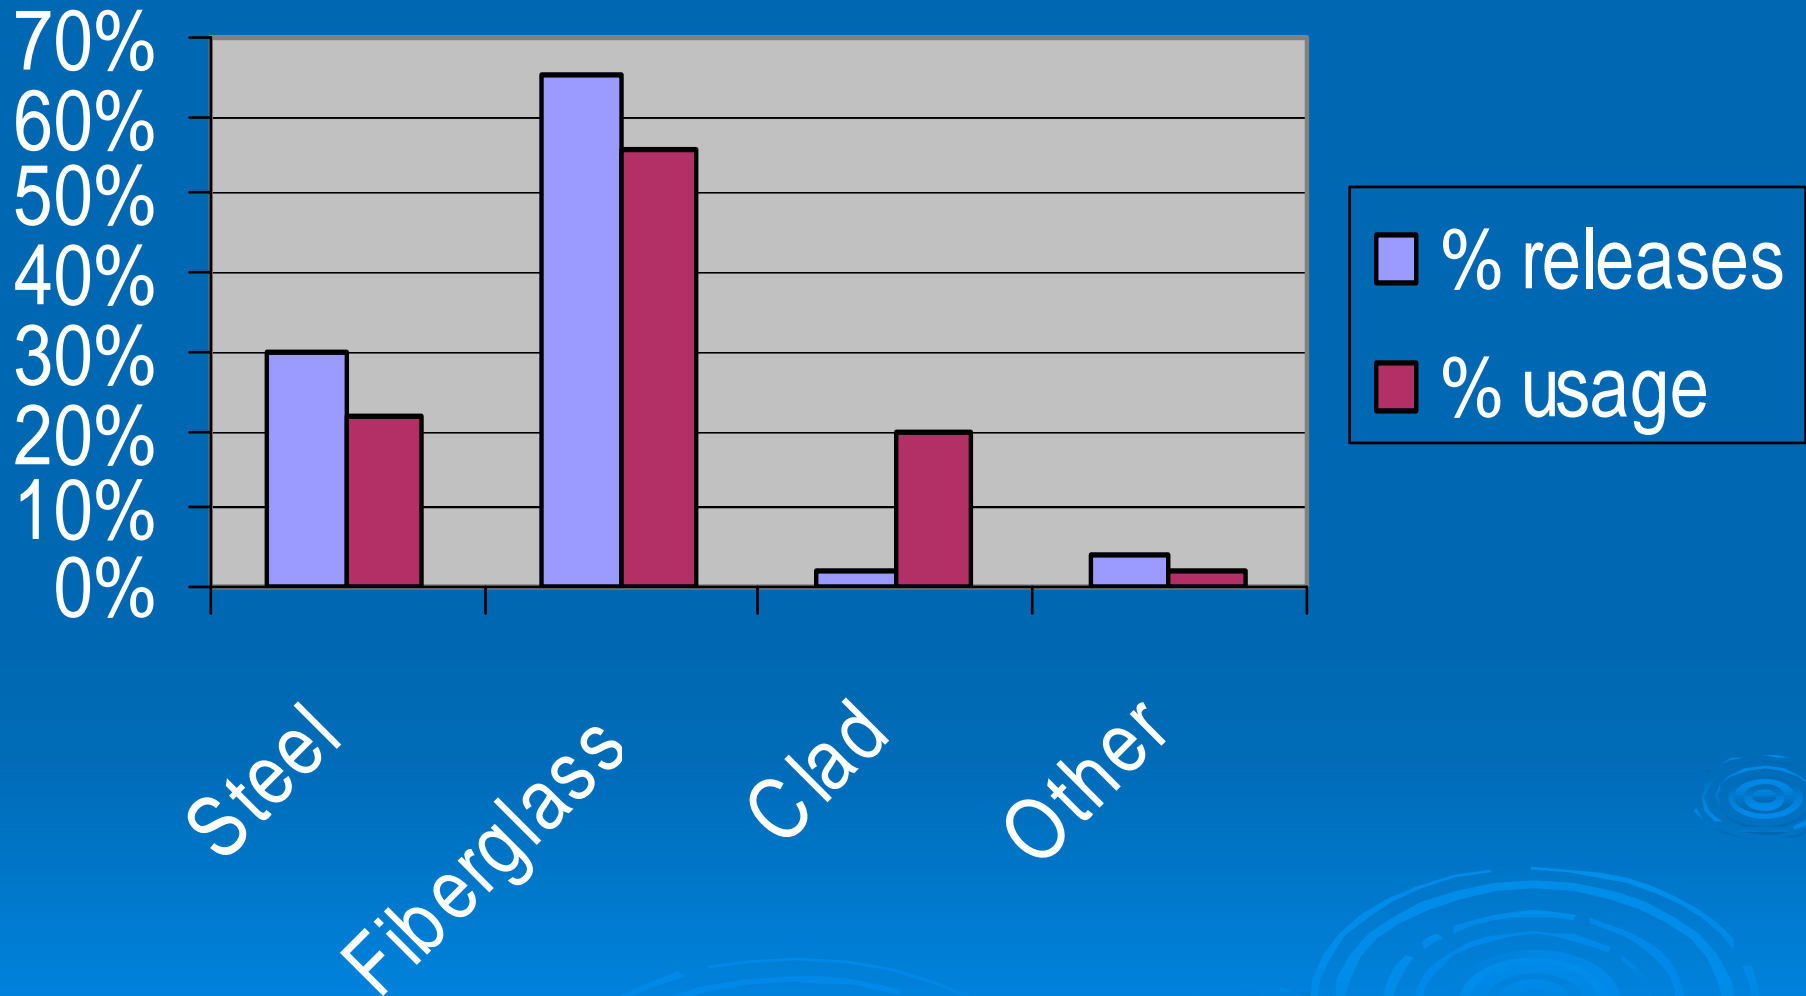
- Tank Usage Versus Releases -

Clad Tanks Had Relatively Fewer Releases

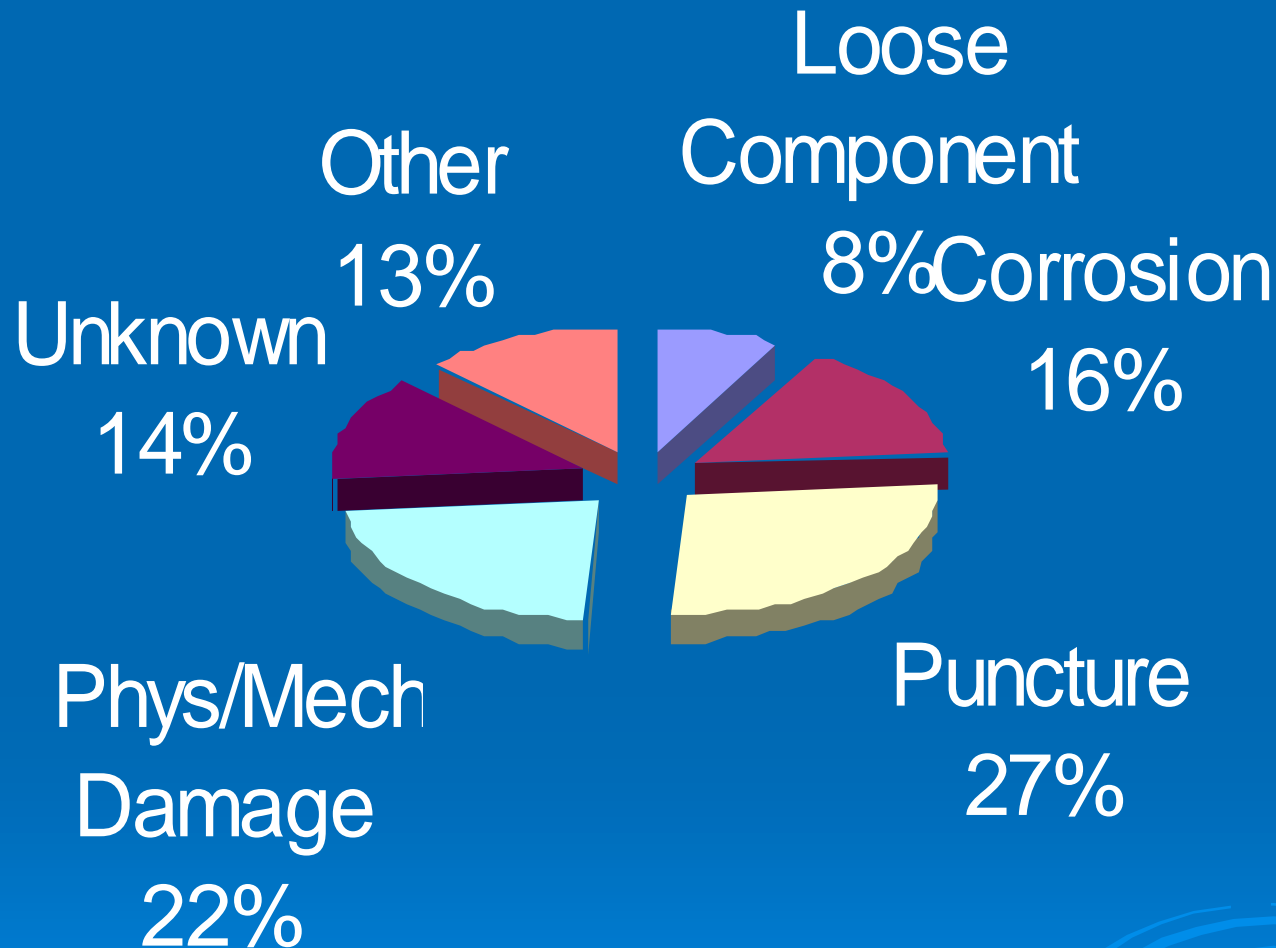
- Causes of Tank Releases -

Primary Cause of Steel Tank Release – Corrosion

Primary Cause of Fiberglass Tank Release - Puncture

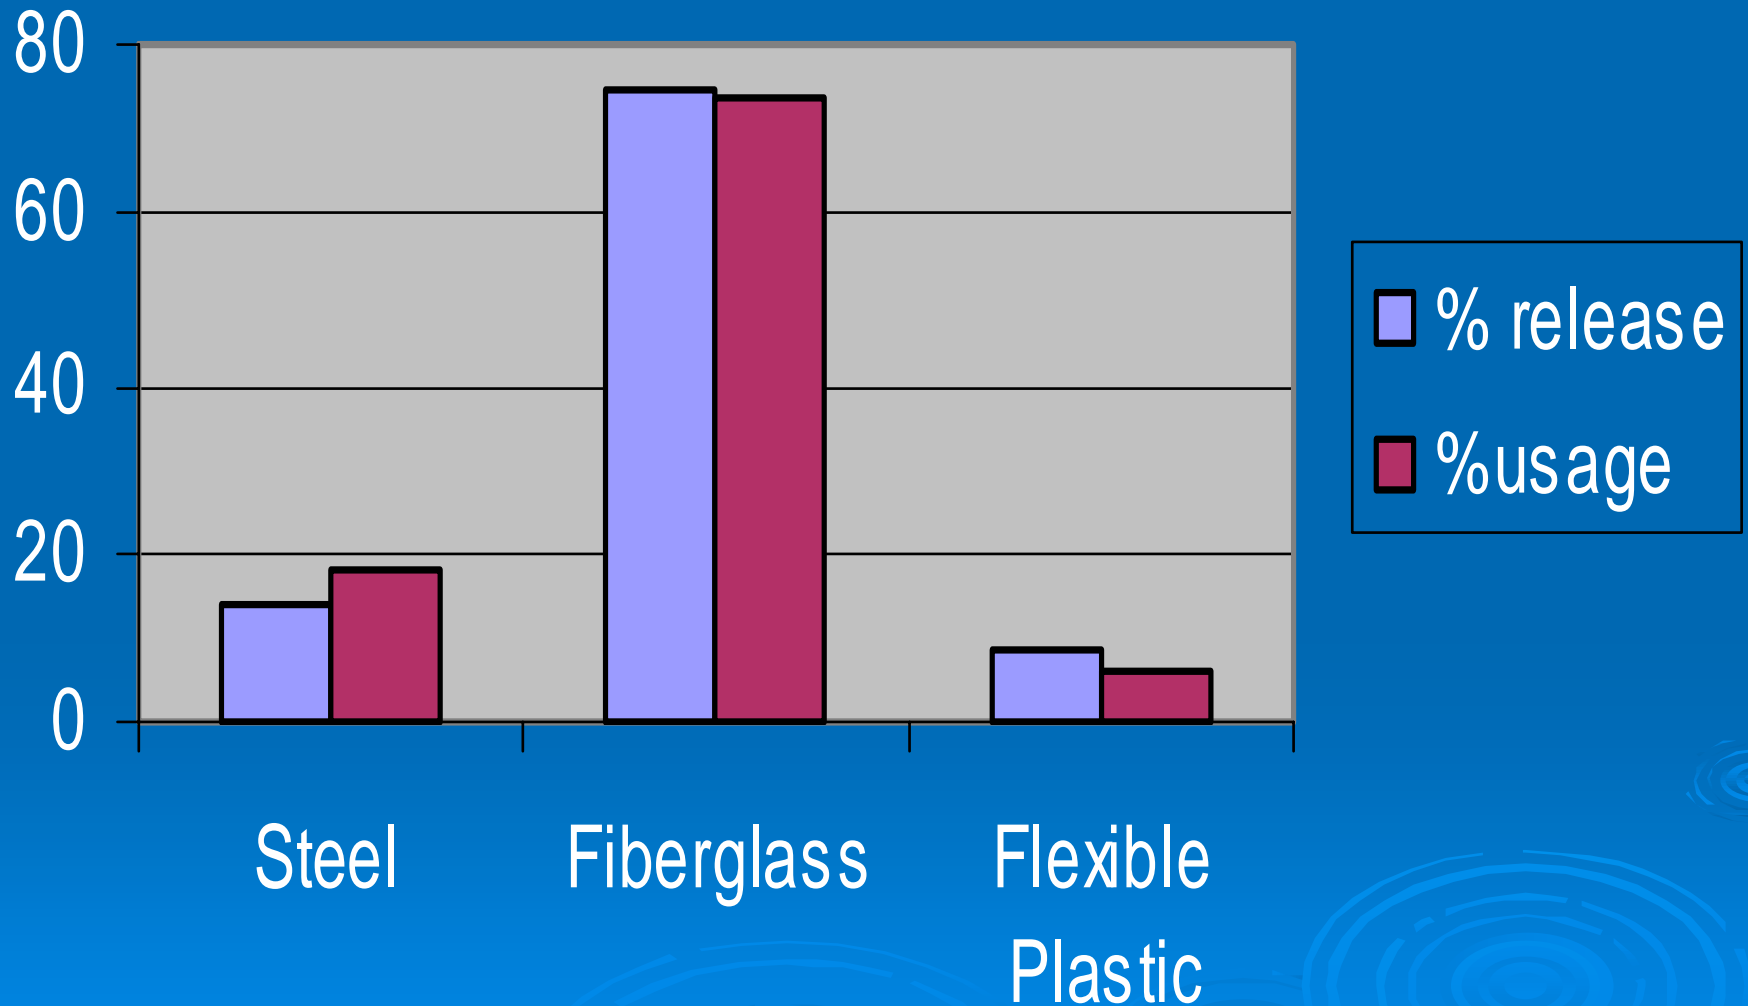
- Piping Usage Versus Releases -

Further Analysis Required to Determine Statistical Significance

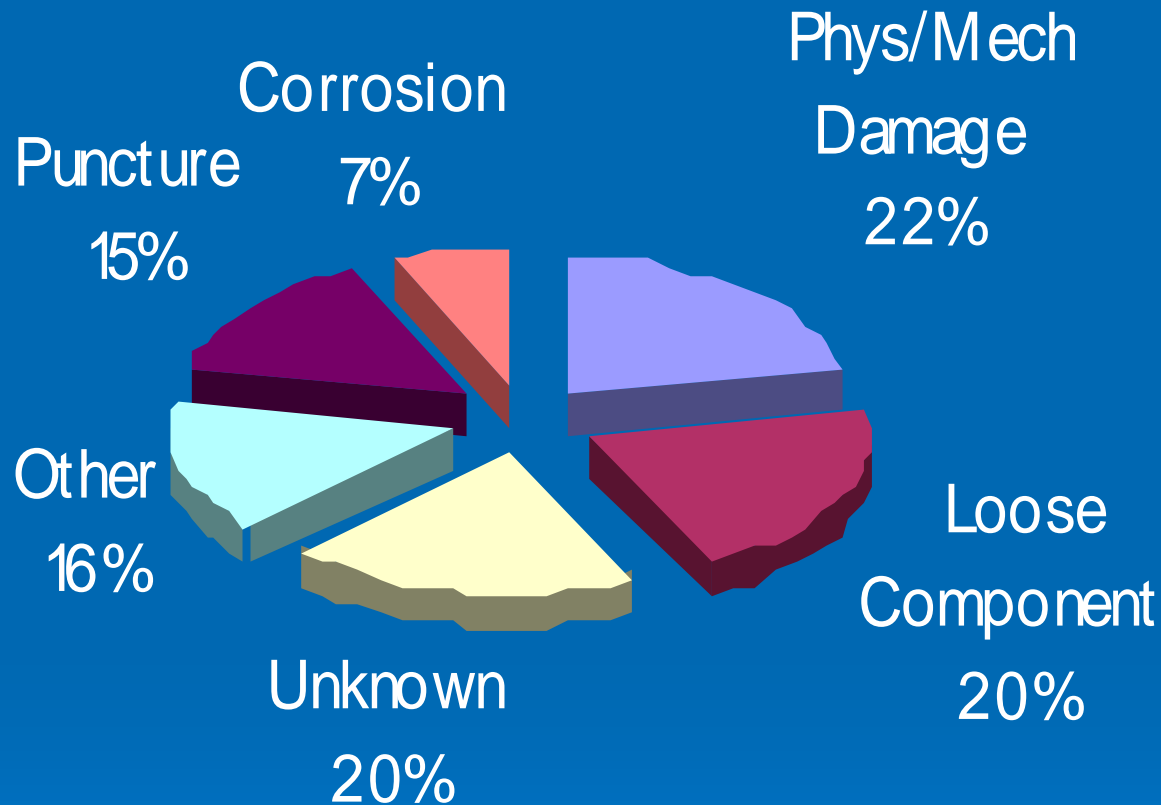
- Causes of Piping Releases -

- Primary Cause of Steel Piping Release – Corrosion
- Primary Cause of Fiberglass Piping Release – Loose Component
- Primary Cause of Flexible Plastic Piping – Phys/Mech Damage

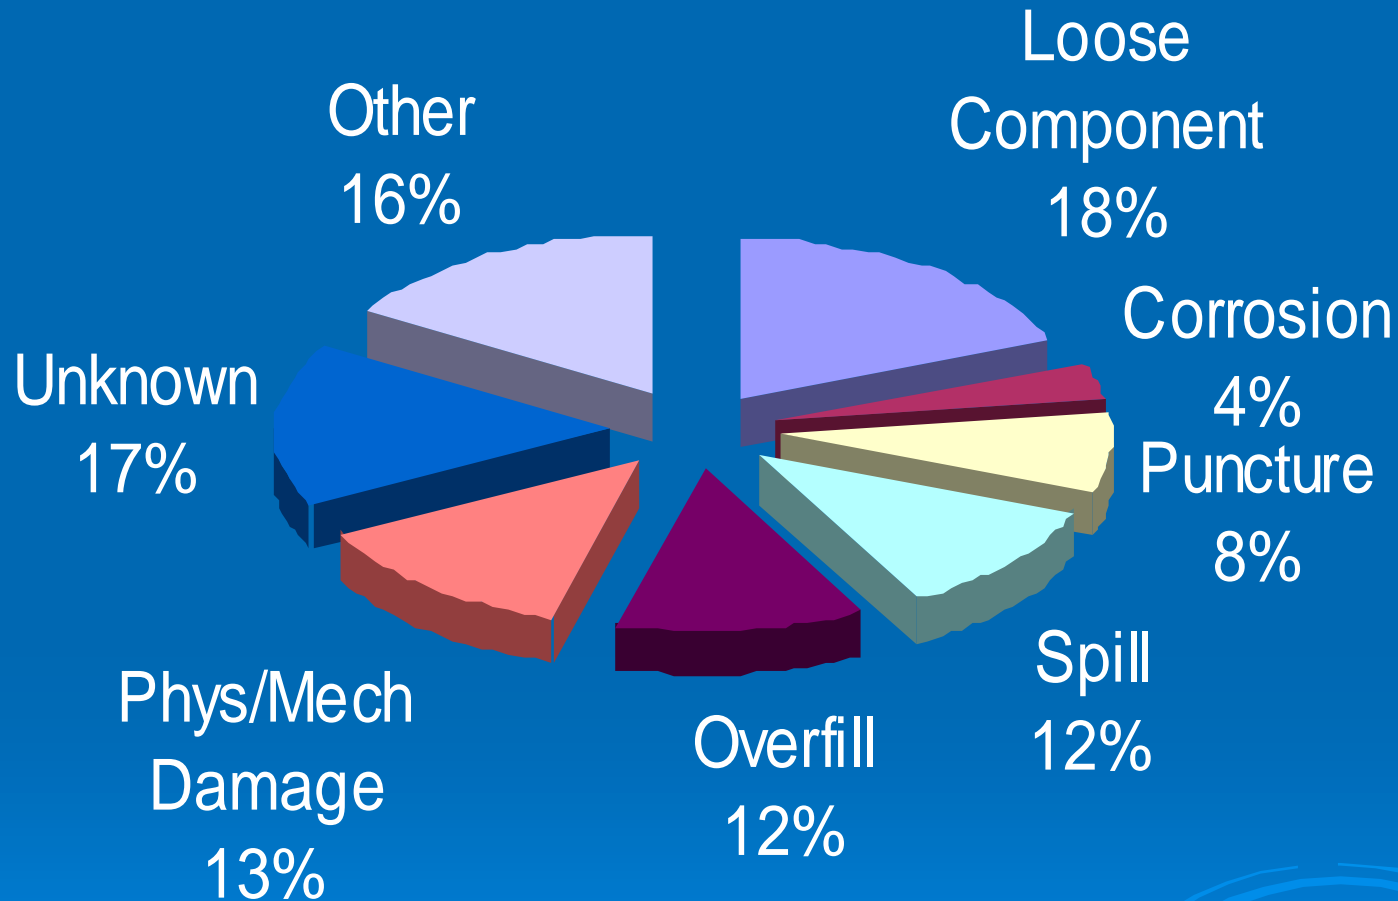
Summary of Causes - USTs

Other Releases Include: Delivery to Monitoring Well, Vehicle Accident, Improper Installation, Vandalism

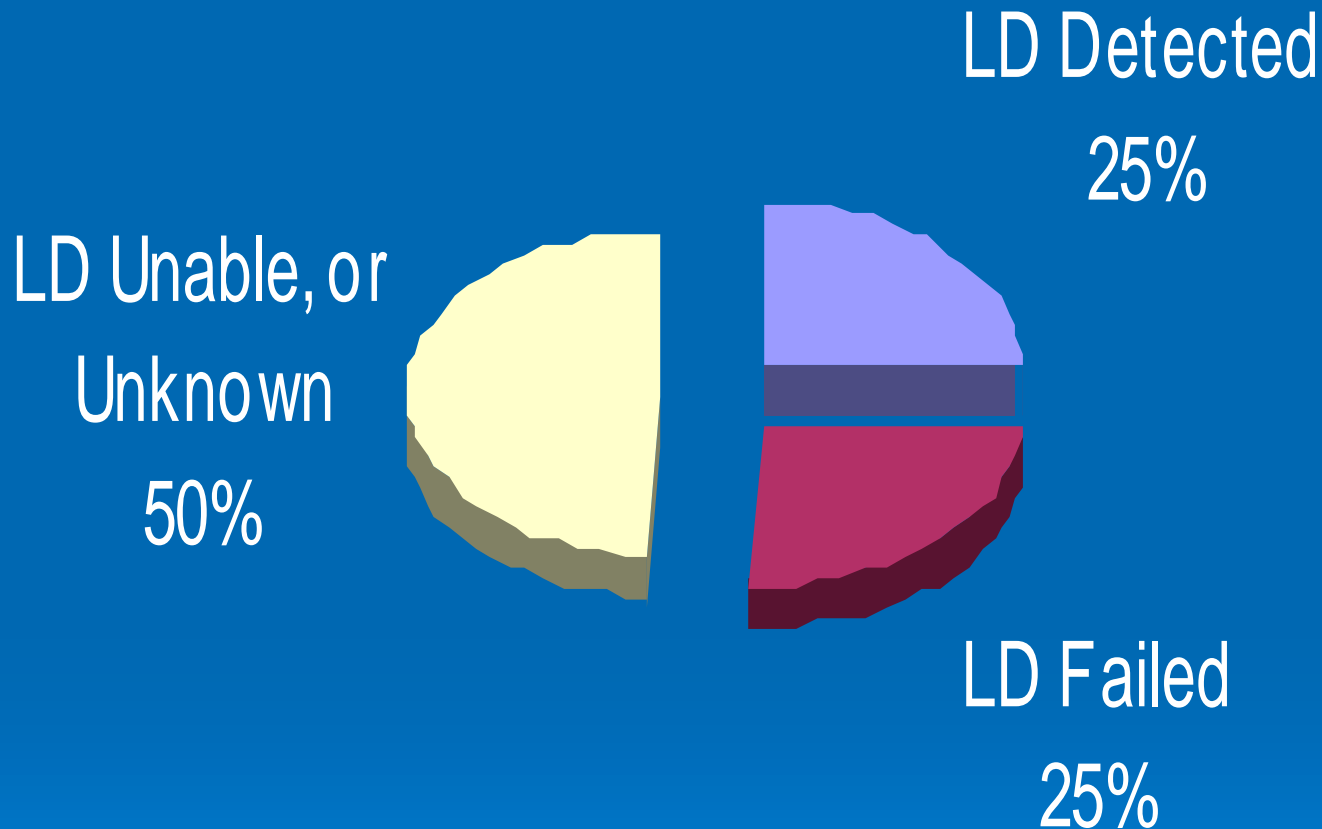
- Success of Leak Detection -

LD Unable, or Unknown: Either the release came from a part of the system that a LD system was not designed to detect, or the inspector could not determine whether LD failed to detect.

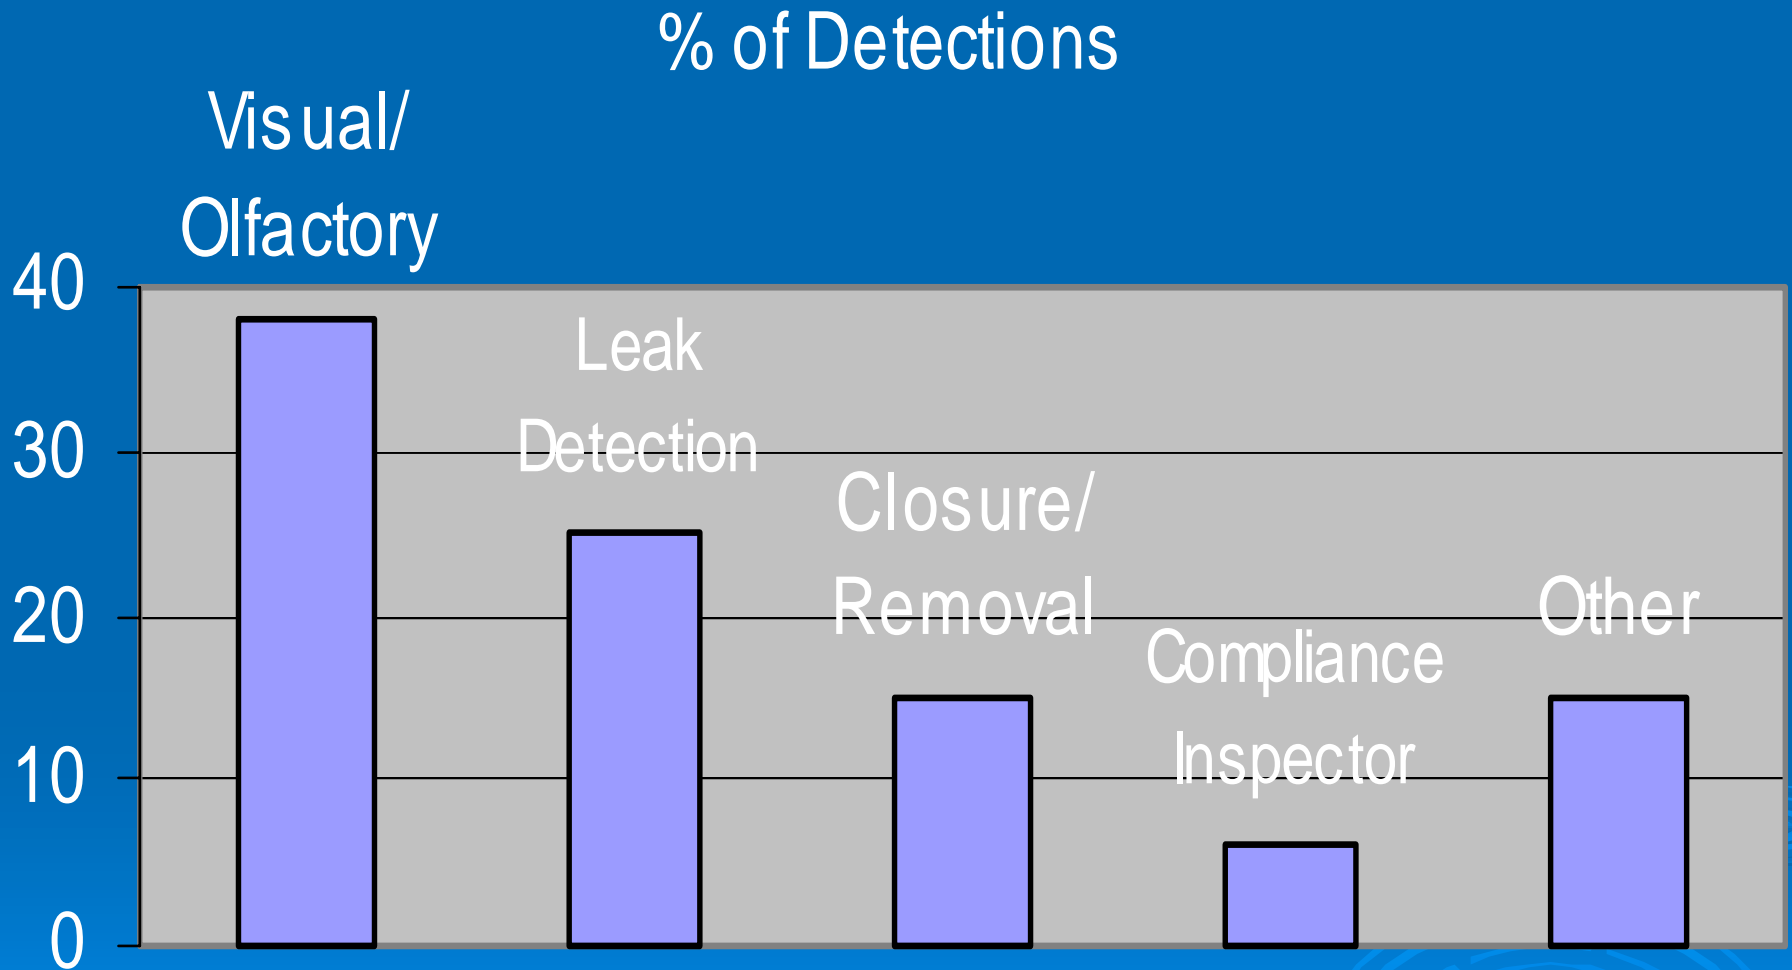
- Method of Detection -

Other Methods Include: Unscheduled TTT/LTT, Dispenser Upgrades, Maintenance Inspections, Water in Tank

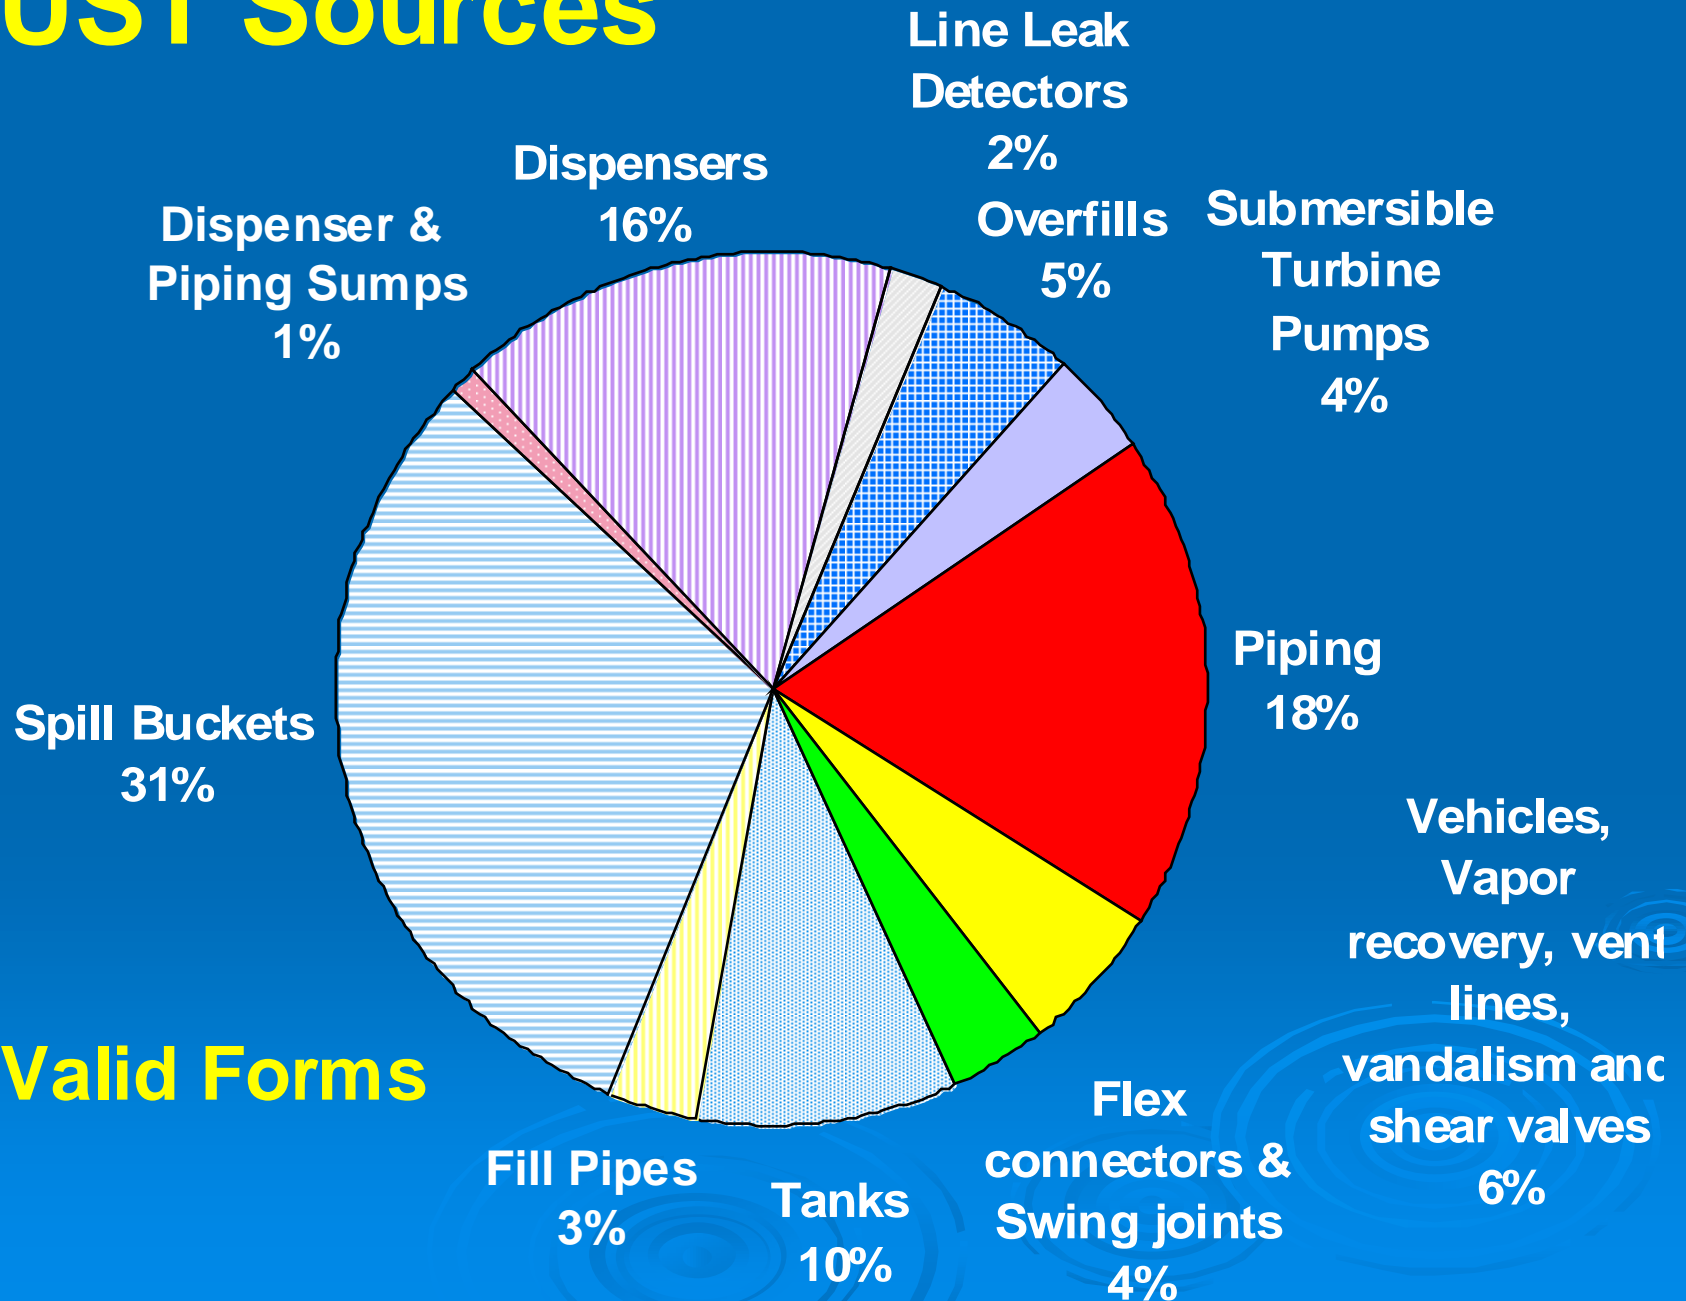
UST Sources

305 Valid Forms

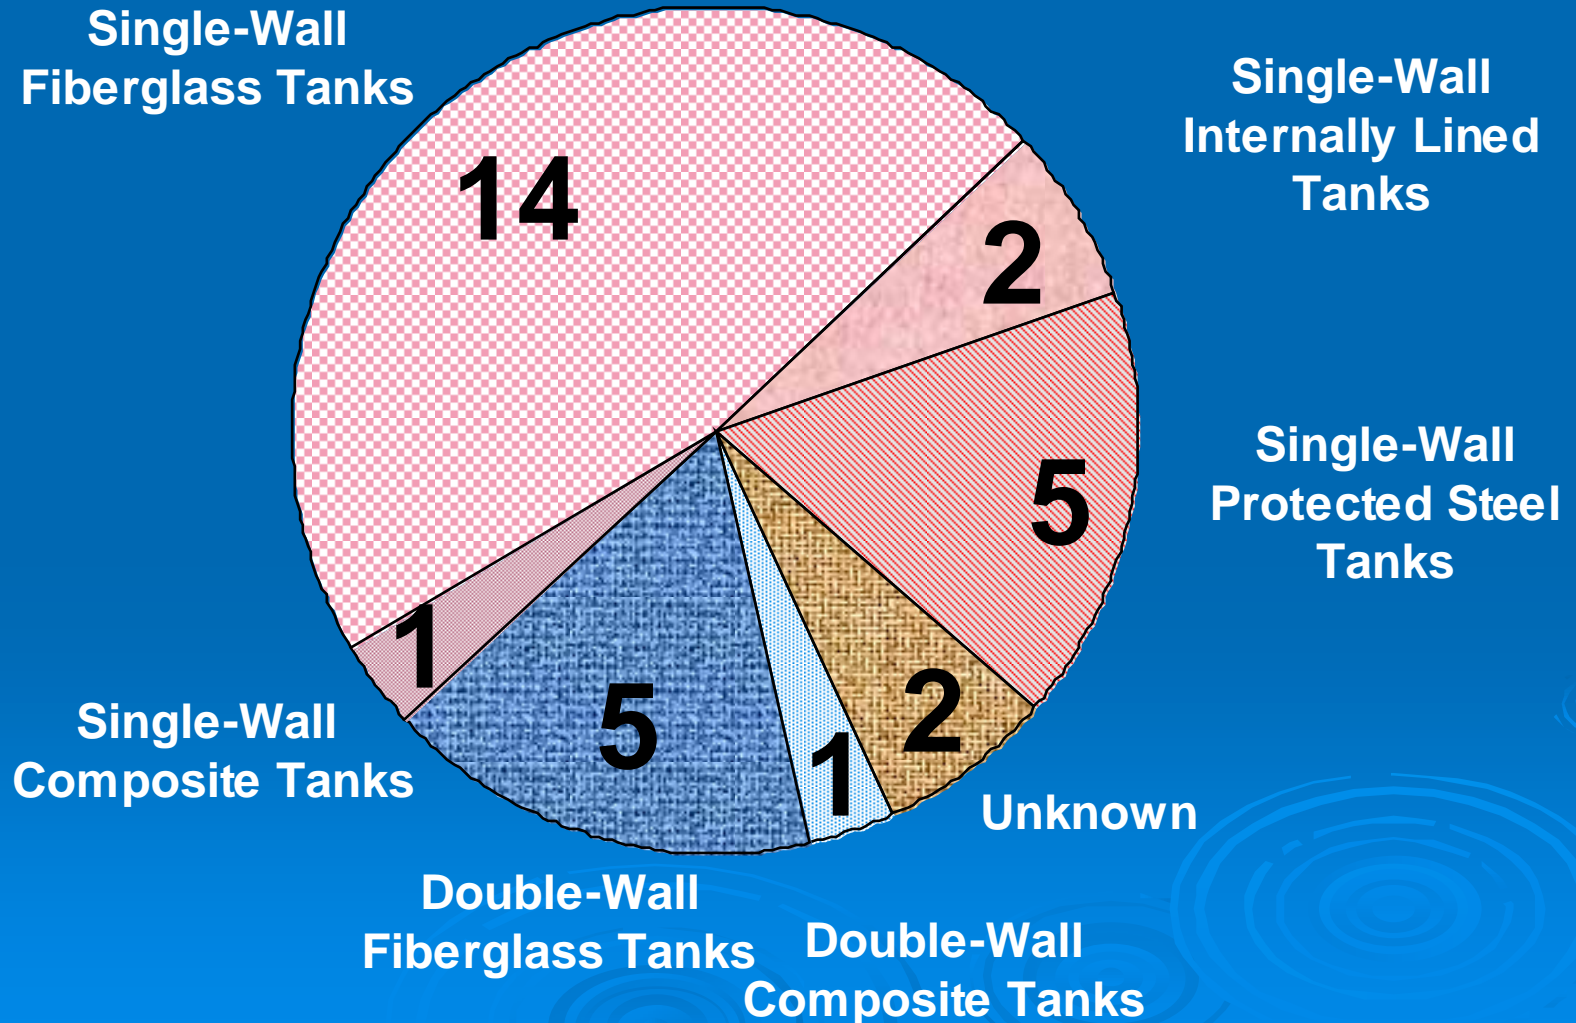
Tanks – 10%

Double-wall tanks – 2%

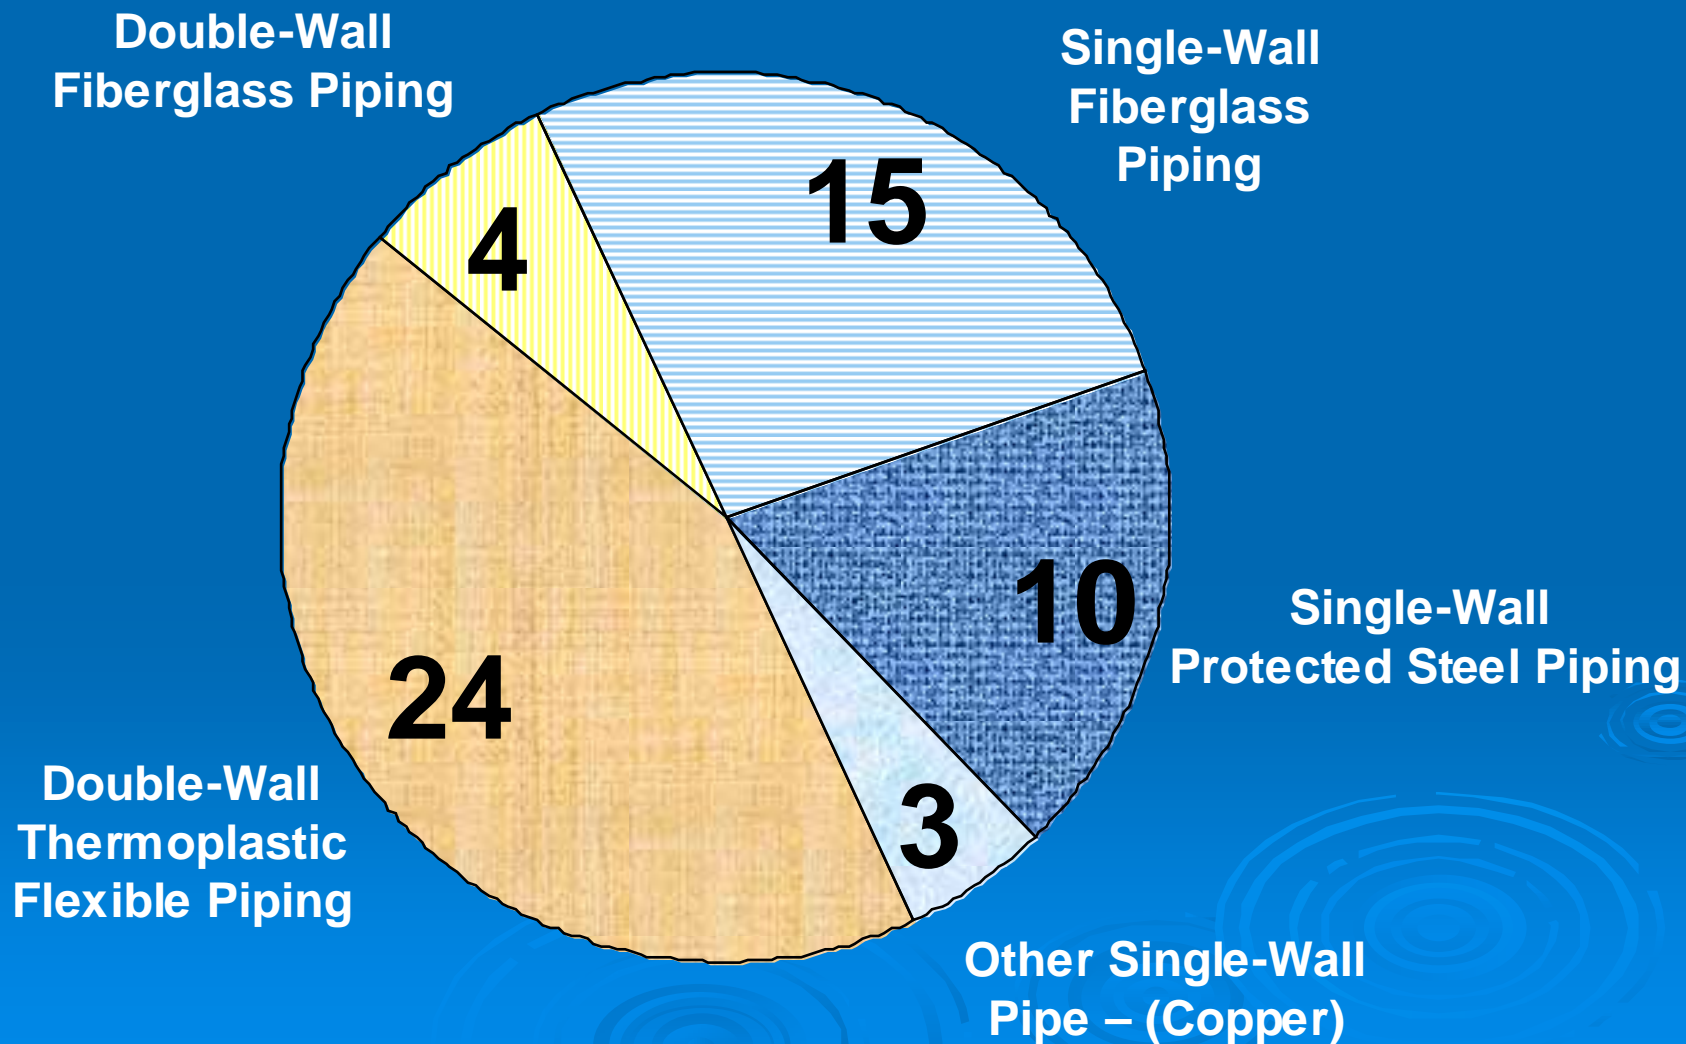
Piping – 18%

Double-wall piping – 9%

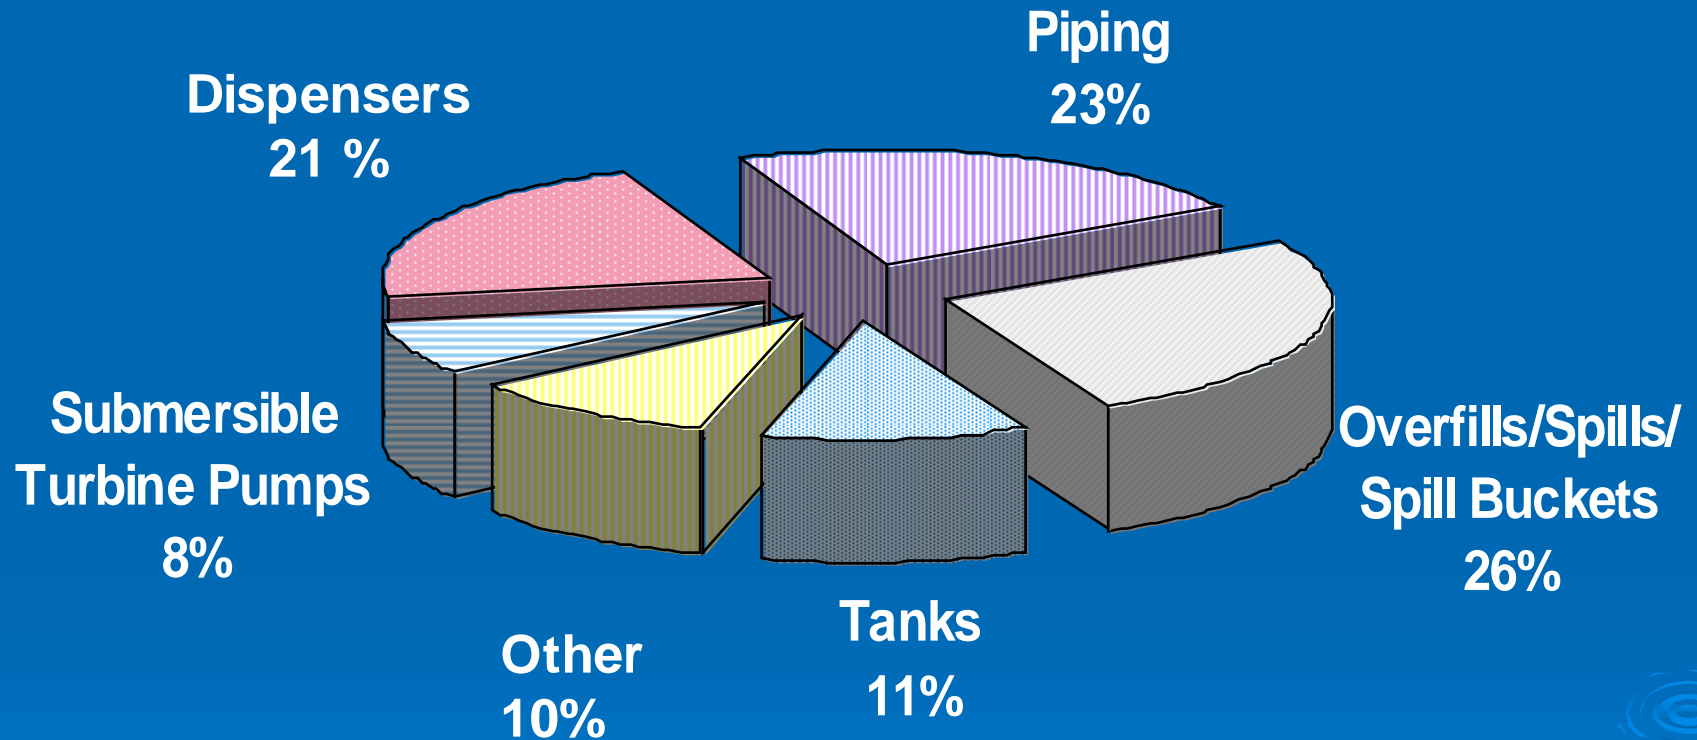
Combined Data

827 Valid UST Forms
