SECONDARY CONTAINMENT - DOUBLE TROUBLE ?

KEVIN HENDERSON

**17th ANNUAL UST/LUST NATIONAL CONFERENCE
SEATTLE, WASHINGTON**

MARCH 15, 2005

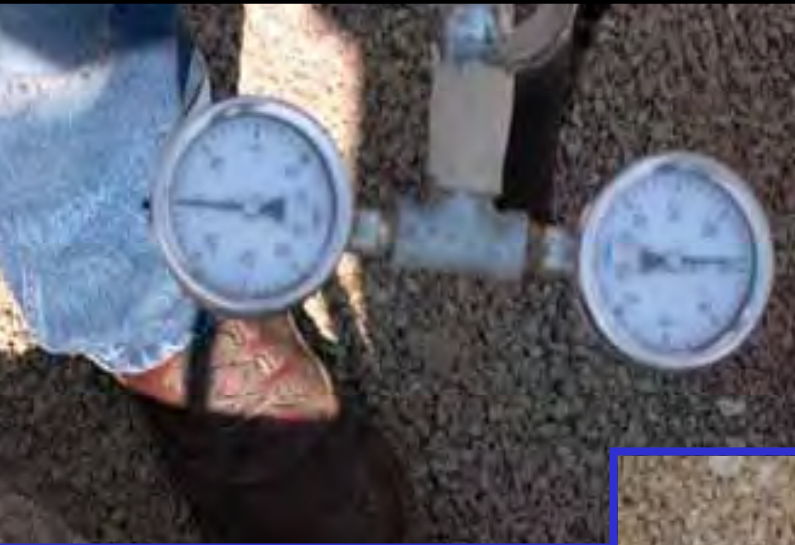
CALIFORNIA INTEGRITY TESTING

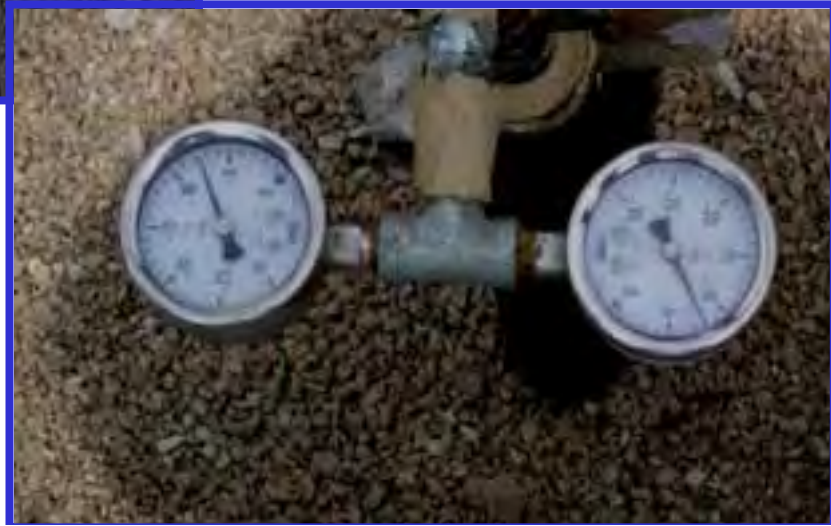
**PERIODIC TANK TEST FOR
INTERSTITIAL TIGHTNESS**

Test Requirements

- **Vacuum Minimum = 15" Hg**
- **Test Period = 12 Hours**
- **Decrease > 5" = Fail**

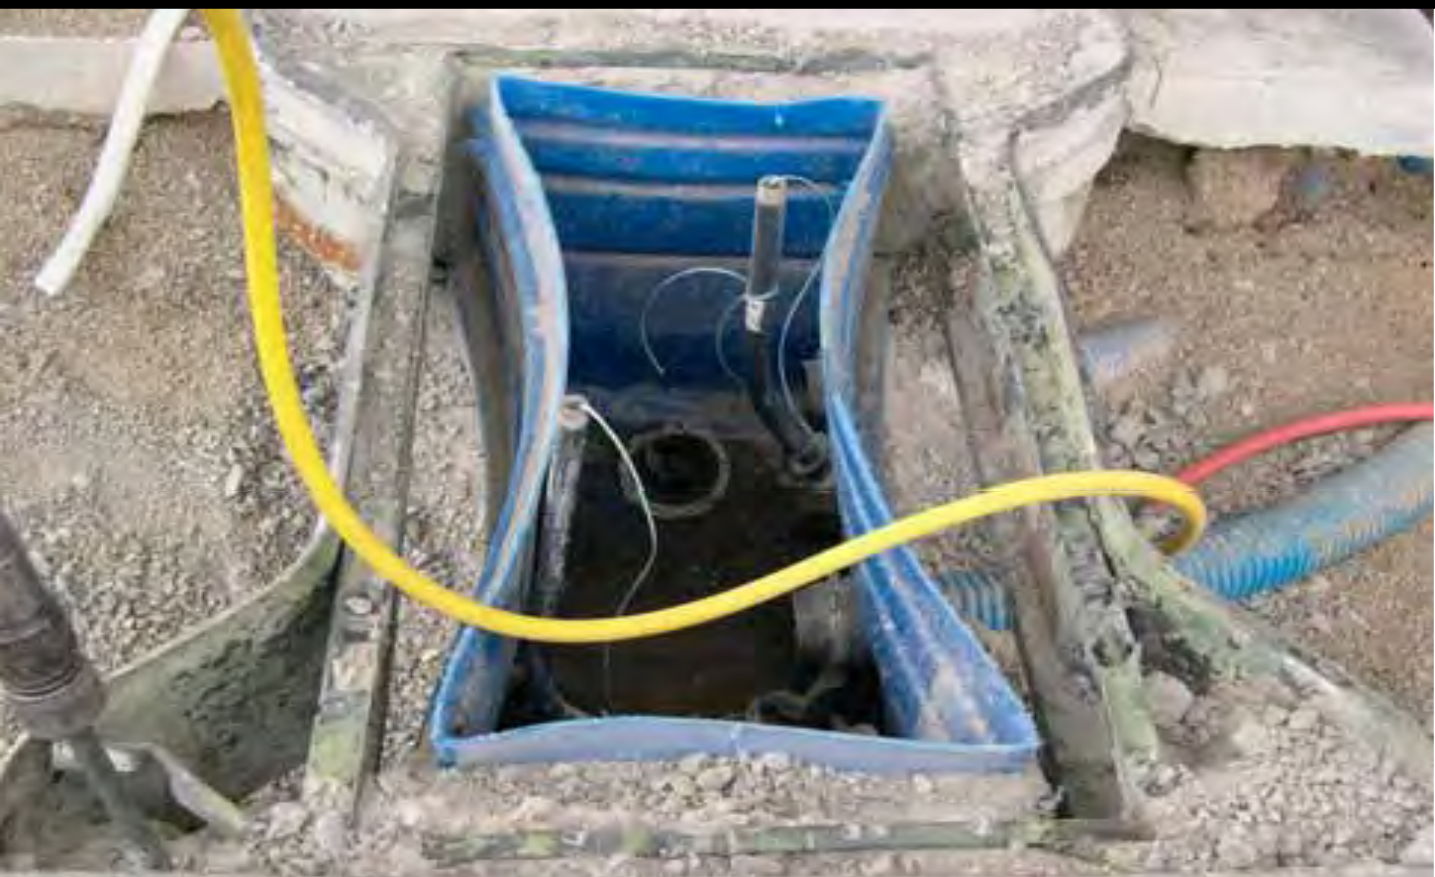
THERMOPLASTIC SUMP INTEGRITY ?

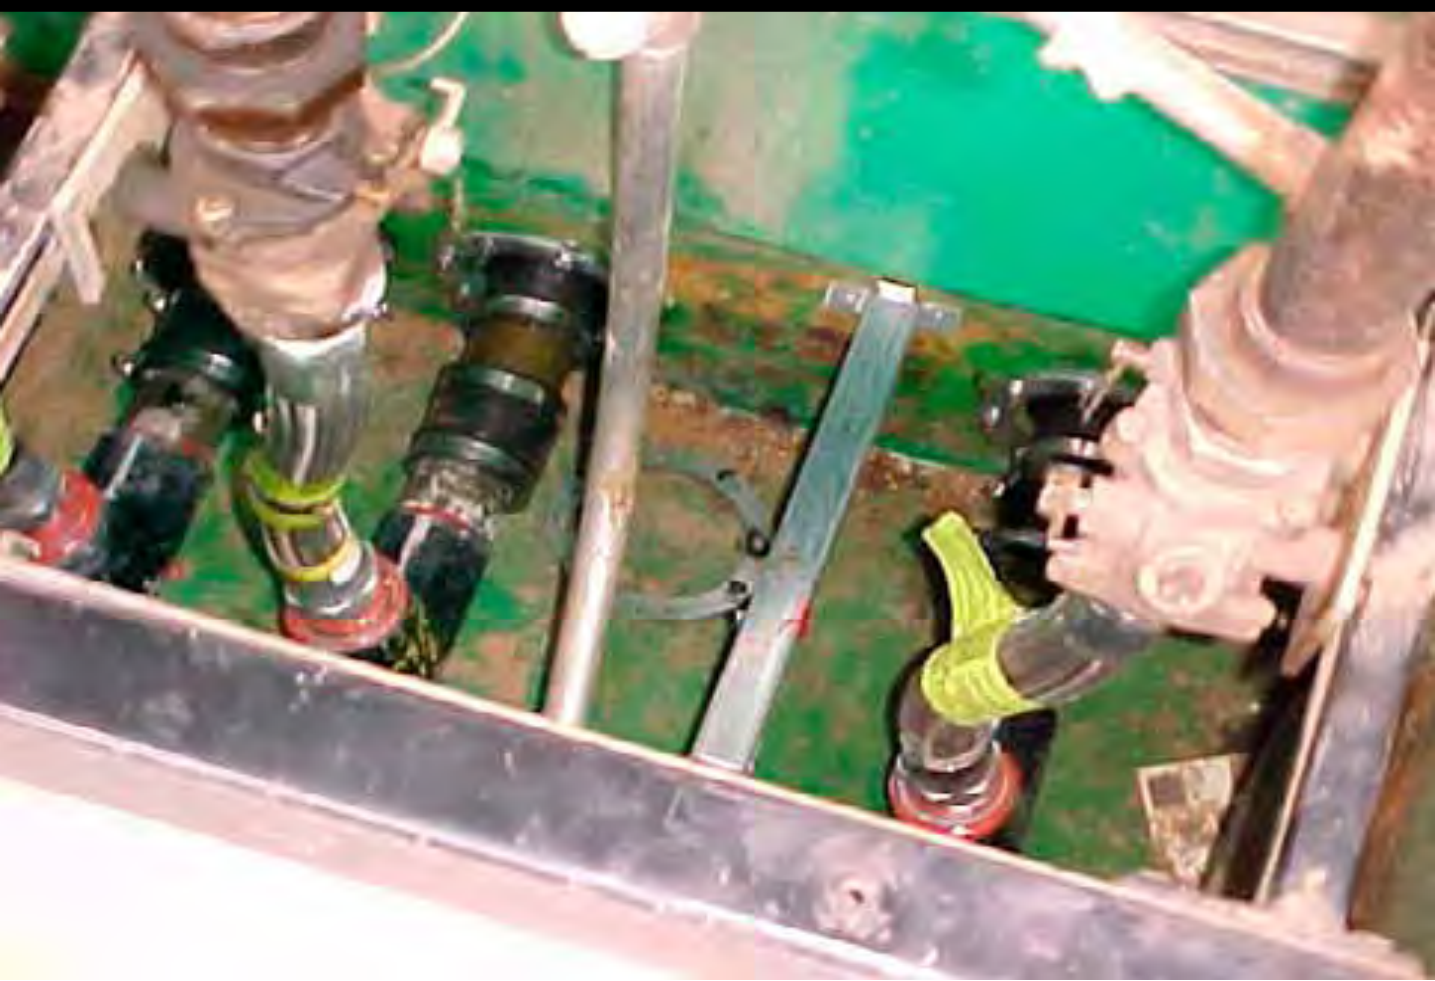
SUMP BRACING

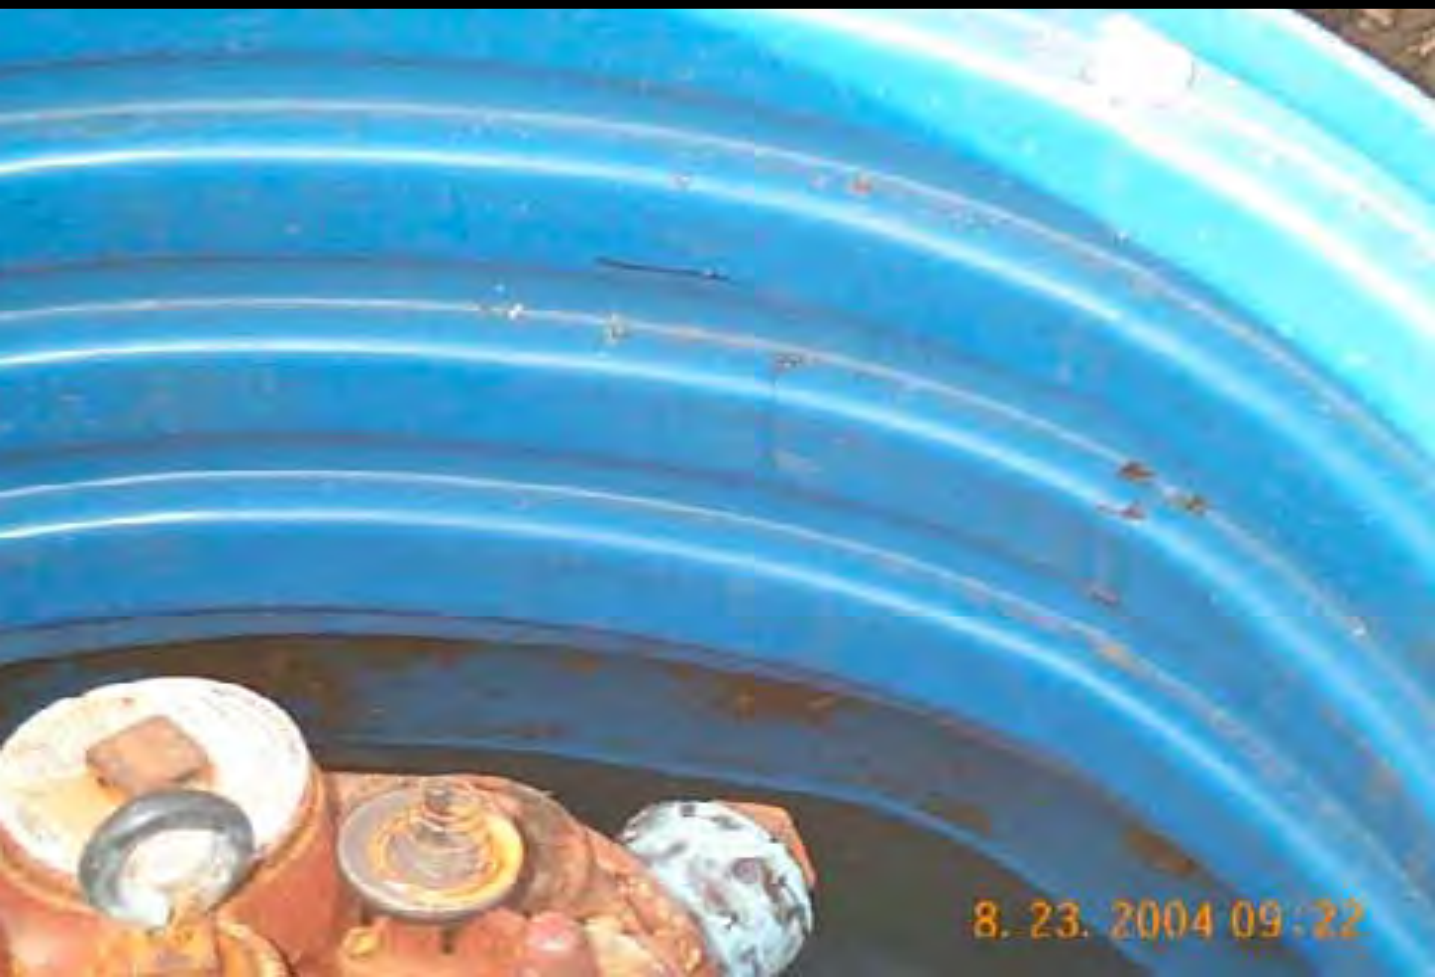
SUMP INTEGRITY TESTING

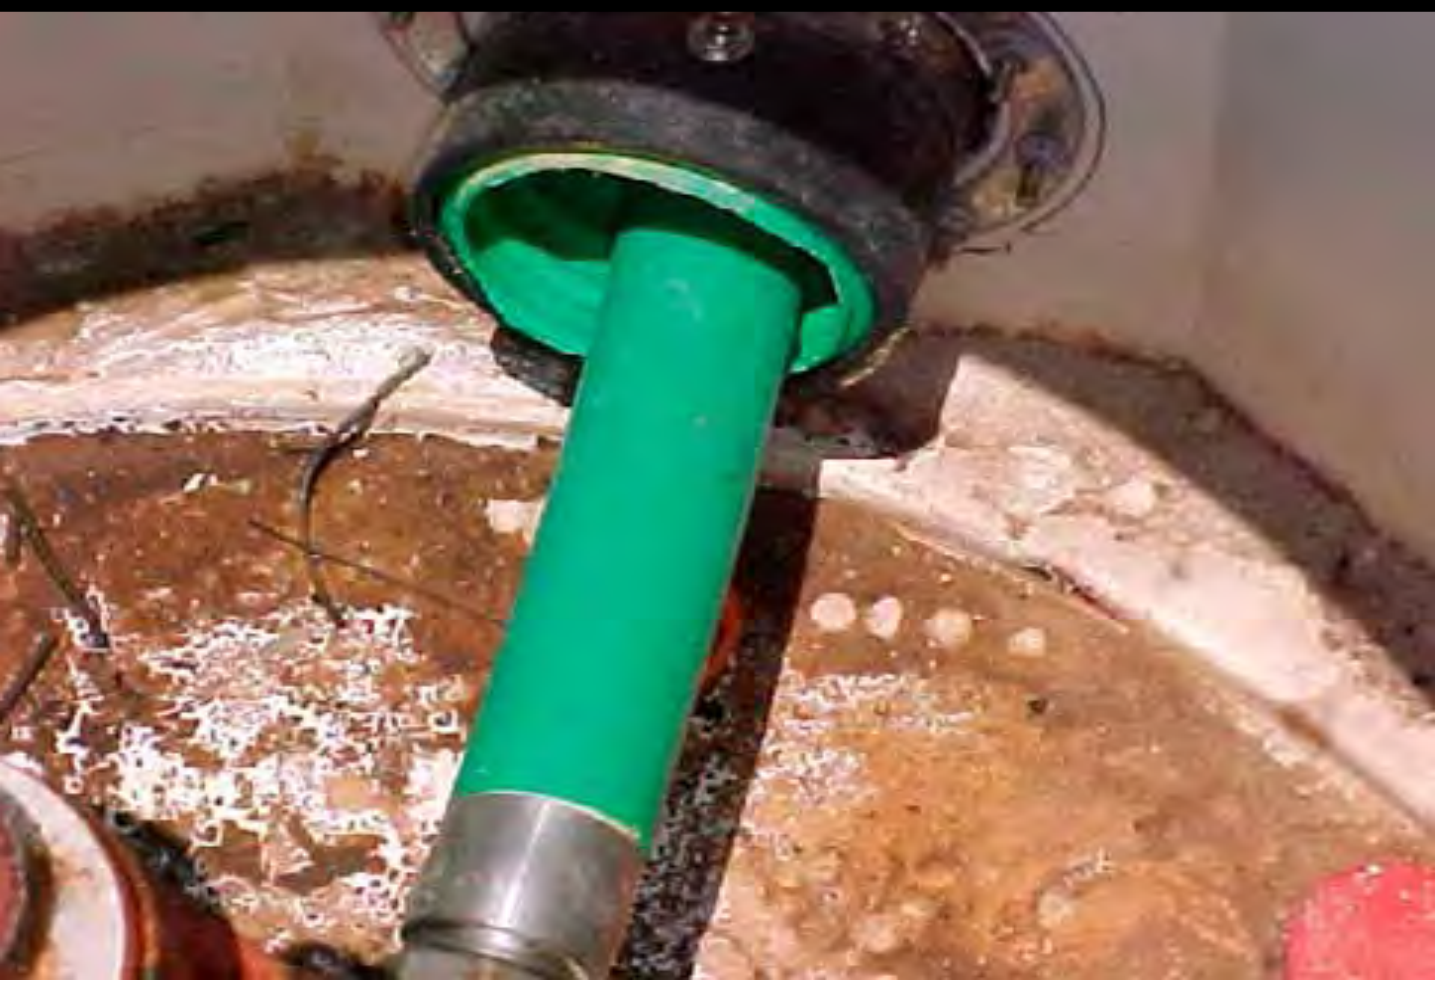
SECONDARY CONTAINMENT ?

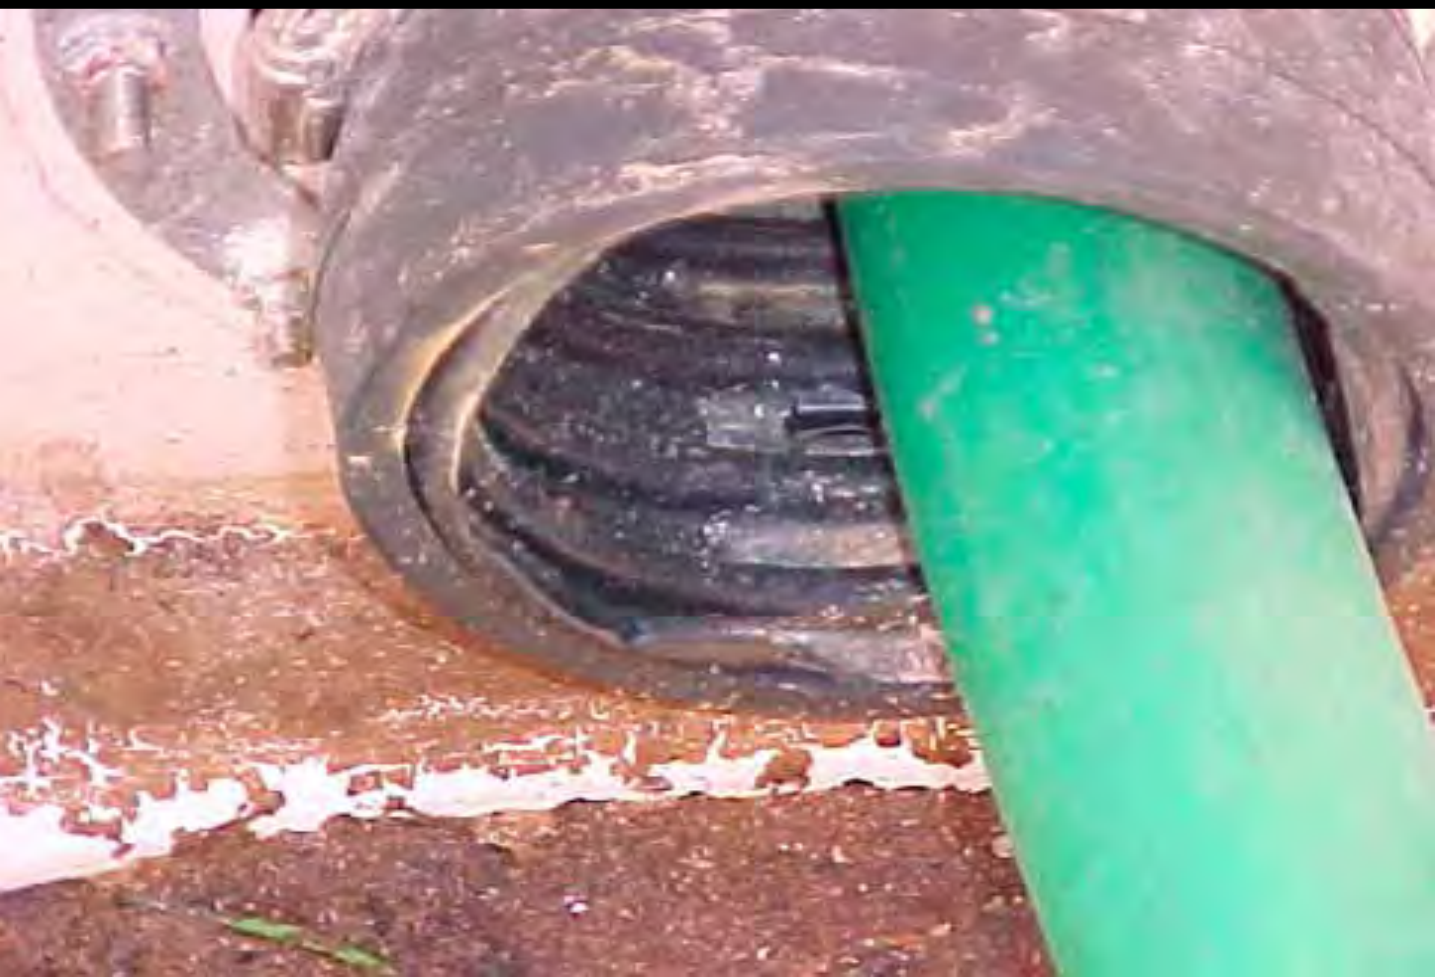
SECONDARY CONTAINMENT ?

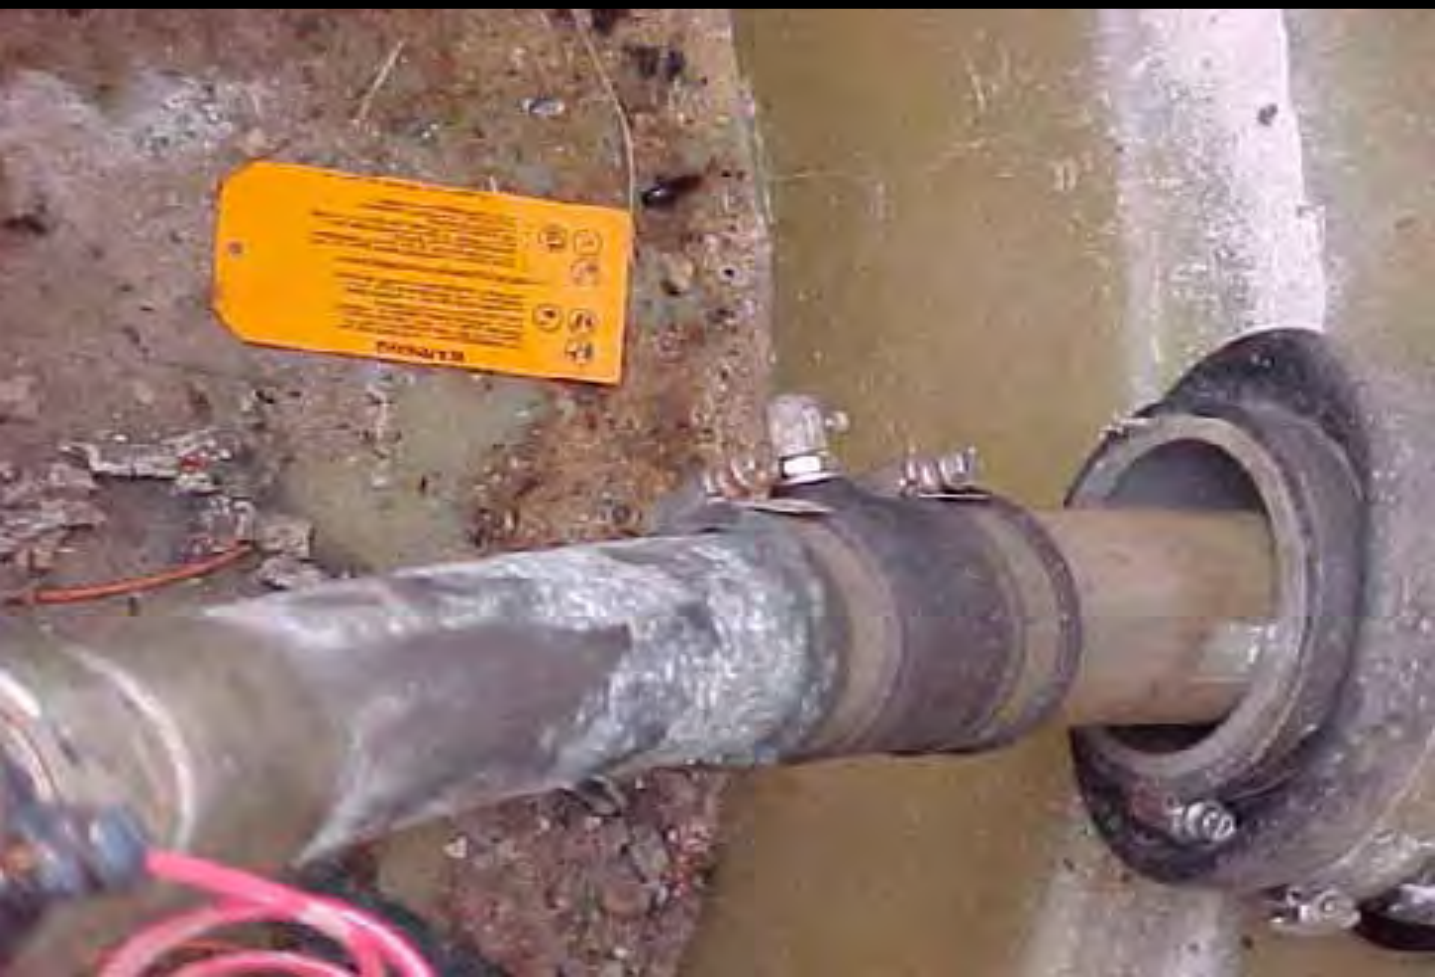
SECONDARY CONTAINMENT ?

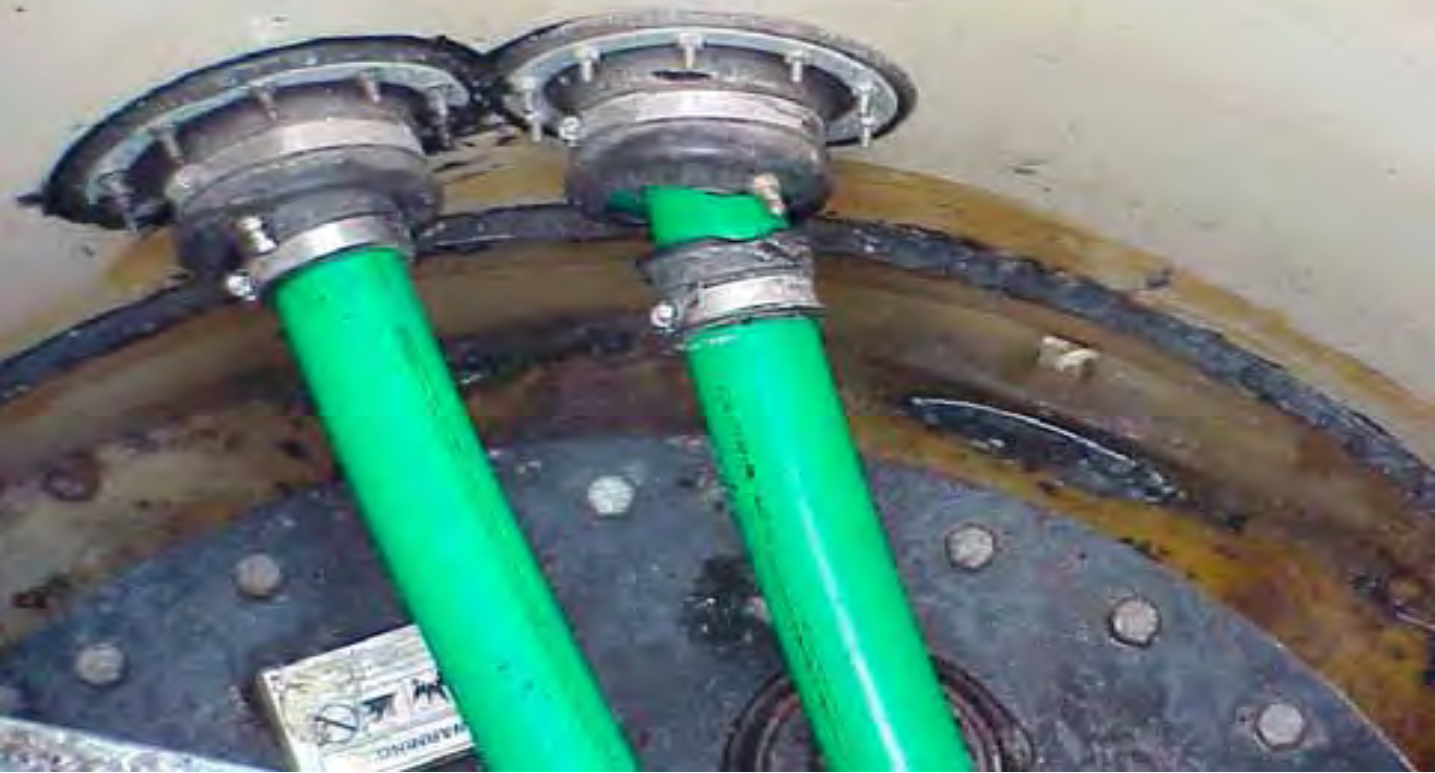
Case #338
Frederick, MD
Environ
1 of 2

PIPE BOOT INTEGRITY
